# Design Guide

for Improving School Safety in Earthquakes, Floods,  
and High Winds

FEMA P-424 / December 2010

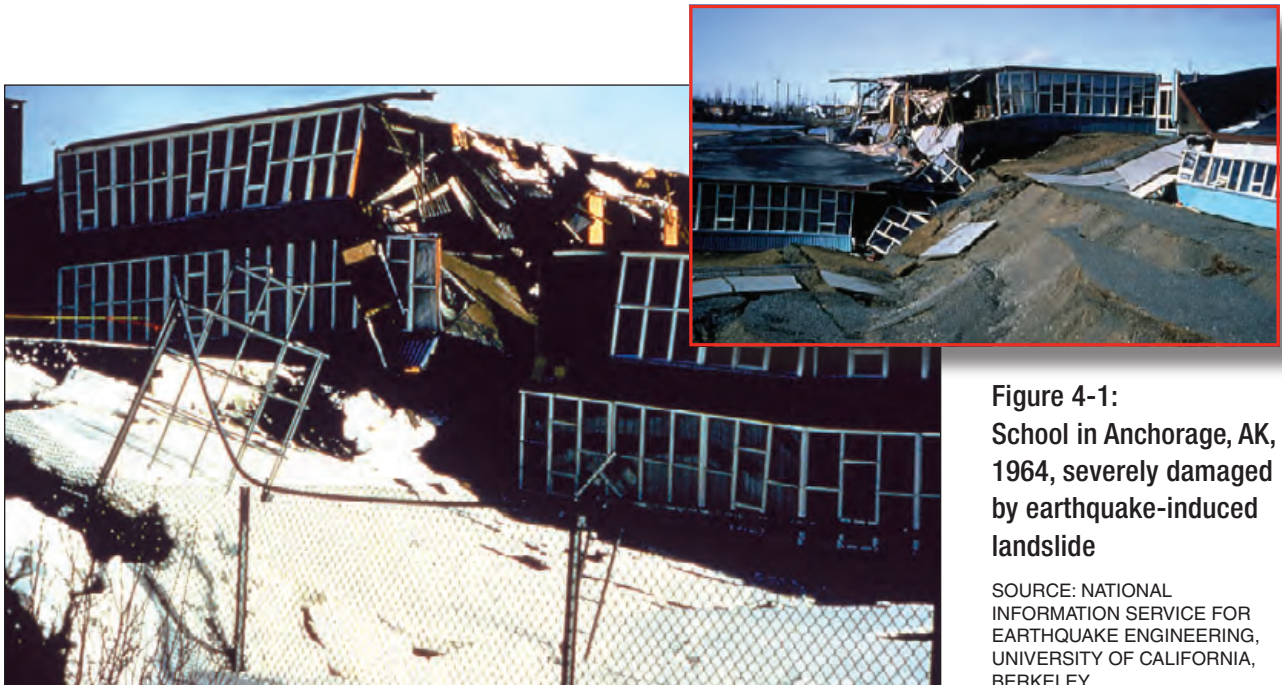
**Figure 4-1:**  
School in Anchorage, AK,  
1964, severely damaged  
by earthquake-induced  
landslide

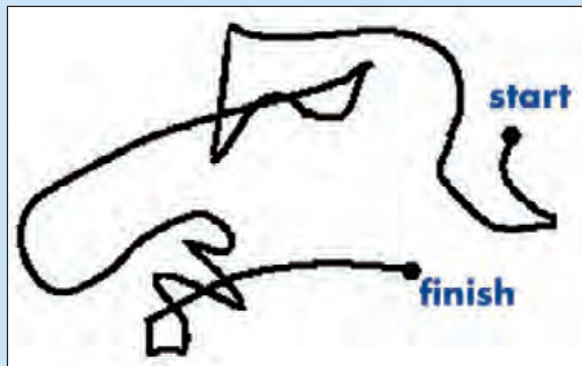
Scratch left on a floor by a kitchen range in the 1933 Long Beach earthquake that shows the random nature of earthquake motion.

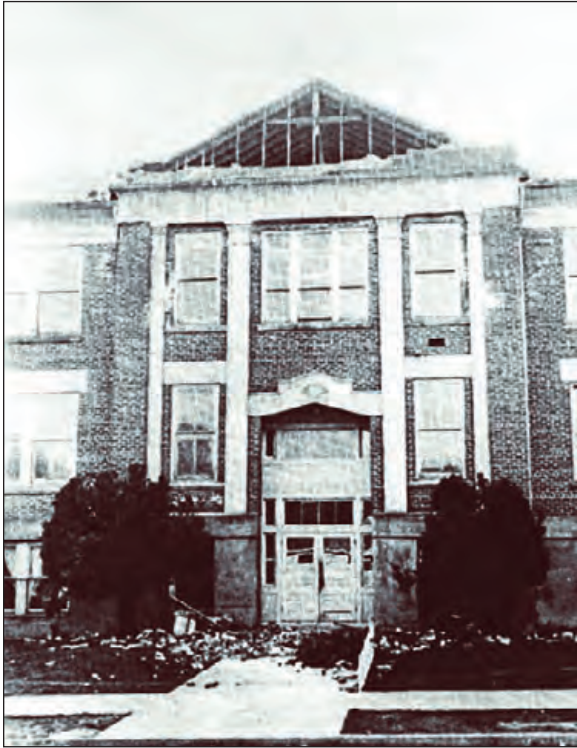
**Figure 4-19:**  
**The student body president was killed here by falling brickwork, Seattle, WA, 1949**

Other States have experienced similar damage to URM and early reinforced concrete structures. Schools in Helena, MT, suffered considerable damage in 1935 (see Figure 4-18). In 1949, several URM schools in Seattle were severely damaged, resulting in one fatality (see Figures 4-19 and 4-20). At Puyallup High School, three boys on a stage just managed to escape when the roof collapsed (see Figure 4-21). The furniture and contents also sustained widespread damage (see Figure 4-22).

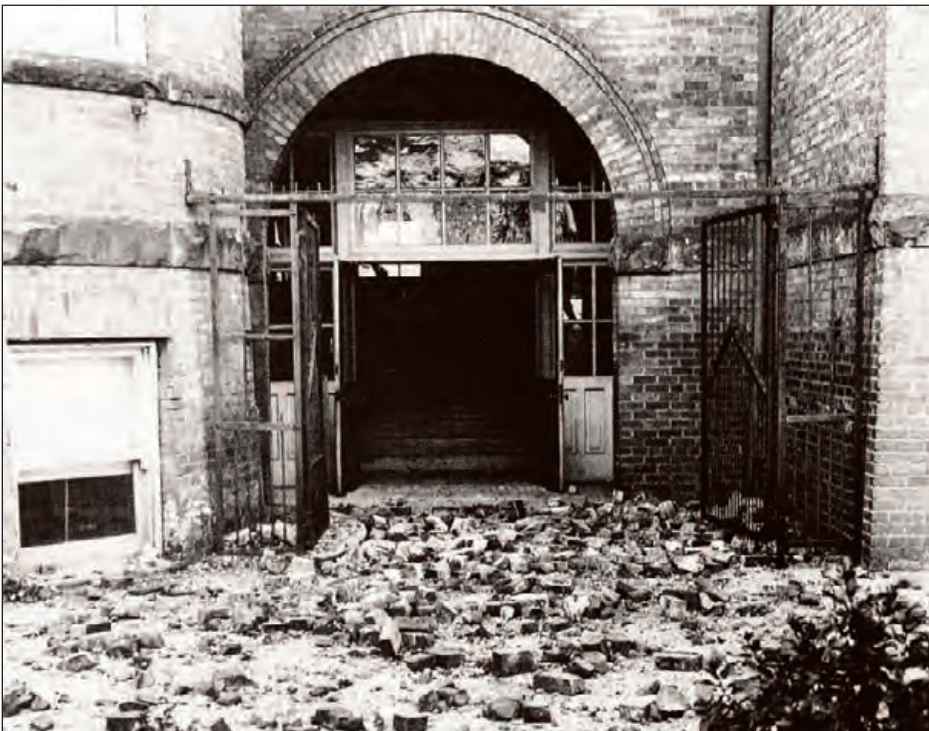
**Figure 4-20:**  
**Another dangerous entry collapse, Seattle, WA, 1949**

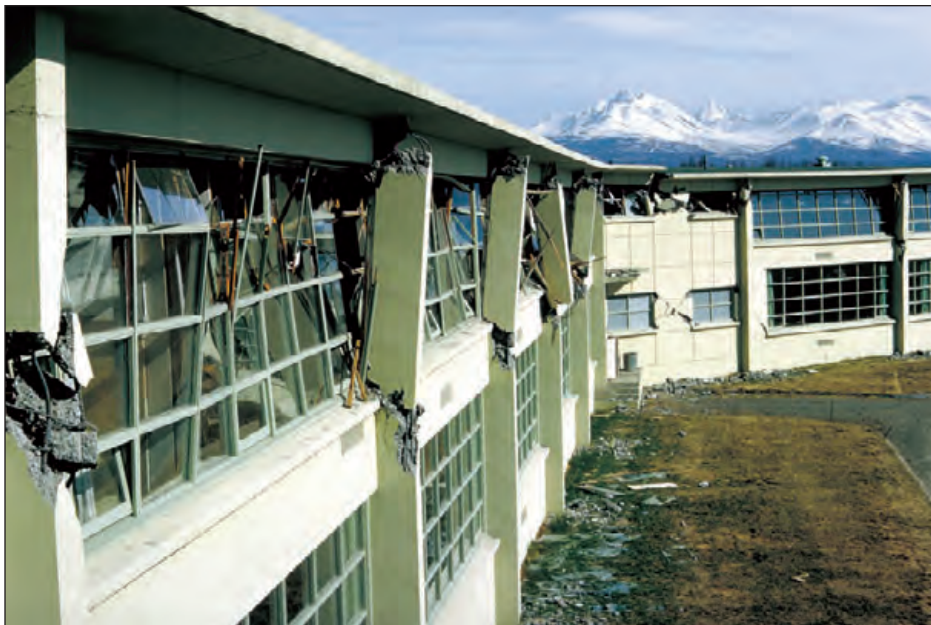
**Figure 4-23:**  
Severe structural damage  
to the West Anchorage High  
School, Anchorage, AK, 1964

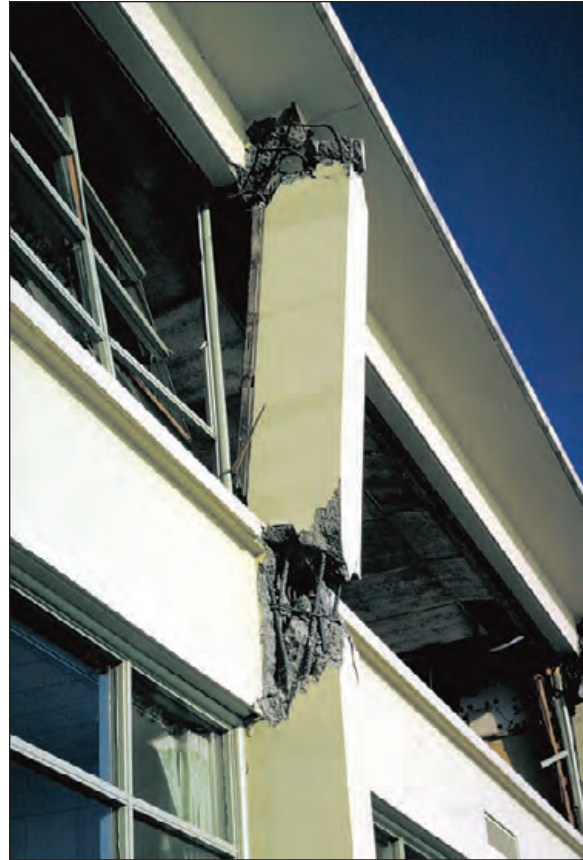
**Figure 4-24:**  
**Brittle failure at nonductile concrete column,**  
**West Anchorage High School, 1964**

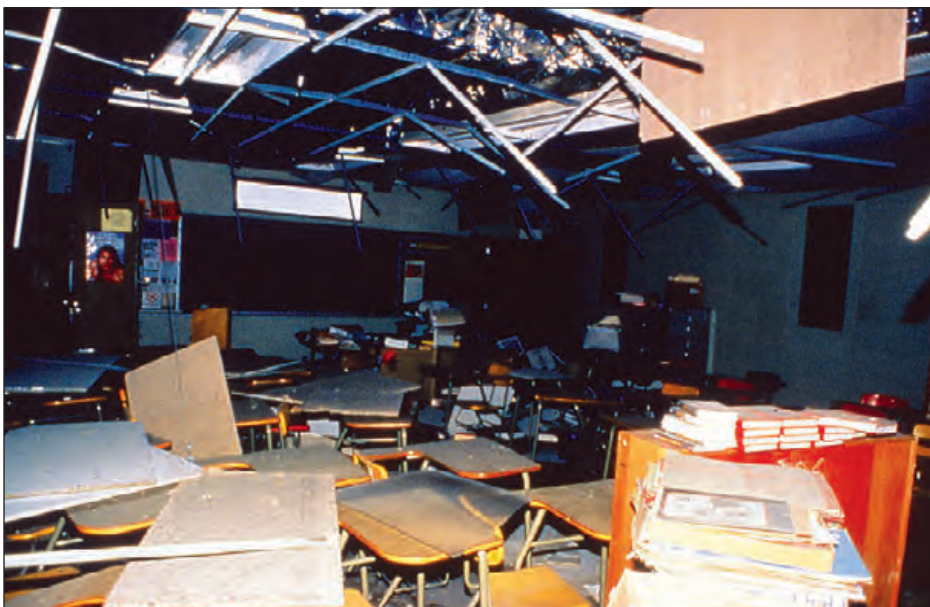
**Figure 4-25:**  
Ceiling damage,  
Northridge, CA, 1994

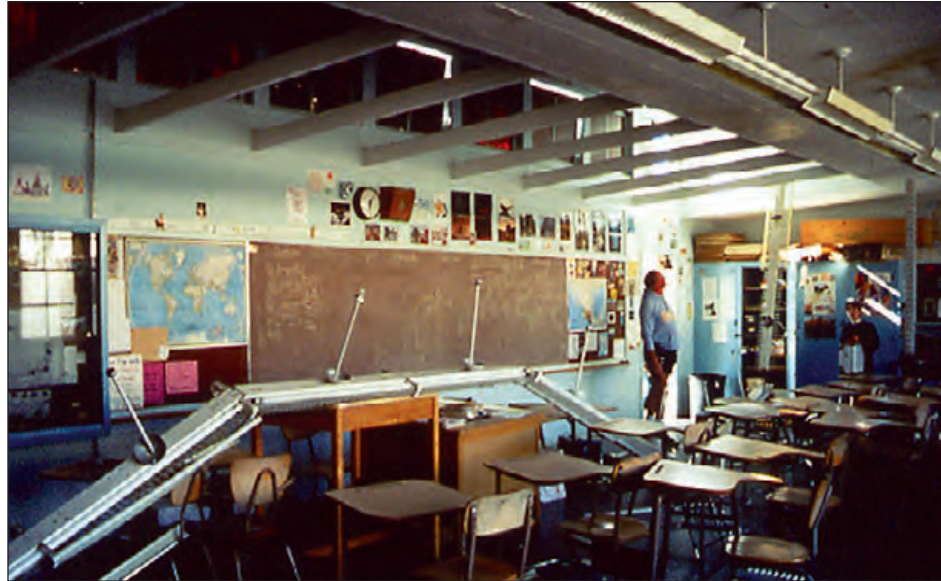
**Figure 4-27:**  
Line of suspended light fixtures fallen on teacher's  
station, Northridge, CA, 1994

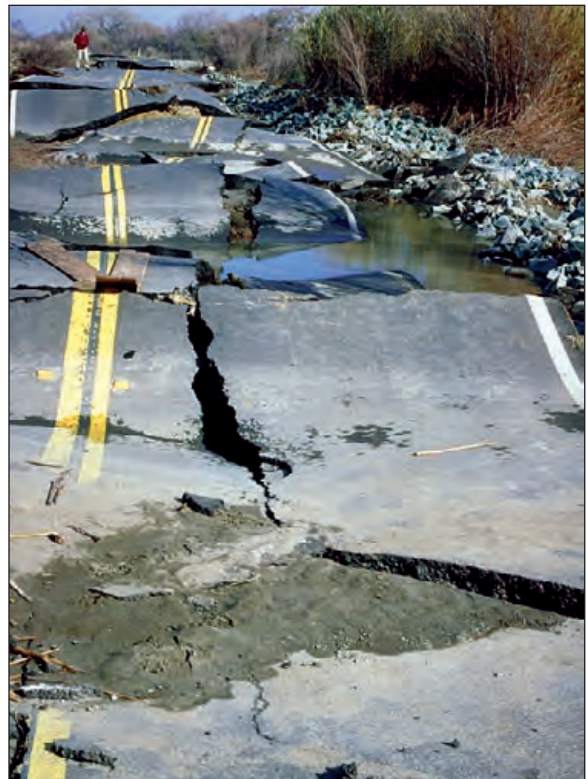
**Figure 5-12:**  
Flooding caused the failure of this road bed

**Access roads:** Access roads that extend across floodprone areas can be damaged by erosion, washout of drainage culverts, failure of fill and bedding materials, and loss of road surface (see Figure 5-12). Road damage could prevent uninterrupted access to a school and thus impair its functionality.

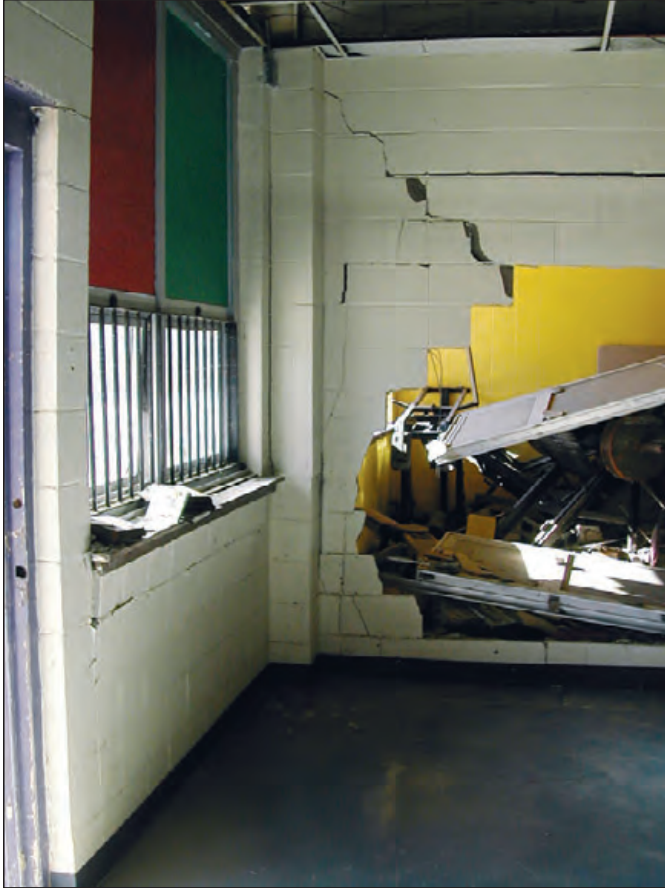
**Figure 5-14:** Interior unreinforced masonry walls of the Port Sulphur High School in Louisiana were damaged by hydrostatic loads associated with Hurricane Katrina's storm surge (2005)

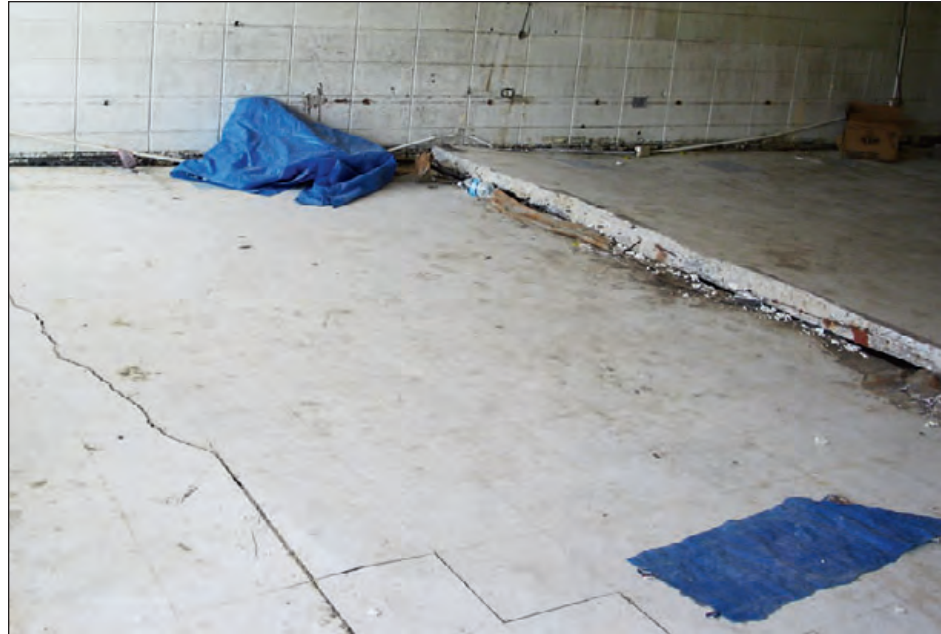
Figure 5-15:  
Concrete slab ruptured  
by hydrostatic pressure  
(buoyancy) induced  
by the floodwaters of  
Hurricane Katrina (2005)

**Buoyancy and uplift:** If below-grade areas are essentially watertight, buoyancy or uplift forces can float a building out of the ground or rupture concrete slabs-on-grade (see Figure 5-15). Buildings that are not adequately anchored can also be floated or pushed off foundations. Although rare for large and heavy school buildings, this is a concern for outbuildings and portable (temporary) classrooms. Buoyancy is a significant concern for underground and aboveground tanks, especially those used for emergency generator fuel.

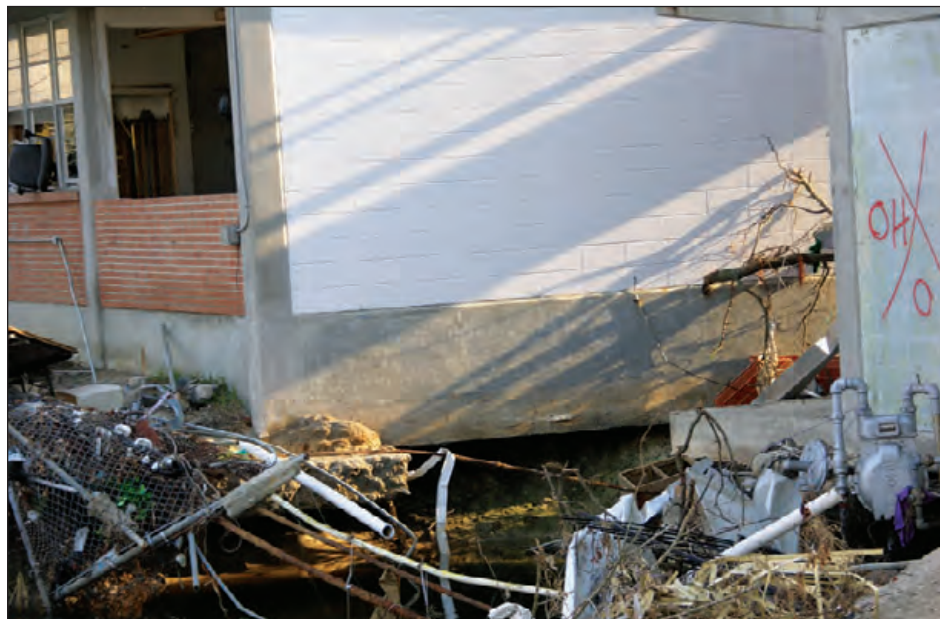
Figure 5-16:  
Scour undermined the  
foundation of St. Paul  
Catholic School, Pass  
Christian, LA.

**Erosion and scour:** Structural damage is associated with foundation failure when erosion or scour results in partial or complete removal of supporting soil (see Figure 5-16). Erosion of slopes, especially unprotected slopes, can lead to slope failures and loss of soils required to support foundations.

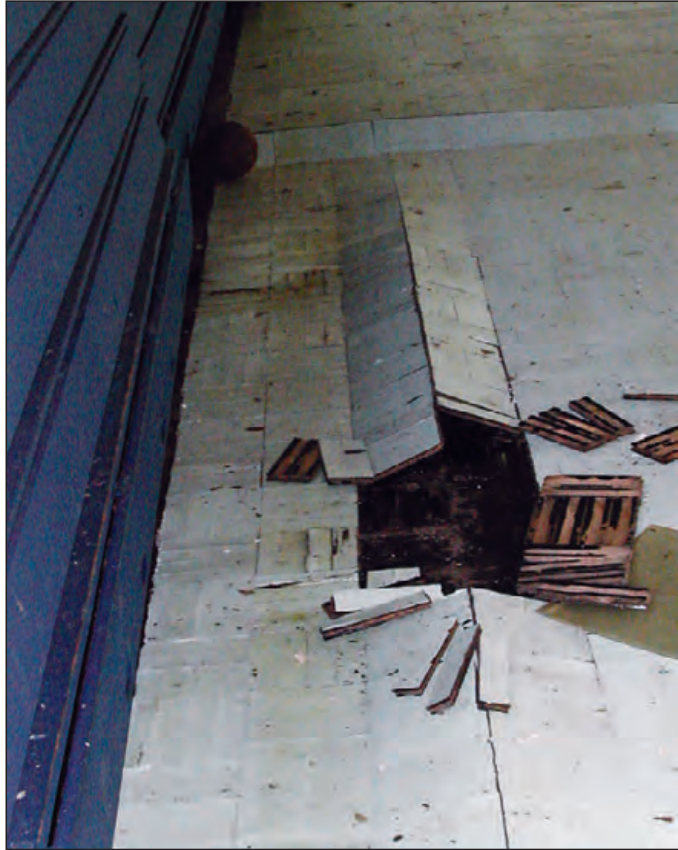
**Figure 5-17:**  
This parquet wood gymnasium floor was damaged by dimensional changes due to saturation (Hurricane Katrina 2005)

**Flooring:** Most schools have durable floors that resist water damage. Ground floors are often slab-on-grade and finished with tile or sheet products. Flooring adhesives that have been in use since the early 1990s are often latex-based and tend to break down when saturated (see Figure 5-17). Most carpeting, even the indoor-outdoor kind, is difficult to clean. Wood floors are particularly susceptible to saturation damage. Short duration inundation may not cause permanent deformation of some wood floors, such as may be present in older buildings. However, because of low tolerance for surface variations, gymnasium floors are particularly sensitive and tend to warp after flooding of any duration.

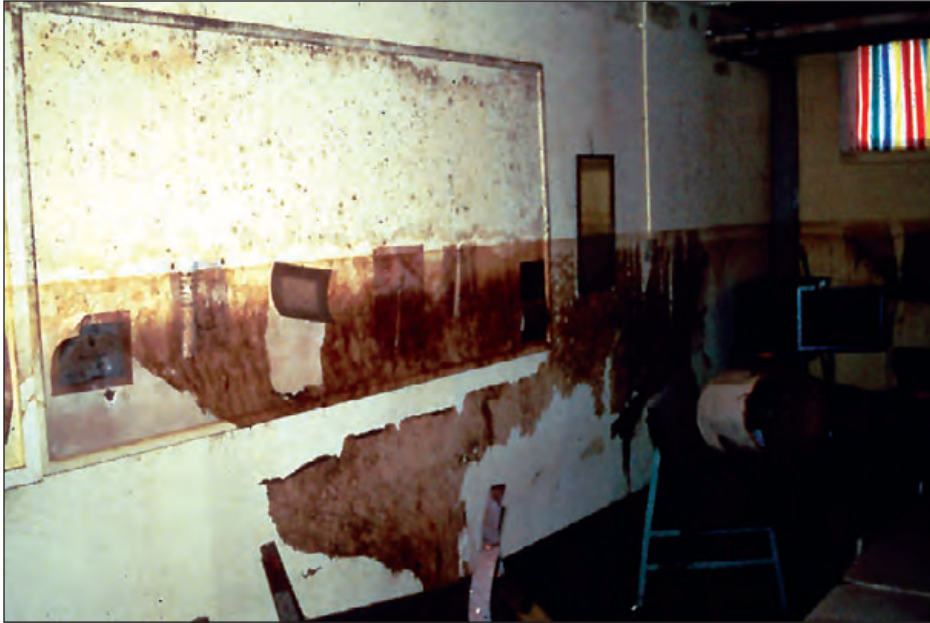
Figure 5-18:  
Saturation damage  
extends above the water  
line in this grade school  
in Gurnee, IL.

**Wall and wood components:** When soaked for long periods of time, some materials change composition or shape. Most types of wood swell when wet and, if dried too quickly, will crack, split, or warp. Plywood can delaminate and wood door and window frames may swell and become unstable. Gypsum wallboard, wood composition panels, other wall materials, and wood cabinetry not intended for wet locations can fall apart. The longer these materials are wet, the more moisture, sediment, and pollutants they absorb and the more likely that mold growth will develop. Some materials, such as the paper facing on gypsum wallboard, “wick” standing water, resulting in damage above the high-water line (see Figure 5-18).

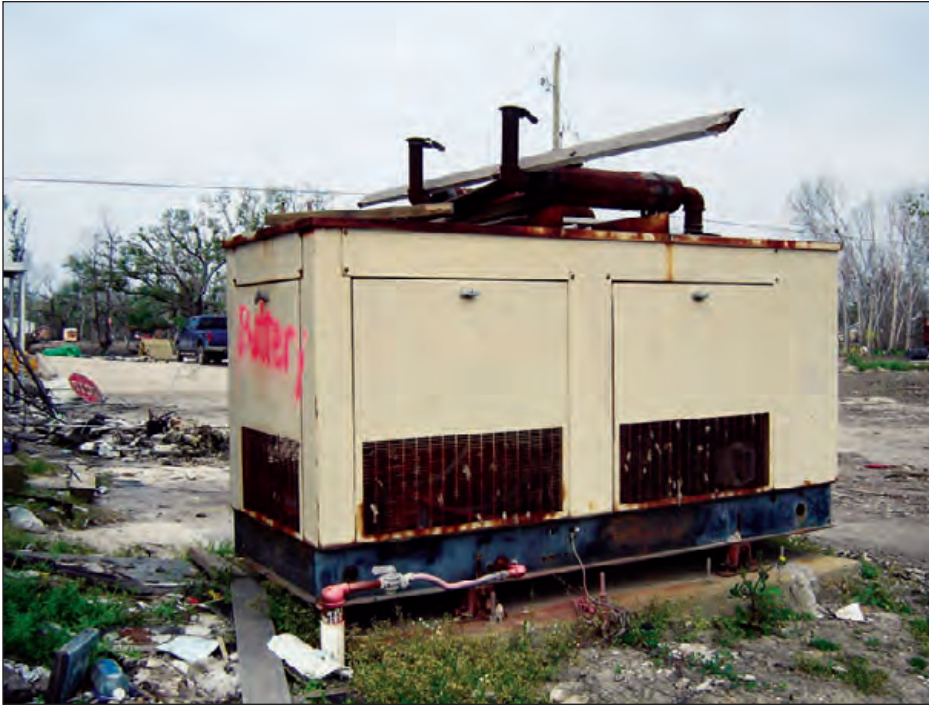
**Figure 5-19:** Although it was anchored and not displaced by floodwaters, this generator was out of service after being submerged (Hurricane Katrina, 2005)

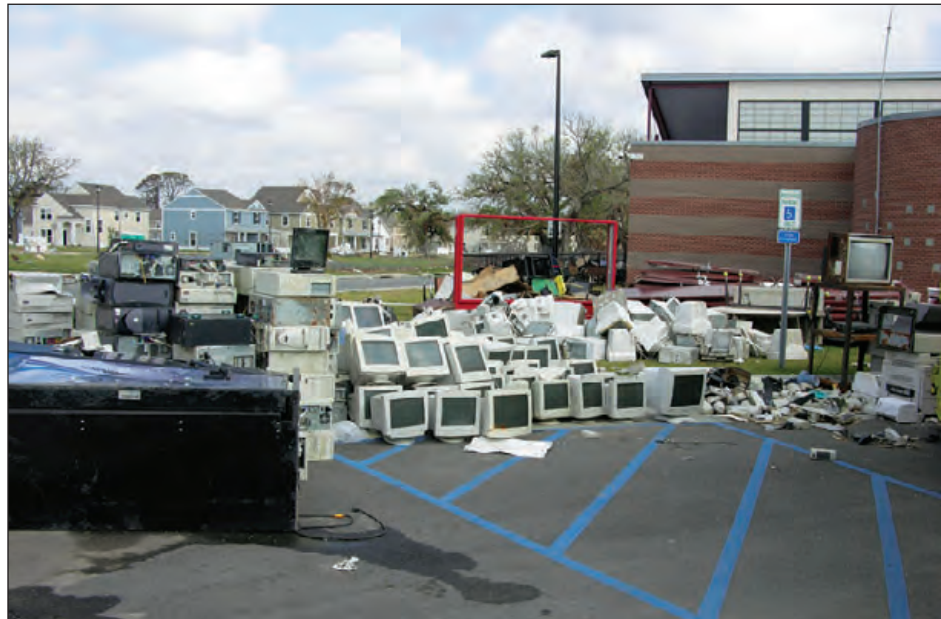
Figure 5-20:  
Destroyed computers  
and peripheral  
equipment, Nichols  
Elementary School,  
Biloxi, MS

**Computers:** Flood-damaged computers and peripheral equipment cannot be restored after inundation (see Figure 5-20), but special recovery procedures may be able to recover information on hard drives.

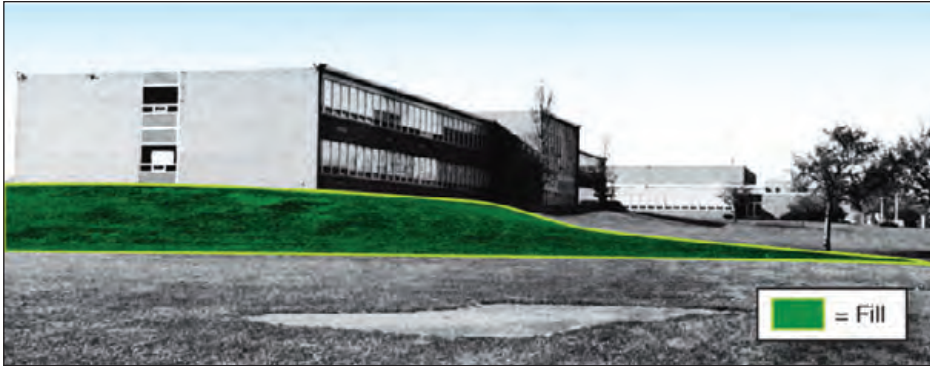
Figure 5-22:  
High school in  
Bloomsburg, PA,  
elevated on fill

**Slab-on-grade foundation on structural fill:** This is considered to be the safest method to elevate a building in many flood hazard areas, except those where waves and high velocity flows may cause erosion. Consequently, this foundation type is not allowed in V zones. Structural fill can be placed so that even if water rises up to the DFE, the building (see Figure 5-22) and building access would still be protected from flooding. The fill must be designed to minimize adverse impacts, such as increasing flood elevations on adjacent properties, increasing erosive velocities, and causing local drainage problems. To ensure stability, especially as floodwaters recede and the soils drain, fill must be designed for the anticipated water depths and duration. A geotechnical engineer or soil scientist may need to examine underlying soils to determine if the bearing capacity is sufficient to carry the added weight of fill, or if consolidation over time may occur. In addition, the effects of long-term compaction of the fill should be considered, and may prompt additional elevation as a factor of safety. The horizontal extent of the fill, away from the foundation, should be designed to facilitate access by emergency vehicles, with a minimum 25-foot width recommended. Engineered concrete slabs supported by piers should have sufficient resistance to erosion and scour if designed for anticipated flood conditions. Designers are cautioned to avoid excavating

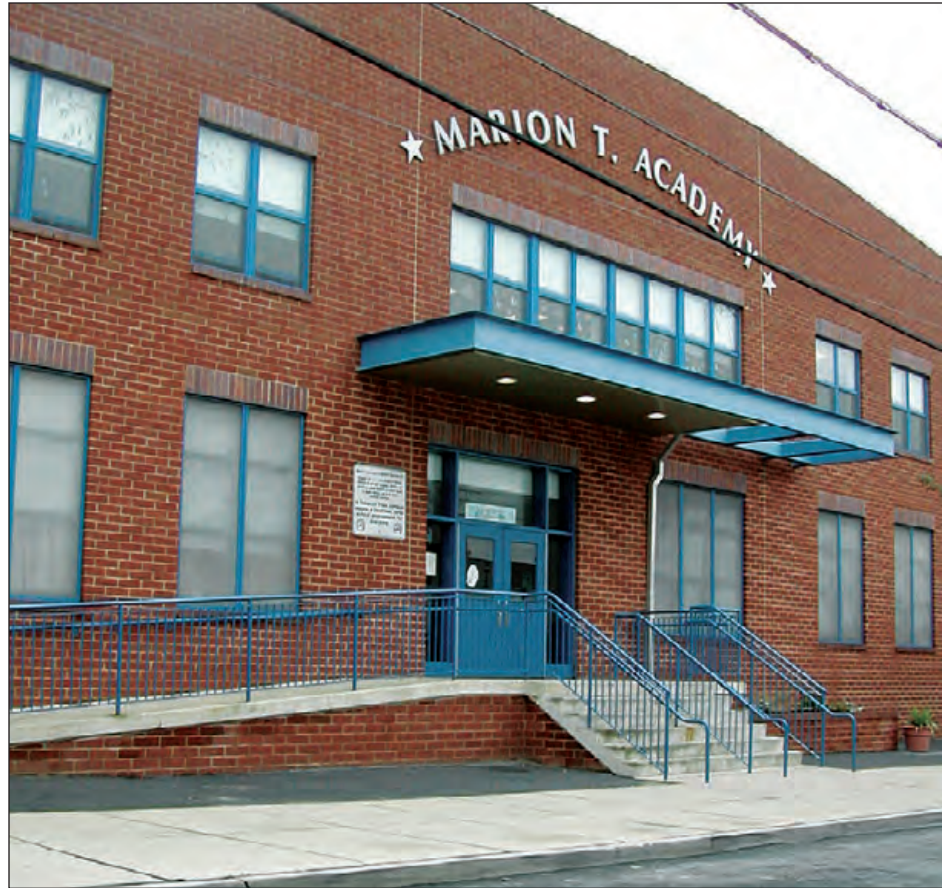
Figure 5-24:  
School elevated on  
columns

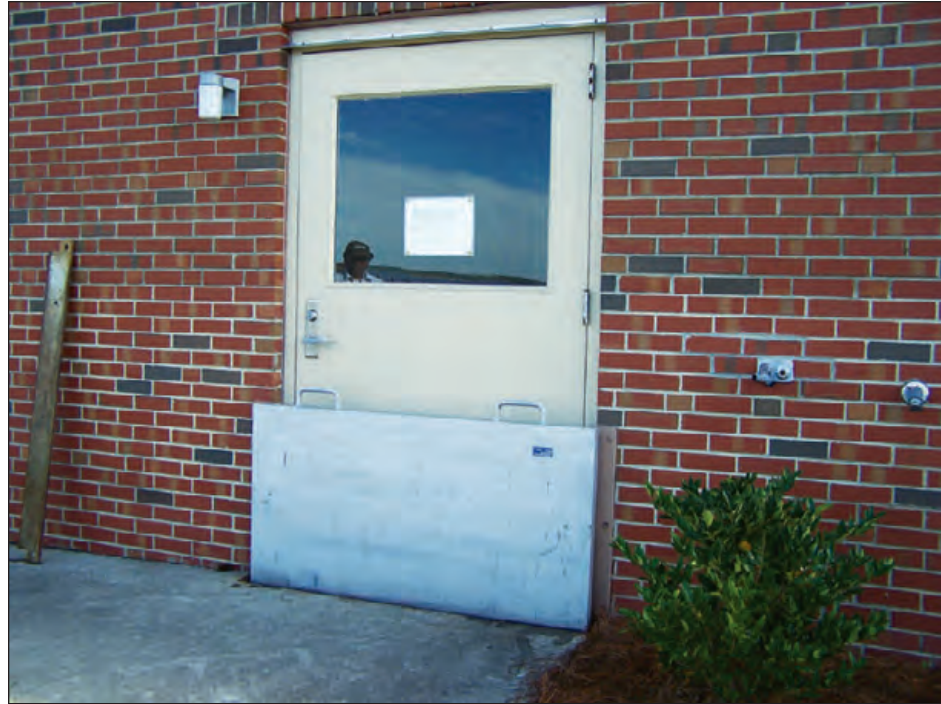
Figure 5-26:  
Specially designed  
panels are mounted to  
block doors, windows,  
and other openings  
to keep water from  
entering the building.

Windows, doors, and other openings that are below the flood level used for dry floodproofing design present significant potential failure points. They must be specially designed units (see Figure 5-26) or be fitted with gasketed, mountable panels that are designed for the anticipated flood conditions and loads. Generally speaking, protecting window and door openings from water more than a few feet deep is difficult. The framing and connections must be specifically designed for these protective measures, or water pressure may cause window and door frames to separate from the building.

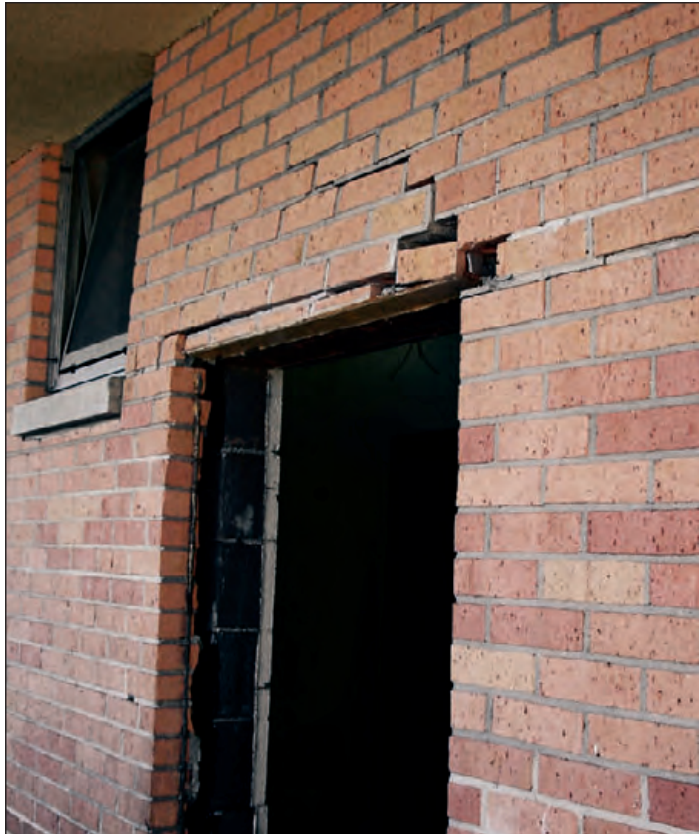
**Figure 5-27:**  
Brick facing separated from masonry wall  
(Hurricane Katrina, 2005)

Concrete and masonry that are designed and constructed in compliance with applicable standards are generally considered to be flood resistant. However, masonry facings are undesirable finishes unless extra anchoring is added to prevent separation (see Figure 5-27). Wood and timber members exposed to floodwaters should be naturally decay-resistant species, or should be pressure treated with appropriate preservatives.

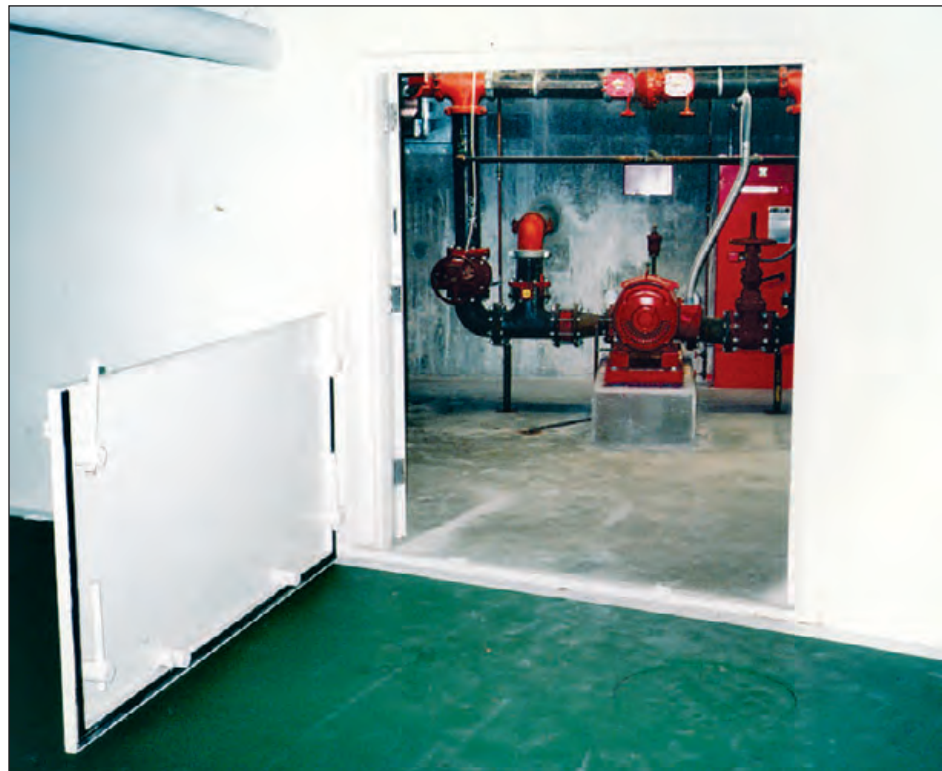
**Figure 5-28:**  
Equipment room with  
watertight door

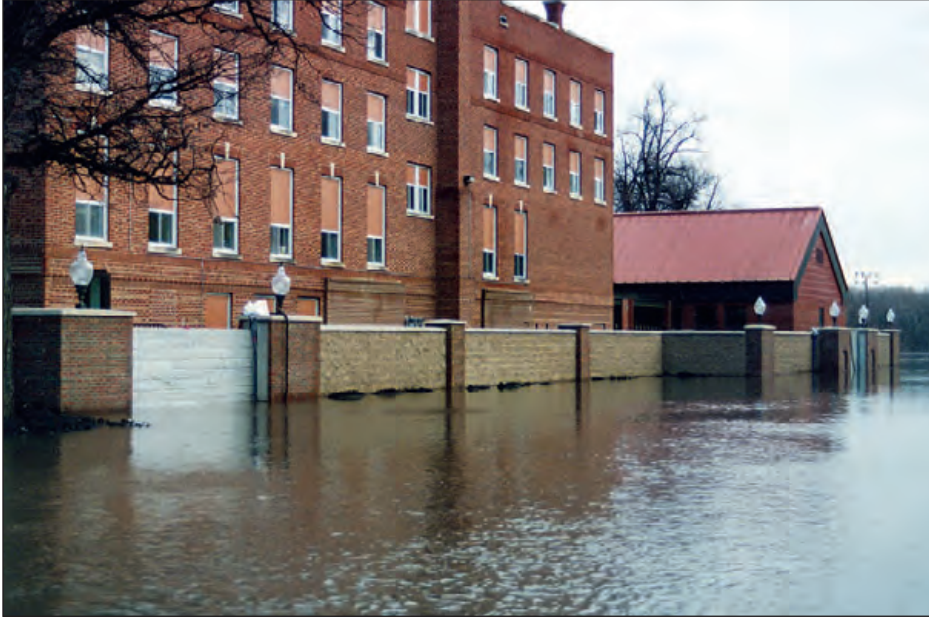
**Figure 5-29:**  
A masonry floodwall  
with multiple engineered  
openings in Fargo, ND,  
during flooding in 2001

**Permanent floodwall:** Floodwalls are freestanding, permanent engineered structures designed to prevent encroachment of floodwaters. Typically, a floodwall is located some distance from a building, so that structural modification of the existing building is not required. Depending on the topography of the site, floodwalls may protect only the low side (in which case they must “tie” into high ground) or completely surround a site (which may affect access because special closure structures are required and must be installed before the onset of flooding, see Figure 5-29).

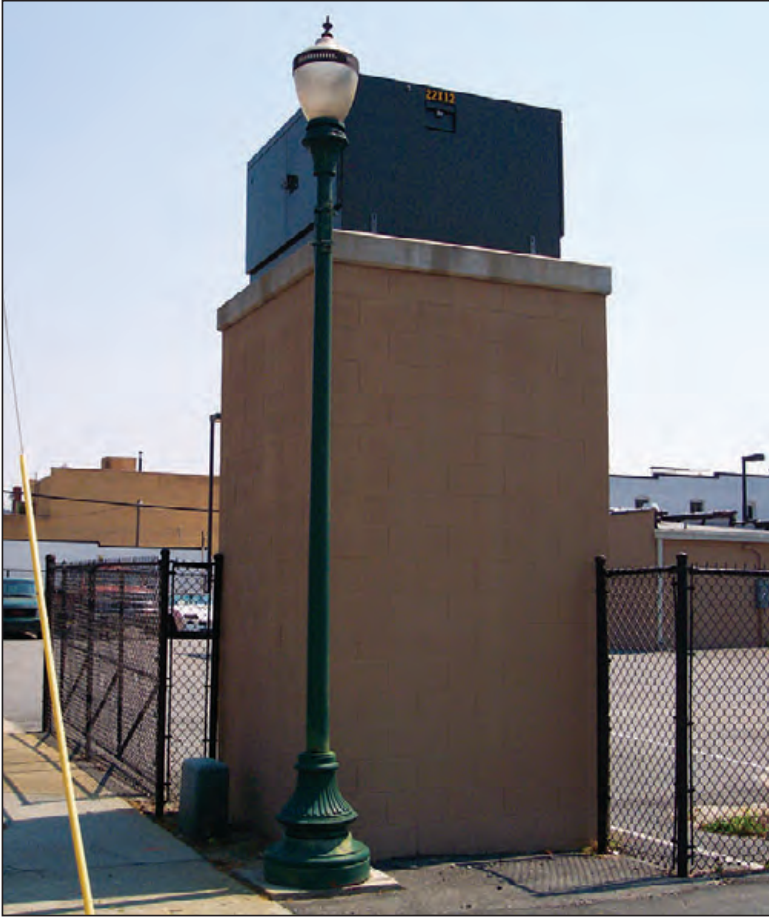
**Figure 5-30:**  
Utility component elevated above flood level

**Elevate components:** Whether located inside or outside of the building, some components of utility systems can be elevated in place on platforms, including electric transformers, communication switch boxes, water heaters, air-conditioning compressors, generators, furnaces, boilers, and heat pumps (see Figure 5-30).

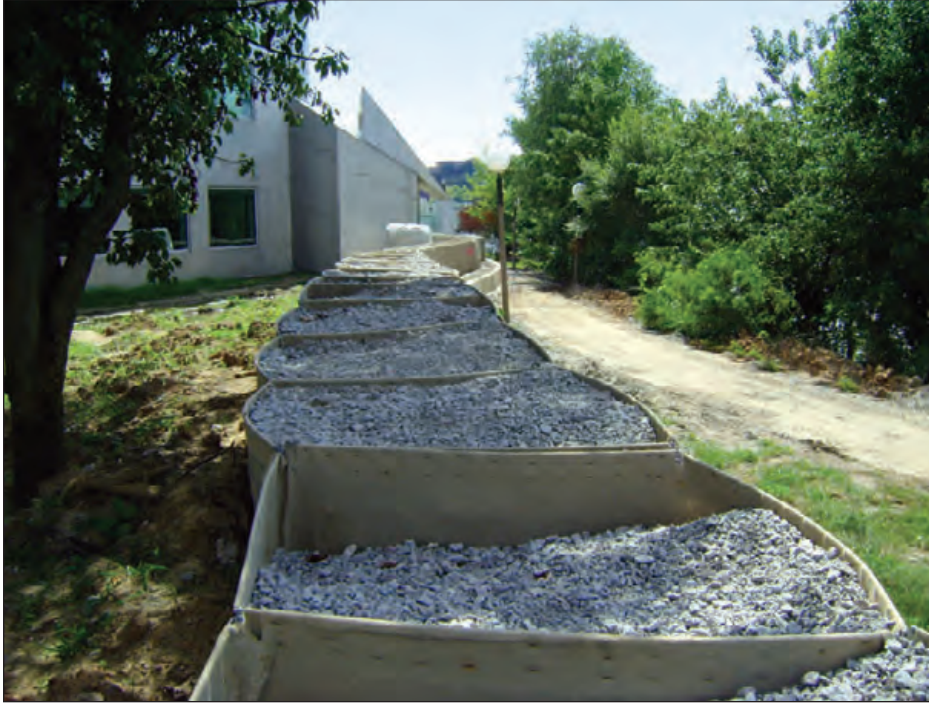
Figure 5-31:  
Gravel-filled containers  
form a barrier to protect  
the University of Iowa  
(2008)

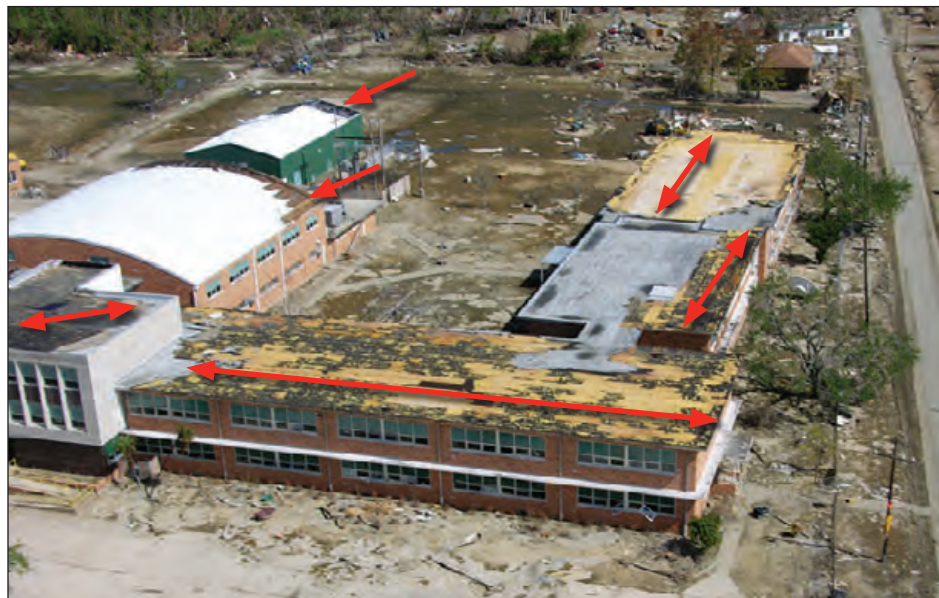
**Figure 6-1:**  
Large portions of the roof coverings blew off of this school. Estimated wind speed: Approximately 125 to 130 miles per hour (mph).<sup>2</sup> Hurricane Katrina (Louisiana, 2005)

This chapter discusses structural, building envelope, and nonstructural building systems, and illustrates various types of wind-induced damage that affect them. Numerous examples of best practices pertaining to new and existing schools are presented as recommended design guidelines. Incorporating those practices applicable to specific projects will result in greater wind-resistance reliability and will, therefore, decrease expenditures for repair of wind-damaged facilities, provide enhanced protection for occupants, and avoid school disruption (see Figure 6-1).

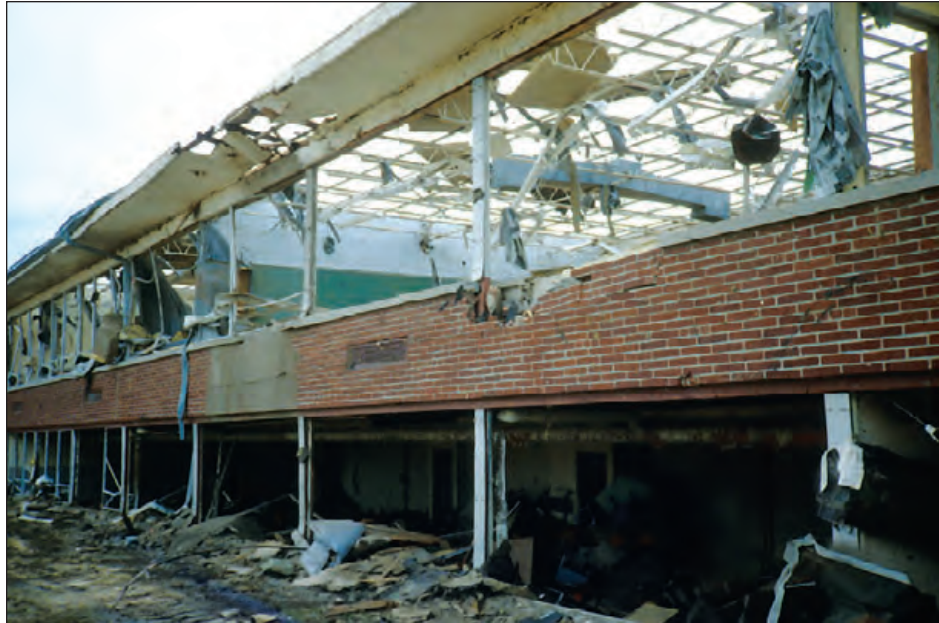
In the classroom wing shown in Figure 6-4, all of the exterior windows were broken, and virtually all of the cementitious wood-fiber deck panels were blown away during a tornado. Much of the metal decking over the band and chorus area also blew off. The gymnasium collapsed, as did a portion of the multi-purpose room. The school was not in session at the time the tornado struck. See Section 6.5 for recommendations pertaining to tornadoes.

**Figure 6-4:**  
This high school was damaged by a strong tornado (Plainfield, IL 1990)

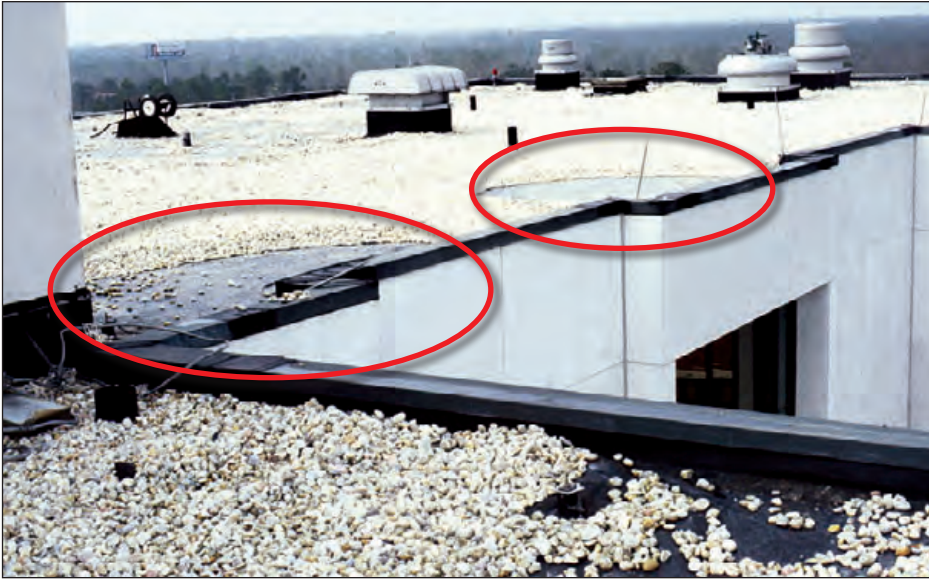
**Figure 6-8:**  
Aggregate blow-off associated with building irregularities. Hurricane Hugo (South Carolina, 1989)

Building irregularities, such as re-entrant corners, bay window projections, a stair tower projecting out from the main wall, dormers, and chimneys can cause localized turbulence. Turbulence causes wind speed-up, which increases the wind loads in the vicinity of the building irregularity, as shown in Figures 6-8 and 6-9. Figure 6-8 shows the aggregate ballast on a building's single-ply membrane roof blown away at the re-entrant corner and in the vicinity of the corners of the wall projections at the window bays. The irregular wall surface created turbulence, which led to wind speed-up and loss of aggregate in the turbulent flow areas.

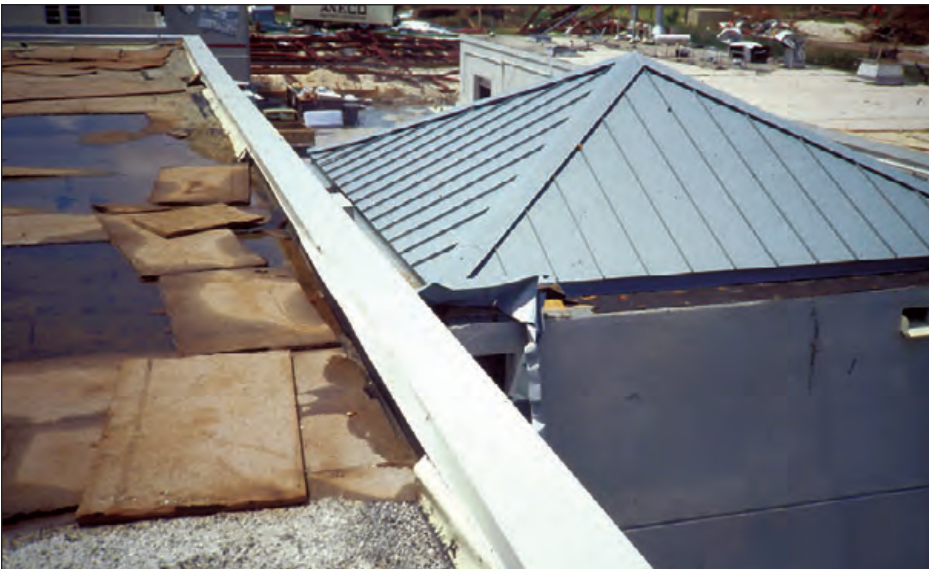
**Figure 6-9:**  
The irregularity created by the stair tower (covered with a metal roof) caused turbulence resulting in wind speed-up and roof damage. Hurricane Andrew (Florida, 1992)

Figure 6-9 shows a building stair tower that caused turbulence resulting in wind speed-up. The speed-up increased the suction pressure on the base flashing along the parapet behind the stair tower. The built-up roof's base flashing was pulled out from underneath the coping because its attachment was insufficient to resist the suction pressure. The base flashing failure propagated and caused a large area of the roof membrane to lift and peel. Some of the wall covering on the stair tower was also blown away. Had the stair tower not existed, the built-up roof would likely not have been damaged. To avoid damage in the vicinity of building irregularities, attention needs to be given to the attachment of building elements located in turbulent flow areas.

To avoid the roof membrane damage shown in Figure 6-9, it would be prudent to use corner uplift loads in lieu of perimeter uplift loads in the vicinity of the stair tower, as illustrated in Figure 6-10. Wind load increases due to building irregularities can be identified by wind tunnel studies; however, wind tunnel studies are rarely performed for schools. Therefore, identification of wind load increases due to building irregularities is normally based on the designer's professional judgment. Usually load

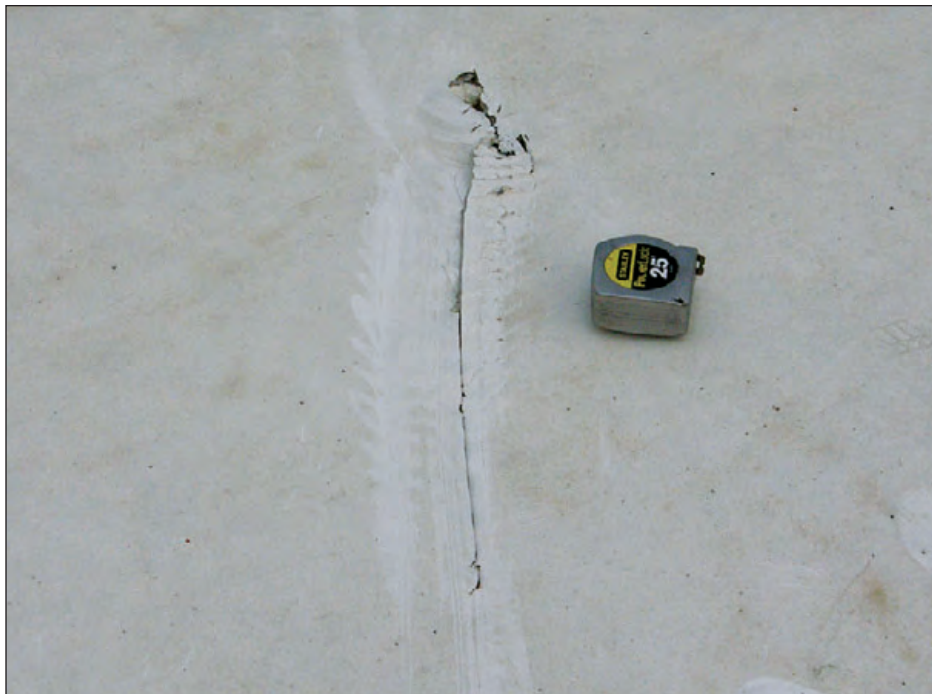
**Figure 6-11:** The single-ply roof membrane on this school was torn by a missile. The tear was still unprotected 6 days after it was damaged. A substantial amount of water can enter the building through such a tear, unless the deck is water tight (see Figure 6-13) or a secondary roof membrane is used as discussed in Section 6.3.3.7. Estimated wind speed: 105 to 115 mph. Hurricane Ivan (Florida, 2004)

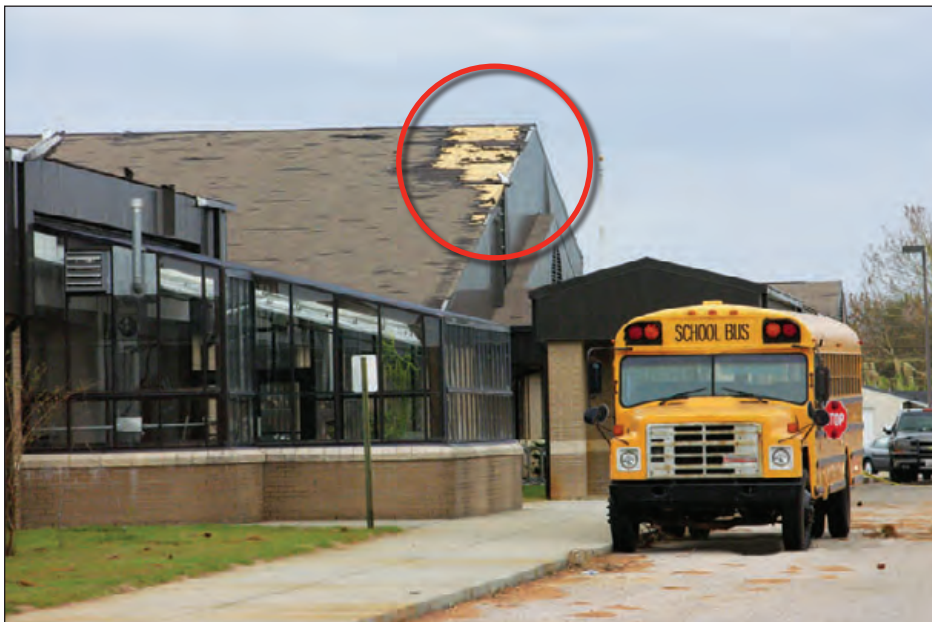
When damaged by wind, schools typically experience a variety of building component damage. For example, at the school shown in Figure 6-12, the roof covering was severely damaged, metal wall panels were blown off, and rooftop equipment was blown away. Water entered the building at all of these envelope breaches. The most common types of damage are discussed below in descending order of frequency.

**Figure 6-12:** Constructed in 1995, this school was used as a hurricane shelter. The large number of occupants moved from one area of the school to another as water entered various areas of the building due to envelope failures. Estimated wind speed: 105 to 115 mph. Hurricane Ivan (Florida, 2004)

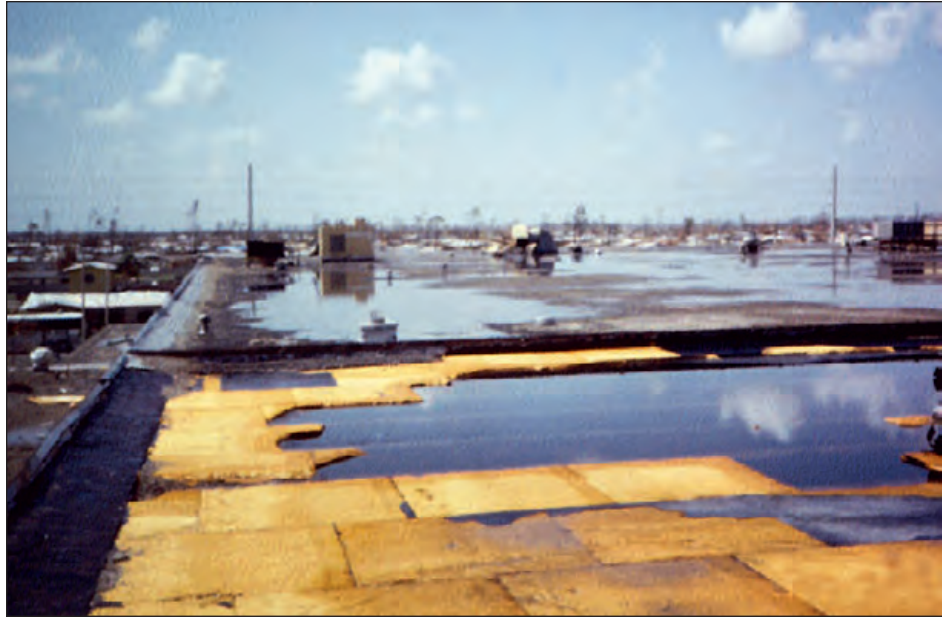
**Roof:** Roof covering damage (including rooftop mechanical, electrical, and communications equipment) is the most common type of wind damage, as illustrated by Figure 6-13. At this school, a portion of the built-up membrane lifted and peeled after the metal edge flashing lifted. The cast-in-place concrete deck kept most of the water from entering the building. Virtually all of the loose aggregate blew off the roof and broke many windows in nearby houses. This school was used as a hurricane shelter at the time of the blow-off.

**Figure 6-13:** Extensive roof covering and rooftop equipment damage occurred on this school. However, the cast-in-place concrete deck kept most of the water from entering the school. Hurricane Andrew (Florida, 1992)

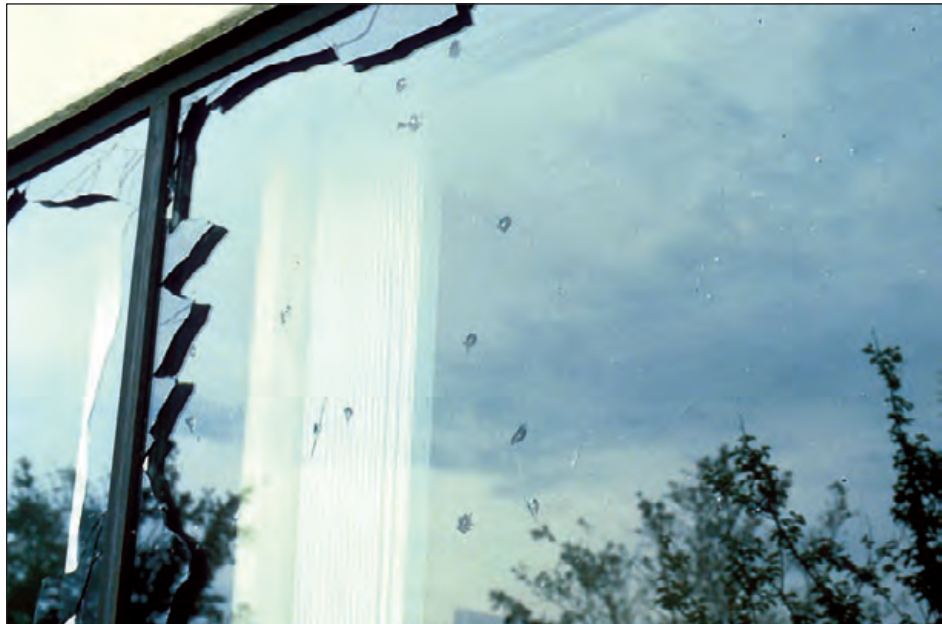
**Glazing:** Exterior glazing damage is very common during hurricanes and tornadoes, but is less common during other storms. The glass shown in Figure 6-14 was broken by the aggregate from a built-up roof. The inner panes had several impact craters. In several of the adjacent windows, both the outer and inner panes were broken. The aggregate flew more than 245 feet.

**Figure 6-14:** The outer window panes were broken by aggregate from a built-up roof. Estimated wind speed: 104 mph. Hurricane Hugo (South Carolina, 1989)
