# Design Guide

for Improving School Safety in Earthquakes, Floods,  
and High Winds

FEMA P-424 / December 2010

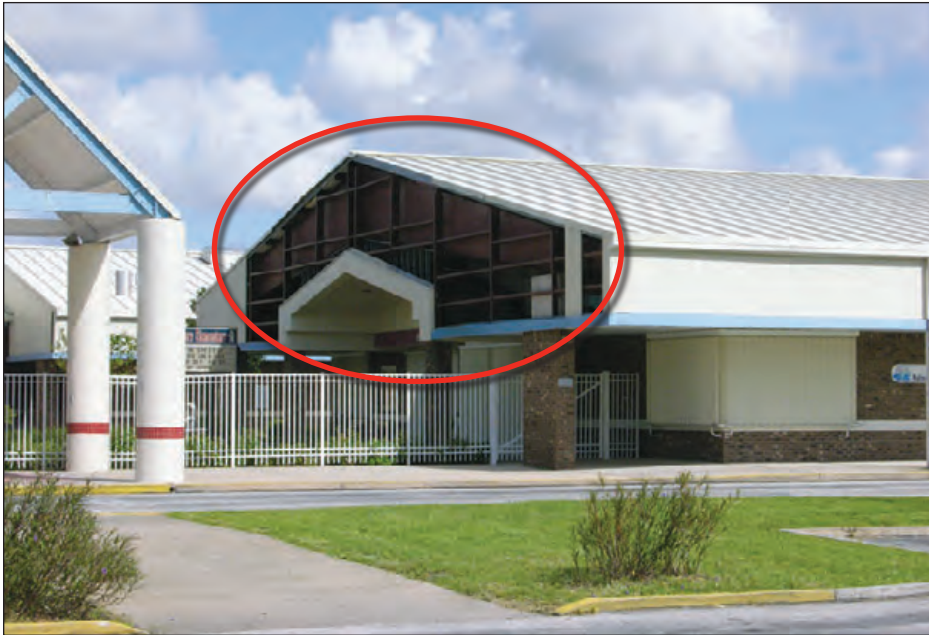
**Figure 6-15:** Blow-off of metal wall panels allowed wind-driven rain to enter this school. Hurricane Frances (Florida, 2004)

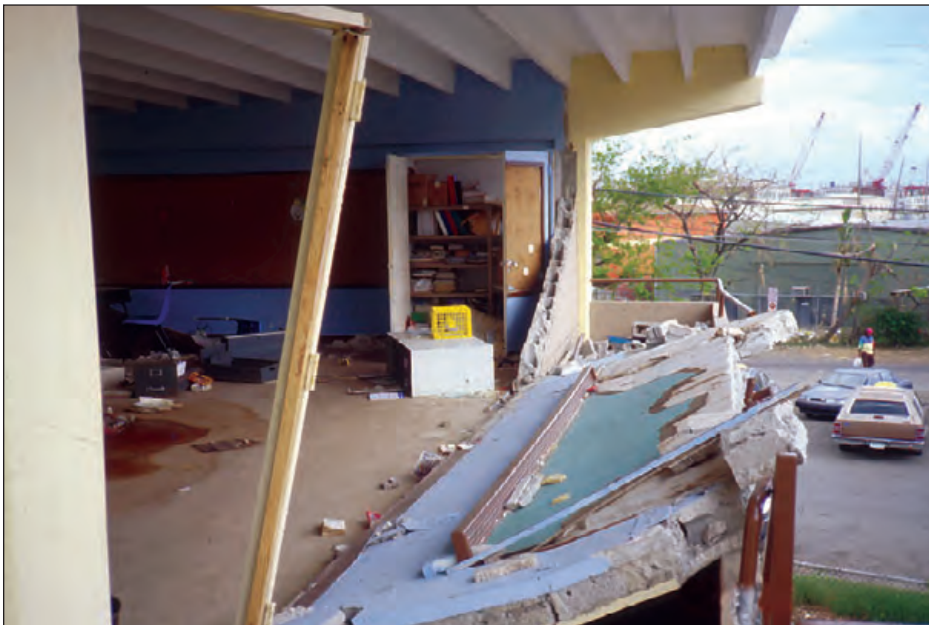
**Wall collapse:** Collapse of non-load-bearing exterior walls is common during tornadoes, but is less common during other storms. At the school shown in Figure 6-16, the unreinforced CMU wall collapsed during a hurricane.

**Figure 6-16:** Collapsed unreinforced CMU wall. Hurricane Marilyn (U.S. Virgin Islands, 1995)

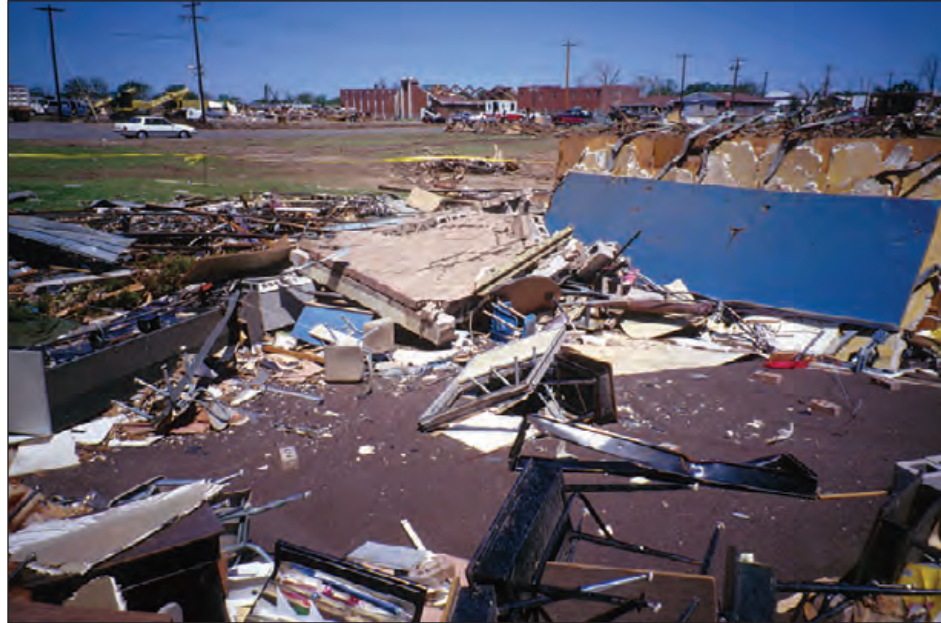
Figure 6-17:  
The roof and all of the walls of a wing of this elementary school were blown away by a violent tornado. (Oklahoma City, 1999)

**Structural system:** Structural damage (e.g., roof deck blow-off, blow-off or collapse of the roof structure, collapse of exterior bearing walls, or collapse of the entire building or major portions thereof) is the principal type of damage that occurs during strong and violent tornadoes (see Figure 6-17). Structural damage occasionally occurs during hurricanes (Figures 6-18, 6-21, 6-24, 6-26, and 6-34). Portable classrooms are also sometimes severely damaged or overturned as shown in Figure 6-19.

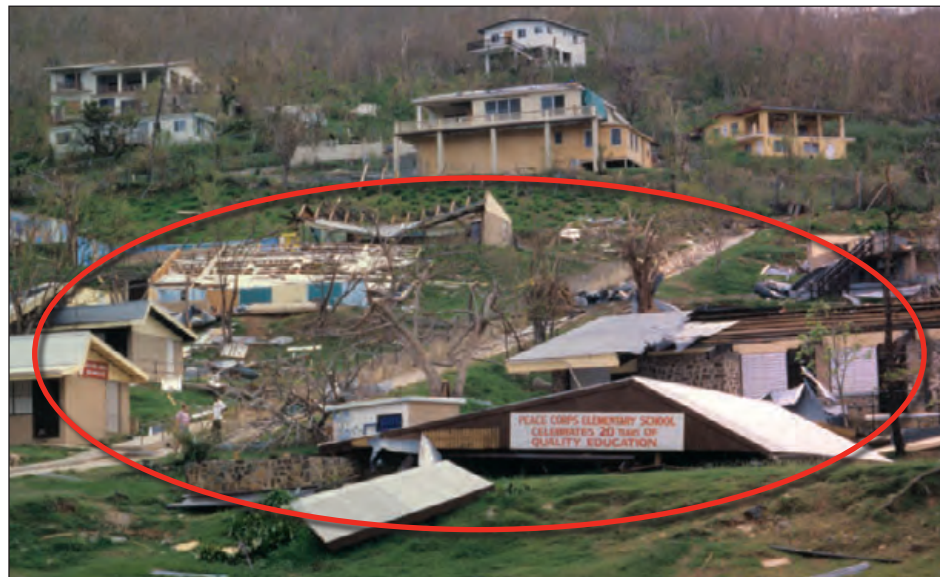
Figure 6-18:  
This elementary school was composed of several buildings. The building in the foreground collapsed and several others experienced significant structural damage. The buildings further up the hillside are residences. Hurricane Marilyn (U.S. Virgin Islands, 1995)

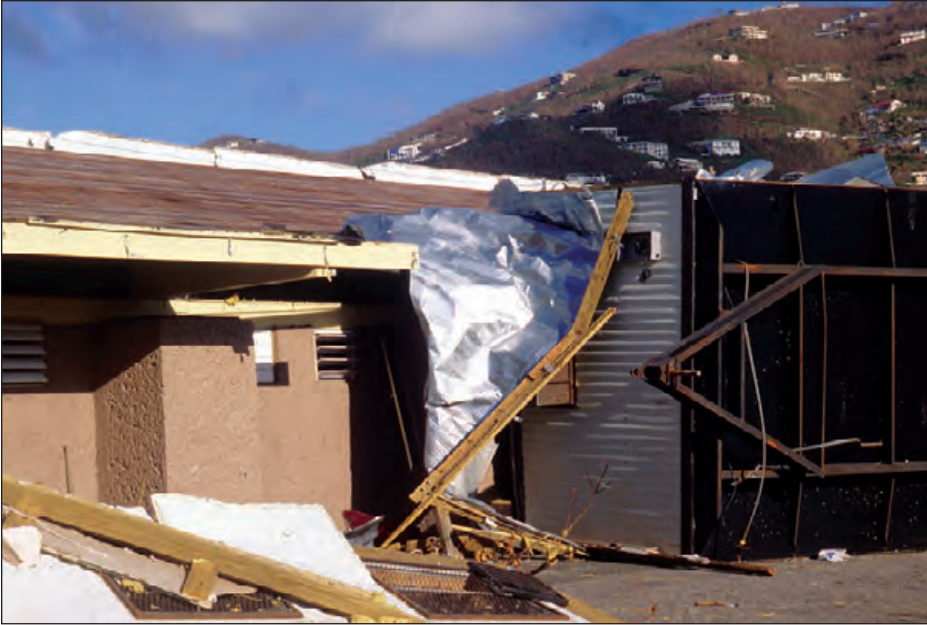
**Figure 6-19:** This portable classroom was blown up against the main school building. Depending upon the type of exterior wall, an impacting portable classroom may or may not cause wall collapse. Hurricane Marilyn (U.S. Virgin Islands, 1995)

Portable classrooms are often particularly vulnerable to significant damage because they are seldom designed to the same wind loads as permanent school buildings. Portable classrooms are frequently blown over during high-wind events because of the inexpensive techniques typically used are inadequate to anchor the units to the ground (see Figures 6-19 and 6-22). Wind-borne debris from portables or an entire portable classroom may impact the permanent school building and cause serious damage (Figure 6-19).

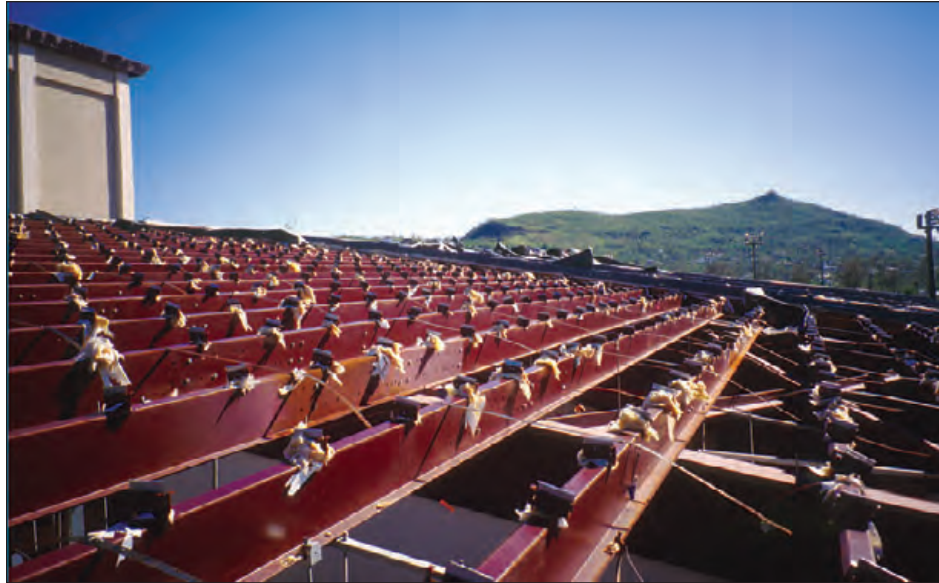
**Figure 6-20:**  
This newly-constructed gymnasium had a structural metal roof panel (3-inch trapezoidal ribs at 24 inches on center) applied over metal purlins. The panels detached from their concealed clips. A massive quantity of water entered the school and buckled the wood gym floor. Typhoon Paka (Guam, 1997)

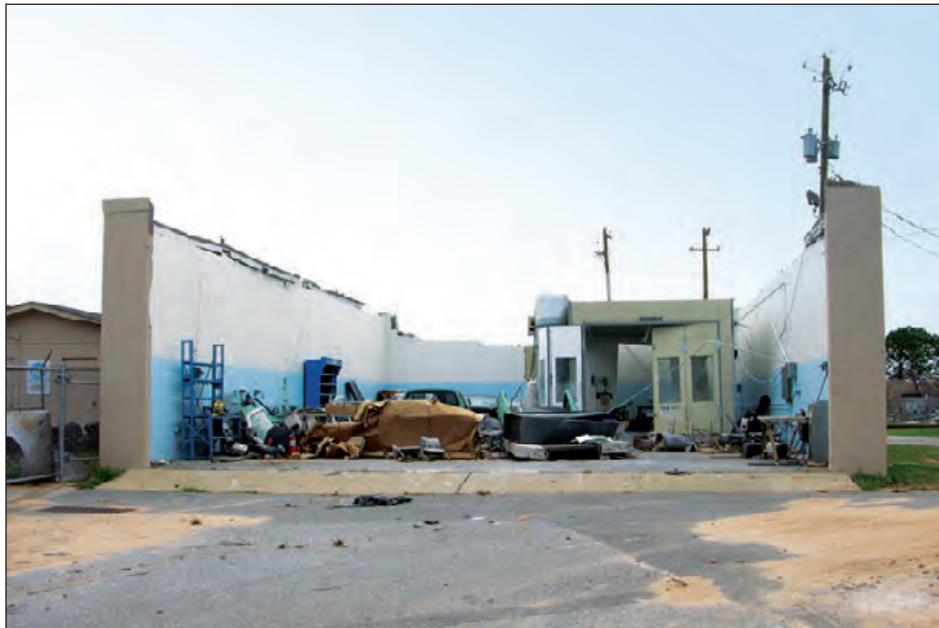
**Figure 6-21:**  
The entire metal deck and steel joist roof structure at this school's auto shop blew off. Estimated wind speed: 105 to 115 mph. Hurricane Ivan (Florida, 2004)

Ancillary buildings (such as storage or shop buildings) adjacent to schools are also vulnerable to damage. Although loss of these buildings may not be crippling to the operation of the school, debris from ancillary buildings may strike and damage the school (Figure 6-21).

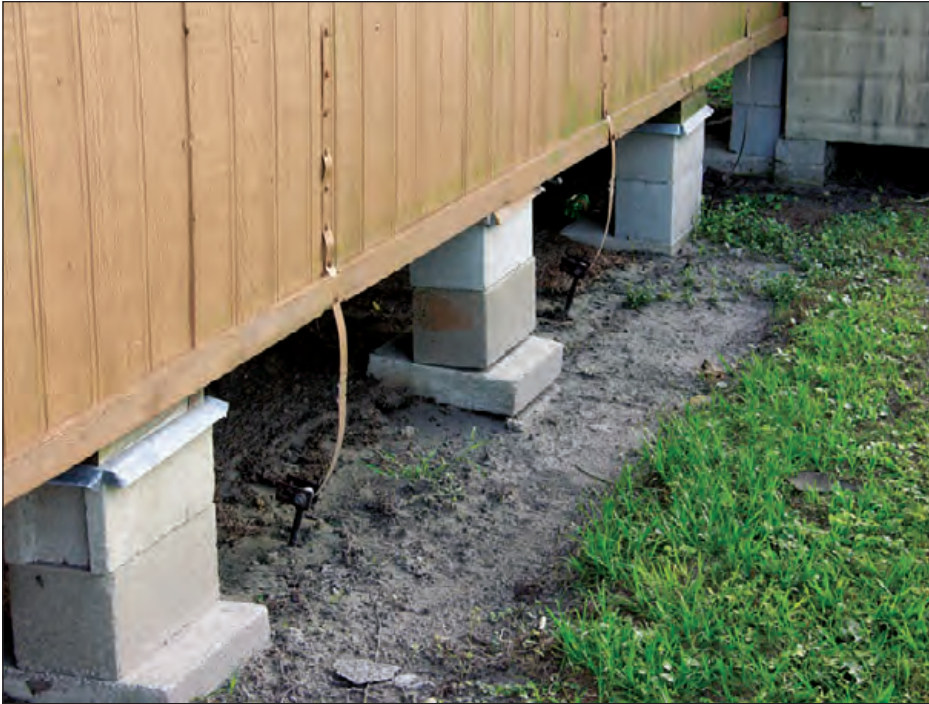
**Figure 6-22:** The metal straps between this portable classroom and the ground anchors were not taut. This classroom is susceptible to being blown off the piers and to overturning. See Figure 6-27 for a robust anchoring system.

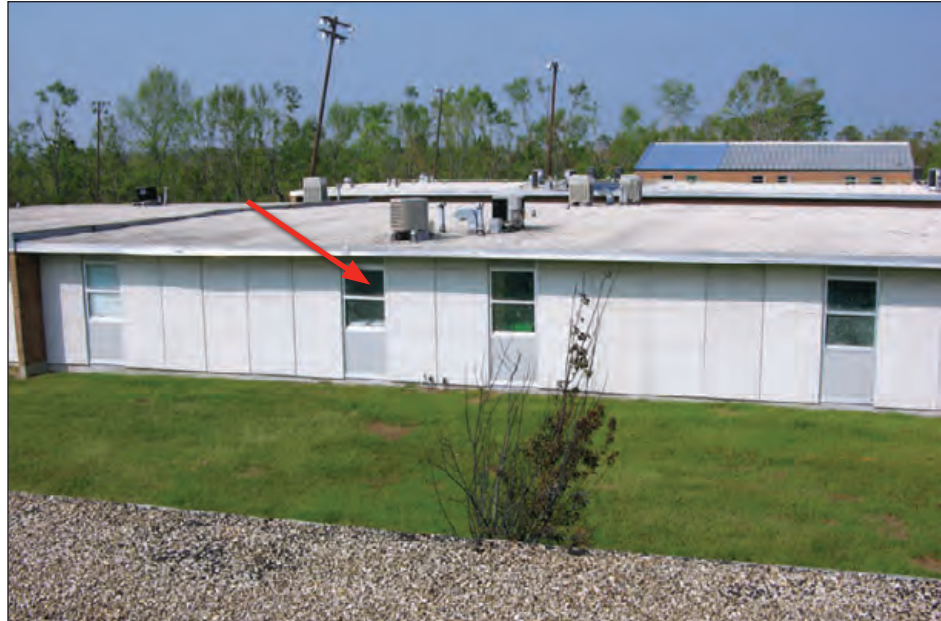
**Figure 6-23:** This old school was used as a hurricane shelter. Structural failure did not occur during this hurricane. However, portions of the roof covering were blown off, rooftop equipment was damaged, and many windows were broken by aggregate from the built-up roof (red arrow). Estimated wind speed: 130 mph. Hurricane Katrina (Mississippi, 2005)

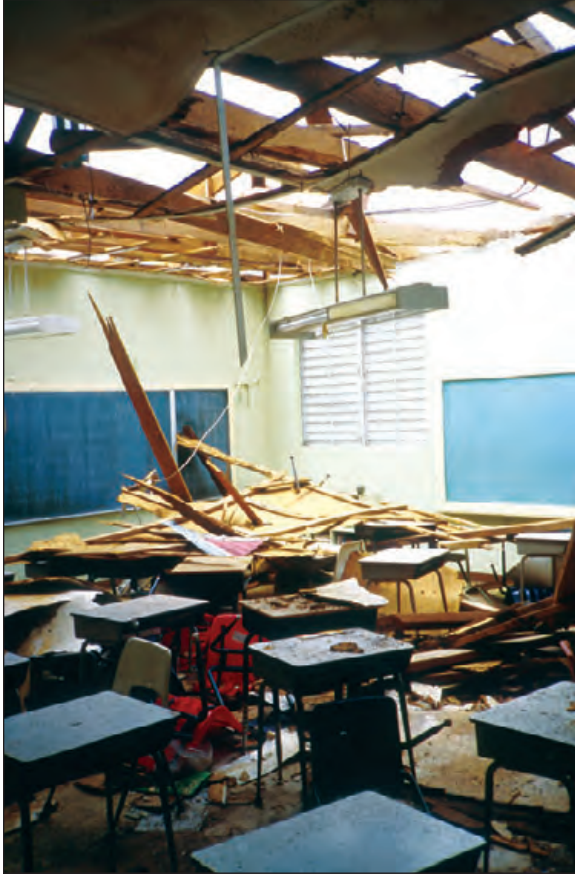
**Figure 6-24:**  
A portion of the roof structure blew off this school, and a portion of it collapsed into classrooms. Extensive water damage can cause such a school to be out of operation for a considerable period of time. Hurricane Marilyn (U.S. Virgin Islands, 1995)

**Interrupted use:** Depending upon the magnitude of wind and water damage, it can take days, months, or more than a year to repair the damage or replace a facility (see Figure 6-24). In addition to the costs associated with repairing/replacing the damage, other social and financial costs can be even more significant. Additional costs related to interrupted use of schools can include the cost of bussing students to alternative schools and/or rental of temporary facilities, and can be quite substantial.

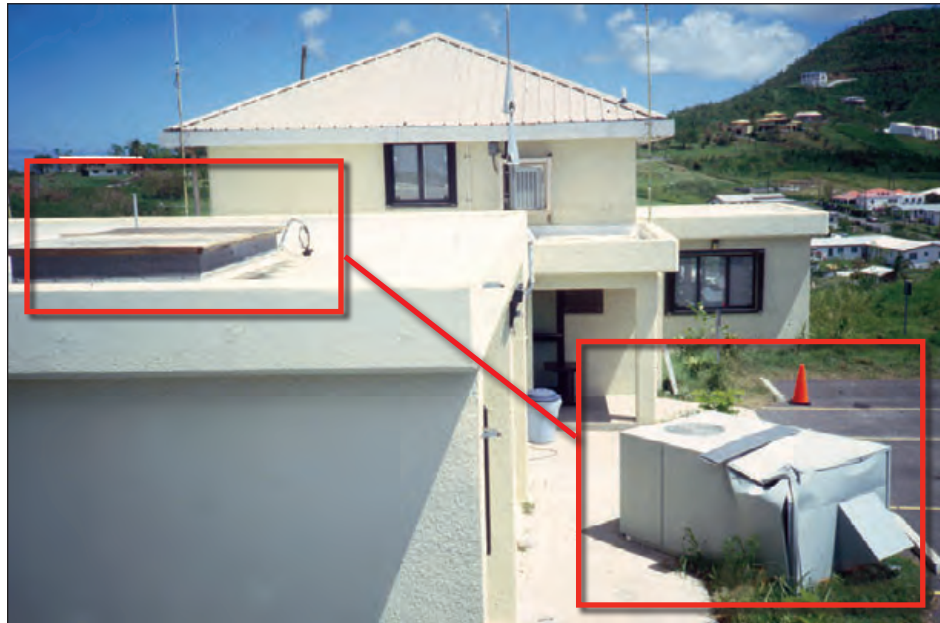
**Figure 6-25:**  
Lack of fasteners  
resulted in blow-off of  
the HVAC unit, which  
caused extensive  
interior water damage  
and interrupted facility  
use. Hurricane Marilyn  
(U.S. Virgin Islands,  
1995)

Fortunately, most of the enhancements for increased wind resistance are relatively inexpensive compared to the benefits that they provide. Enhancements that provide greater performance reliability at a lower cost should be considered. For the building shown in Figure 6-25, a few inexpensive fasteners would have prevented costly repairs and interrupted use of a portion of the building. After the HVAC unit blew off the roof curb and landed in the parking lot, a substantial amount of water entered the building before a temporary covering could be placed over the opening. The blow-off was caused by a load path discontinuity; no provisions had been made to anchor the unit to the curb. The insignificant cost of a few fasteners would have prevented

repairs costing several thousand dollars and also prevented interrupted use of a portion of the building.

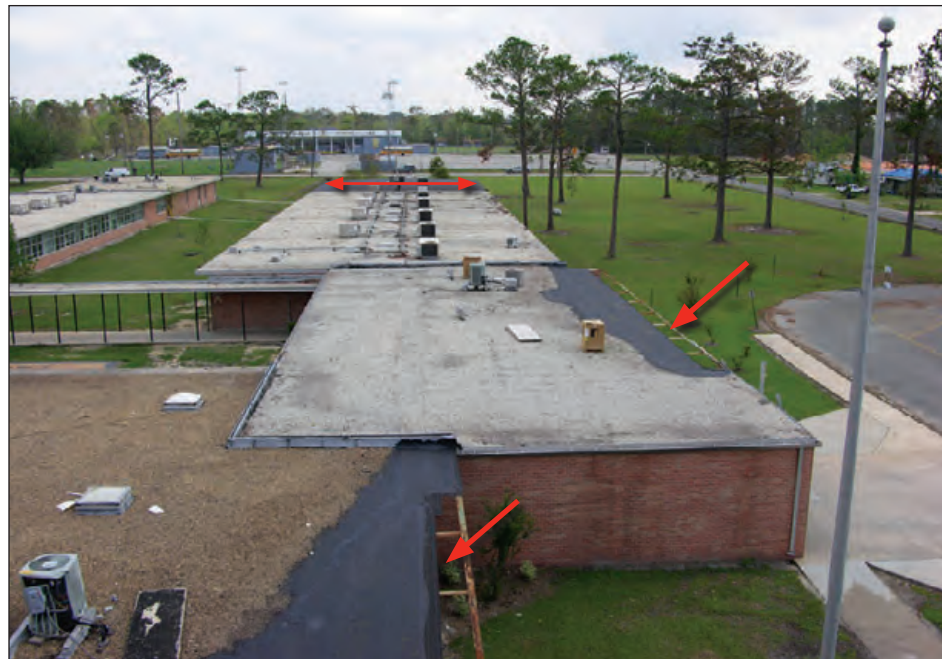
**Figure 6-26:** The cementitious wood-fiber deck panels blew off the overhangs and caused a progressive lifting and peeling of the roof membrane. Strengthening (or replacing) inadequately attached roof decks during a reroofing project is both prudent and relatively economical. Estimated wind speed: 120 mph. Hurricane Katrina (Mississippi, 2005)

Costs can be minimized if wind-resistance improvements are executed as part of planned repairs or replacement. For example, if the roof deck is inadequately attached in the perimeter and corners (see Figure 6-26), and the roof covering has another 10 years of remaining service life, it would typically be prudent to postpone performing deck attachment upgrade until it is necessary to replace the roof covering. Then, as part of the reroofing work, the existing roof system could be torn off, the deck reattached or replaced, and the new membrane installed.<sup>9</sup> This approach provides the cost benefit of utilizing the full service life of the roof membrane.

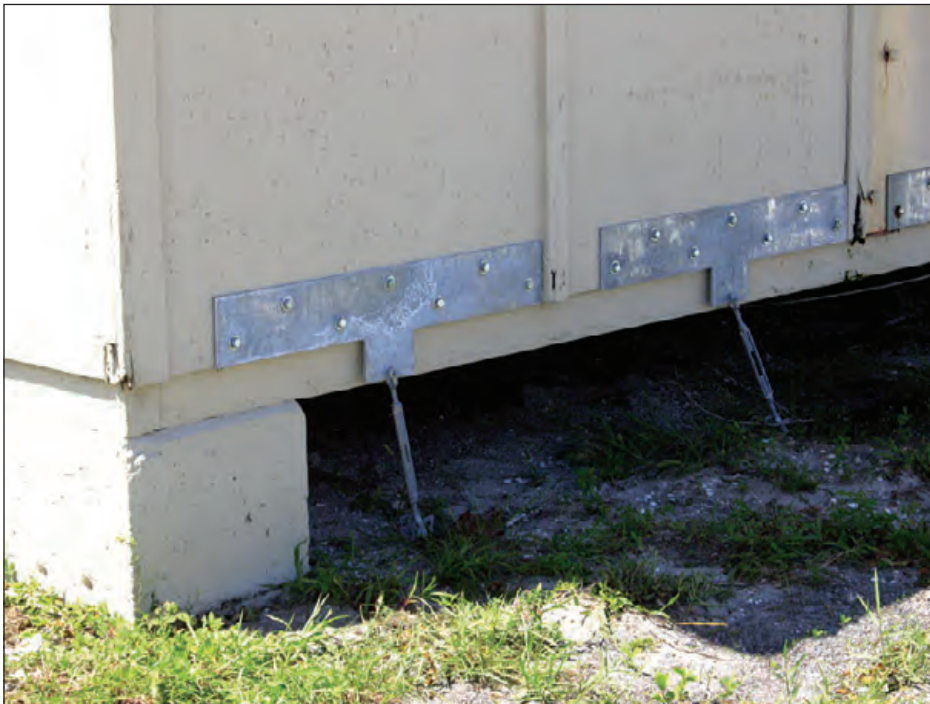
**Figure 6-27:** Unlike the portable classroom shown in Figure 6-22, with the thick T-shaped plates and taut turnbuckles, this portable classroom has a robust anchorage to the ground. Hurricane Francis (Florida, 2004)

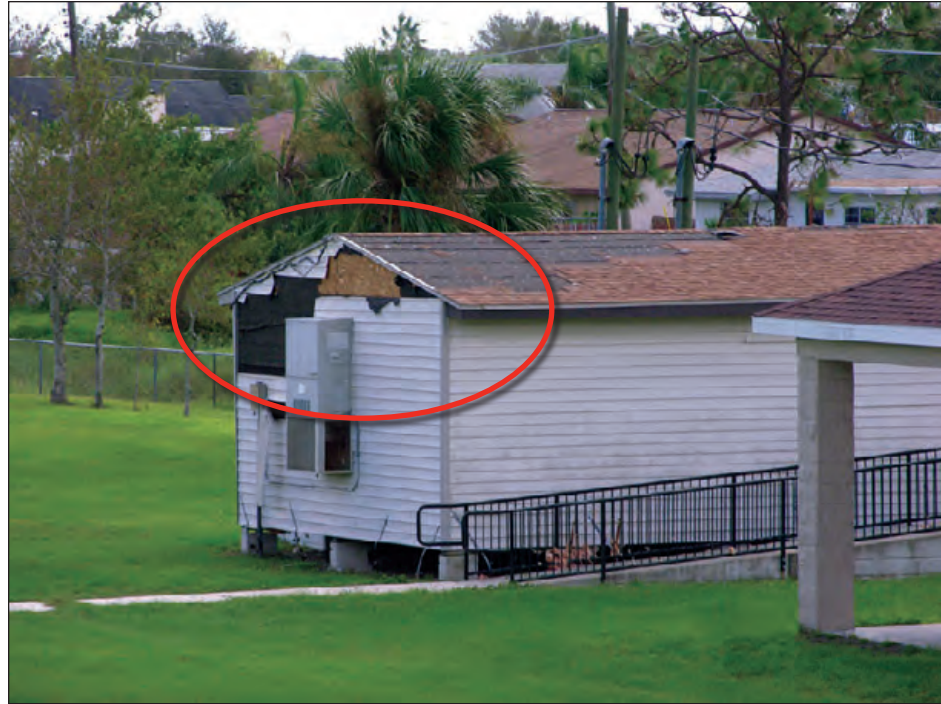
**Figure 6-28:**  
Asphalt shingles and vinyl siding blew off of this portable classroom. This type of wind-borne debris can break unprotected glazing. Hurricane Francis (Florida, 2004)

Unless portable classrooms are designed and constructed (including anchorage to the ground—see Figure 6-27) to meet the same wind loads as the main school building, students and faculty should be considered at risk during high winds. Therefore, portable classrooms should not be occupied when high winds are forecast (even though the forecast speeds are well below design wind conditions for the main building). Also, during winds that are well below design wind conditions, wind-borne debris from disintegrating portable classrooms could impact and damage the main school building and/or nearby residences (Figure 6-28).

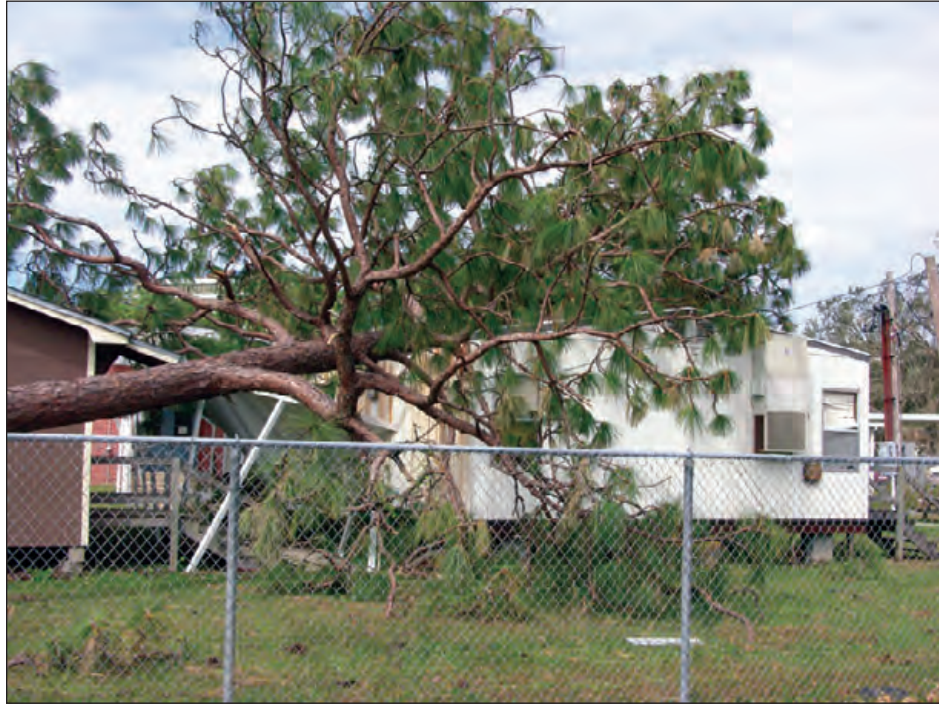
**Figure 6-29:** This fallen tree caused minor damage to these portable classrooms. However, had the tree landed on the classroom at the left of the photograph, it could have caused injuries if the building had been occupied. Although portable classrooms are not occupied during hurricanes, they are frequently occupied during thunderstorms, which often topple trees. Estimated wind speed: 105 to 115 mph. Hurricane Ivan (Florida, 2004)

Trees with trunks larger than 6 inches in diameter, poles (e.g., light fixture poles, flagpoles, and power poles), or towers (e.g., electrical transmission and large communication towers) should not be placed near the building. Falling trees, poles, and towers can severely damage a school and injure the occupants. Large trees can crash through pre-engineered metal buildings and wood frame construction (see Figure 6-29). Falling trees can also rupture roof membranes and break windows.

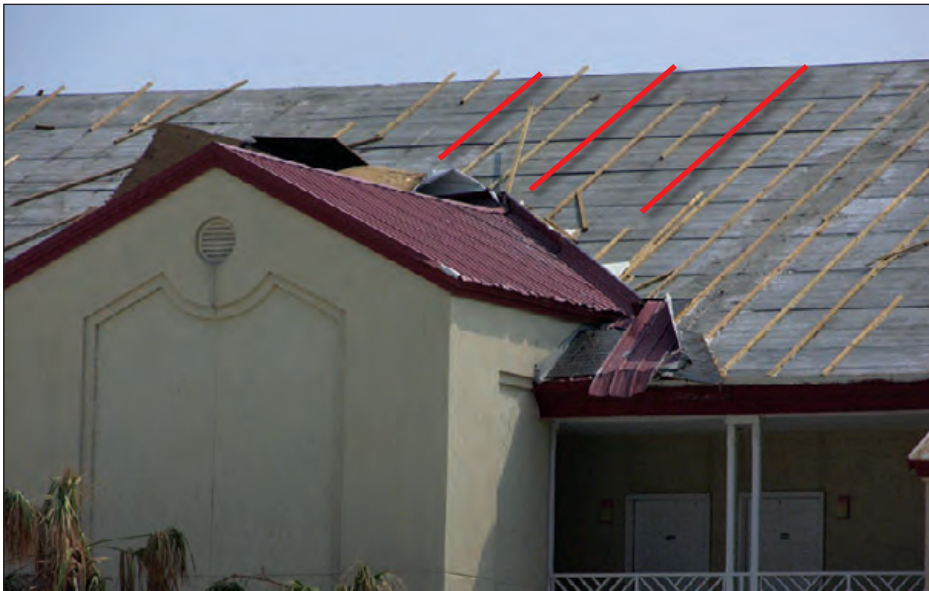
**Figure 6-30:** In most of the areas on this roof, the connection of the top nailer to the bottom nailer was the weakest link. However, in a few locations, the connection of the bottom nailer to the roof structure was the weak link (three of the blown-off bottom nailers are shown by the red lines).

As part of the detailed design effort, load path continuity should be clearly indicated in the contract documents via illustration of connection details. Load paths need to accommodate design uplift, racking, and overturning loads. Load path continuity obviously applies to MWFRS elements, but it also applies to building envelope elements. Figure 6-30 shows load path discontinuities within a roof covering system. In this system, metal roof panels were attached to plywood, which was attached to 4x4 nailers running cross-slope. These top nailers were attached to 4x4 nailers that ran up-slope. The top nailers were inadequately attached to the bottom nailers and the bottom nailers were inadequately attached to the roof structure. To effectively attach the top nailer to the bottom nailer, high-strength connectors such as metal framing connectors are needed. To effectively attach the bottom nailers, a variety of fasteners may be used, provided a sufficient number are used.

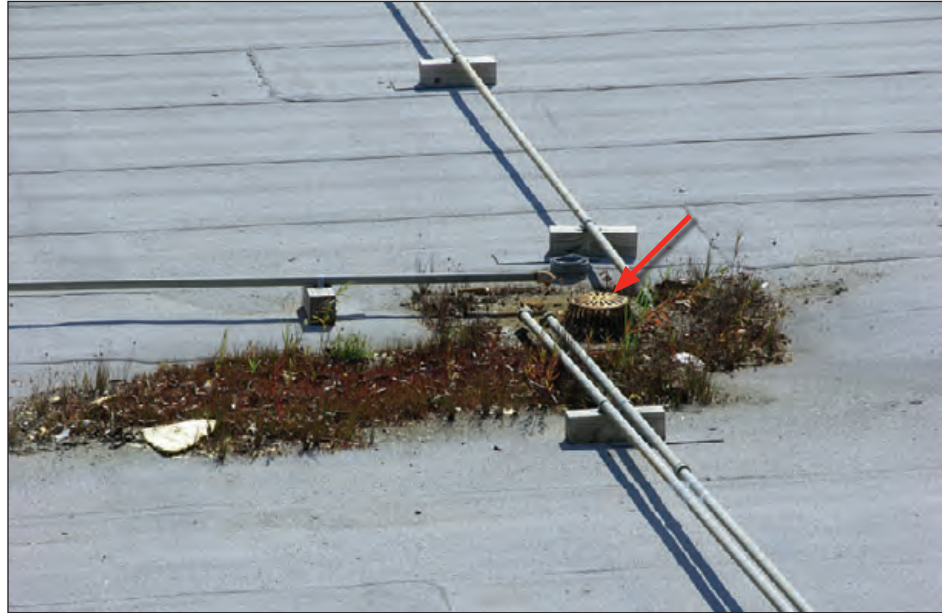
**Figure 6-32:**  
Dirt and vegetation surrounded this roof drain (red arrow) and impeded drainage. Roof drains should be checked at least annually and cleaned of debris if found. Drains should also be checked prior to hurricane landfall. Hurricane Ike (Texas, 2008)

Prior to hurricane landfall, a special roof inspection is recommended. Remove debris and other items that are not anchored so that they do not become wind-borne debris. Also, clean roof drains and sumps so that their drainage capacity is not impaired (see Figure 6-32). Lack of debris maintenance can lead to clogging. If overflow drains or scuppers are also clogged, roof collapse may occur.

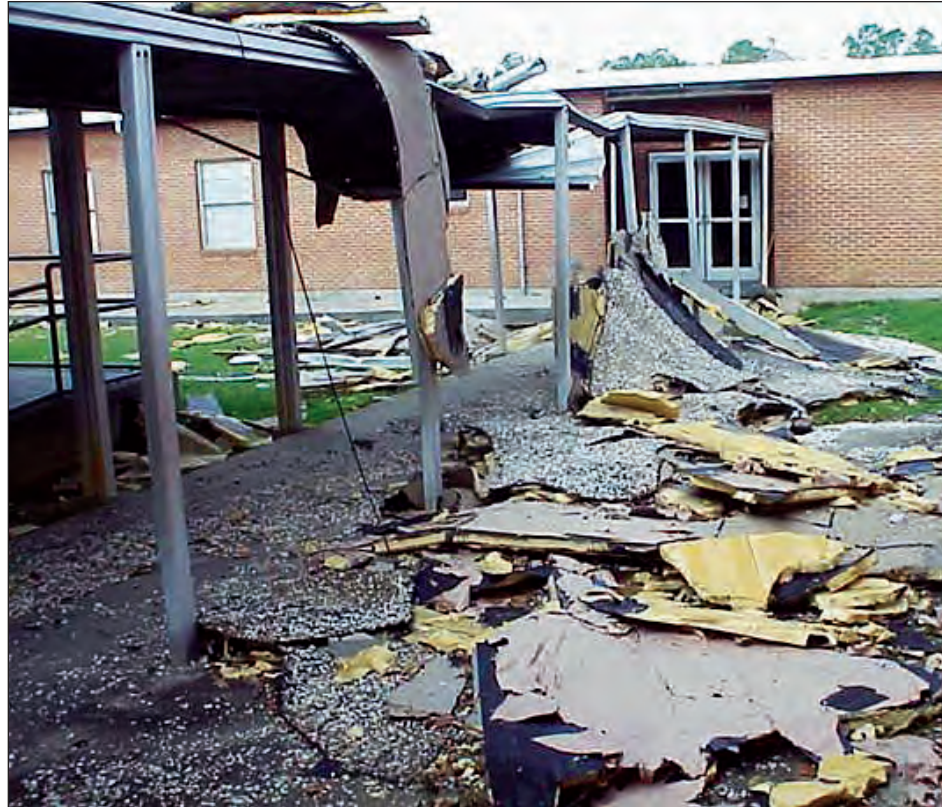
Figure 6:33:  
Open walkways do not  
provide protection from  
wind-borne debris.  
Hurricane Katrina  
(Mississippi, 2005).

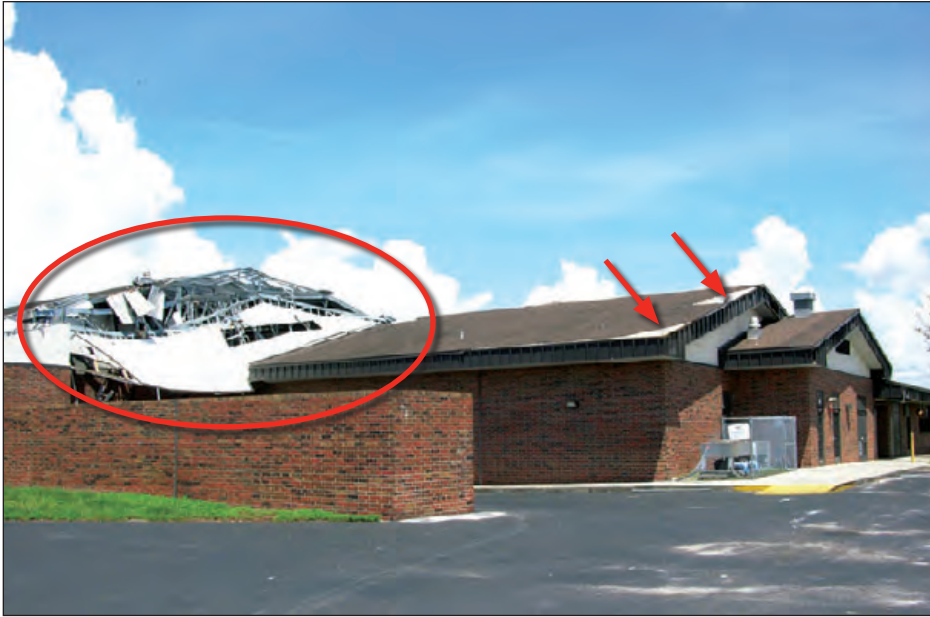
**Figure 6-34:** The structure on this school was composed of light gauge metal framing, with a proprietary composite deck system composed of light gauge corrugated metal deck and gypsum board. In addition to the gable end wall failure, the asphalt shingles and underlayment were blown off at the corner of the eave and ridge. Estimated wind speed: 140 to 160 mph. Hurricane Charley (Florida, 2004)

**Figure 6-42:**  
At the school shown in Figure 6-34, wind-borne debris ruptured the proprietary composite deck system composed of light gauge corrugated metal deck and gypsum board. Estimated wind speed: 140 to 160 mph. Hurricane Charley (Florida, 2004)

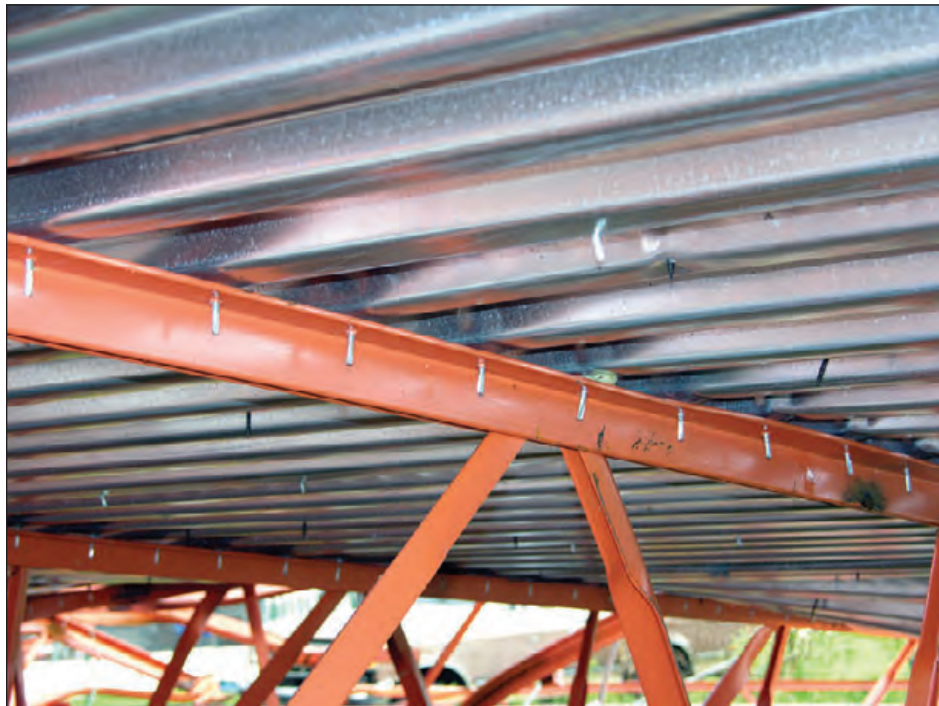
**Figure 6-35:**  
Even though the roof structure blew off, because of the strength and reliability of the screwed deck connections, the decking remained attached to the joists. Hurricane Charley (Florida, 2004)

- For roof decks, concrete, steel, plywood, or oriented strand board (OSB) is recommended.
- For steel roof decks, it is recommended that a screw attachment be specified, rather than puddle welds or powder-driven pins. Screws are more reliable and much less susceptible to workmanship problems, as illustrated by Figure 6-35. These roof joists and decking blew off and landed several feet from the building. The decking was attached with closely-spaced screws. Because of the strength and reliability of the screwed connections, the decking remained attached to the joists.

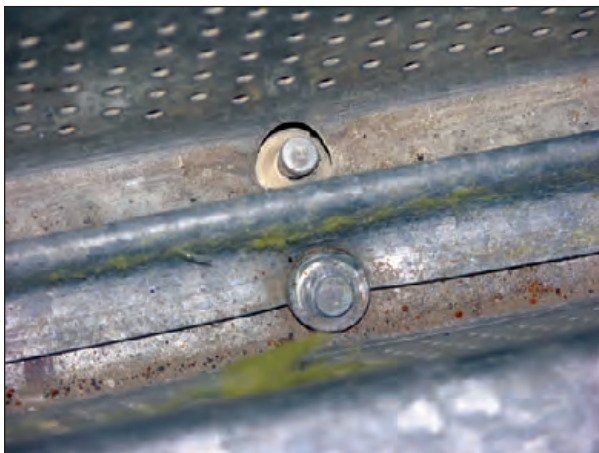
**Figure 6-37:**  
Looking down at a sidelap of a deck attached with powder-driven pins. The washer at the top pin blew through the deck.

Figure 6-36 shows decking that was attached with puddle welds. At most of the welds, there was only superficial bonding of the metal deck to the joist. Only a small portion of the deck near the center of the weld area (as delineated by the circle) was well fused to the joist. Figures 6-37 and 6-38 show problems with acoustical decking attached with powder-driven pins. The pin shown on the left of Figure 6-38 is properly seated. However, the pin at the right did not penetrate far enough into the steel joist below.

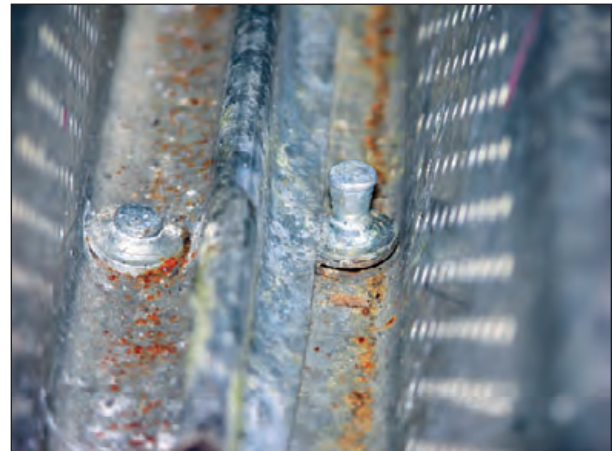
**Figure 6-38:**  
View looking along a sidelap of a deck attached with powder-driven pins. The right pin does not provide adequate uplift and shear resistance.

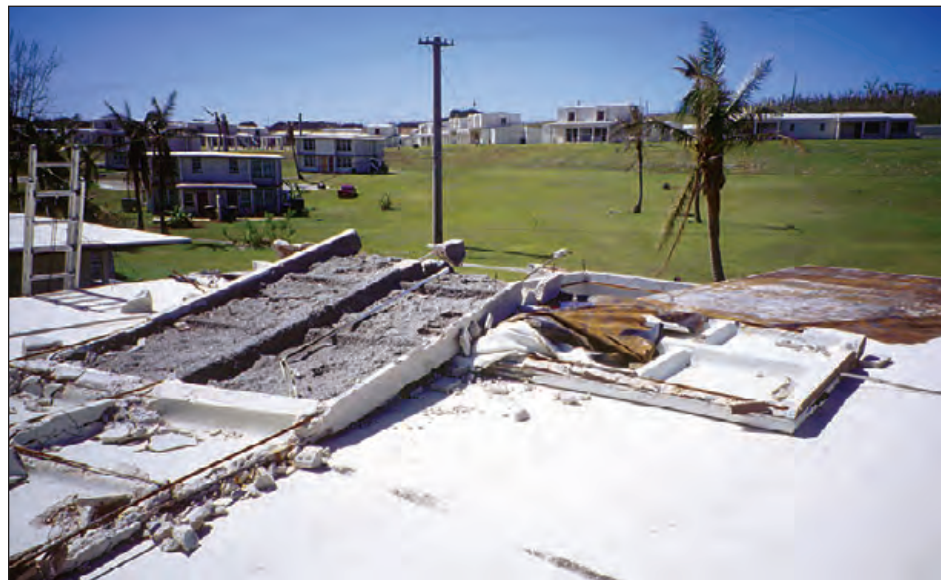
**Figure 6-39:**  
Portions of this waffled precast concrete roof deck were blown off. Typhoon Paka (Guam, 1997)

- For precast concrete decks it is recommended that the deck connections be designed to resist the design uplift loads because the deck dead load itself is often insufficient to resist the uplift. The deck in Figure 6-39 had bolts to provide uplift resistance; however, anchor plates and nuts had not been installed. Without the anchor plates, the dead load of the deck was insufficient to resist the wind uplift load.

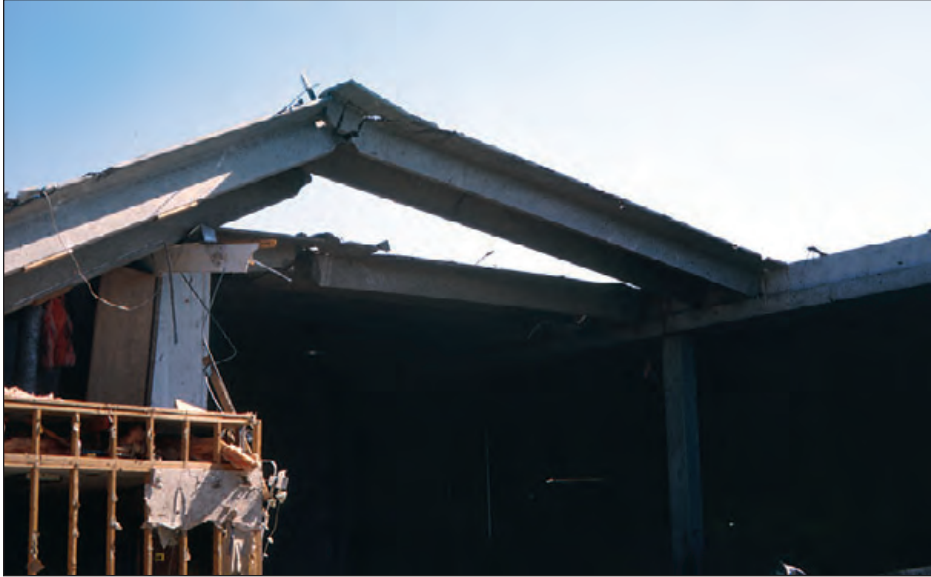
**Figure 6-40:**  
Twin-Tee roof panel  
lifted as a result of  
the combined effects  
of wind uplift and  
pre-tension. Tornado  
(Missouri, May 2003)

- For precast Tee decks, it is recommended that the reinforcing be designed to accommodate the uplift loads in addition to the gravity loads. Otherwise, large uplift forces can cause member failure due to the Tee's own pre-stress forces after the uplift load exceeds the dead load of the Tee. This type of failure occurred at one of the roof panels shown in Figure 6-40, where a panel lifted because of the combined effects of wind uplift and pre-tension. Also, because the connections between the roof and wall panels provided very little uplift load resistance, several other roof and wall panels collapsed.

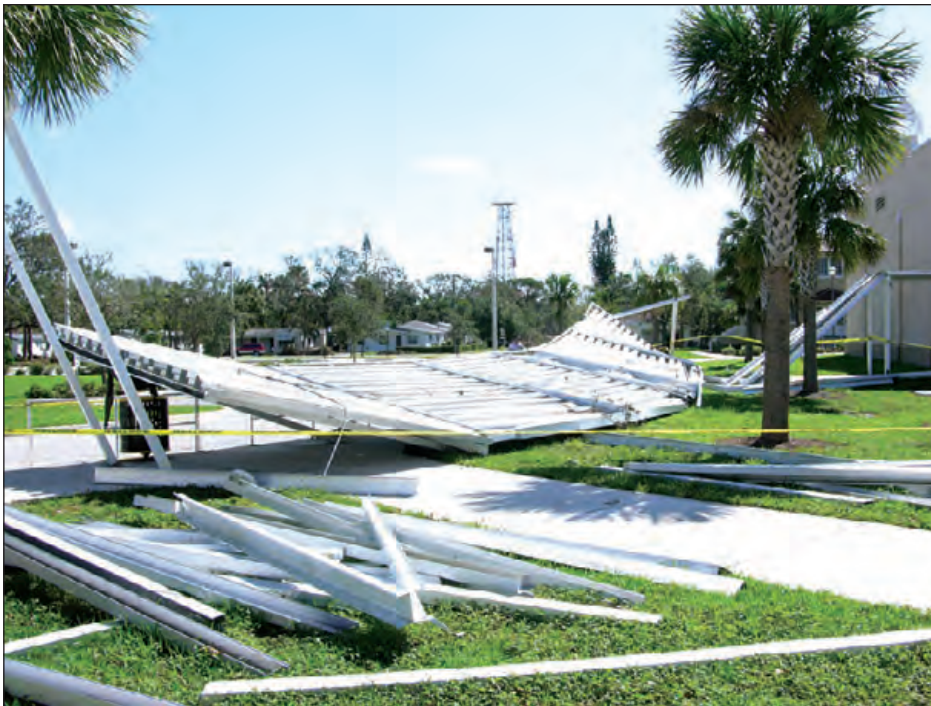
**Figure 6-41:**  
The wind speed was  
sufficient to collapse  
this school's canopy,  
but the speed was not  
high enough to blow  
the canopy debris very  
far. Hurricane Francis  
(Florida, 2004)

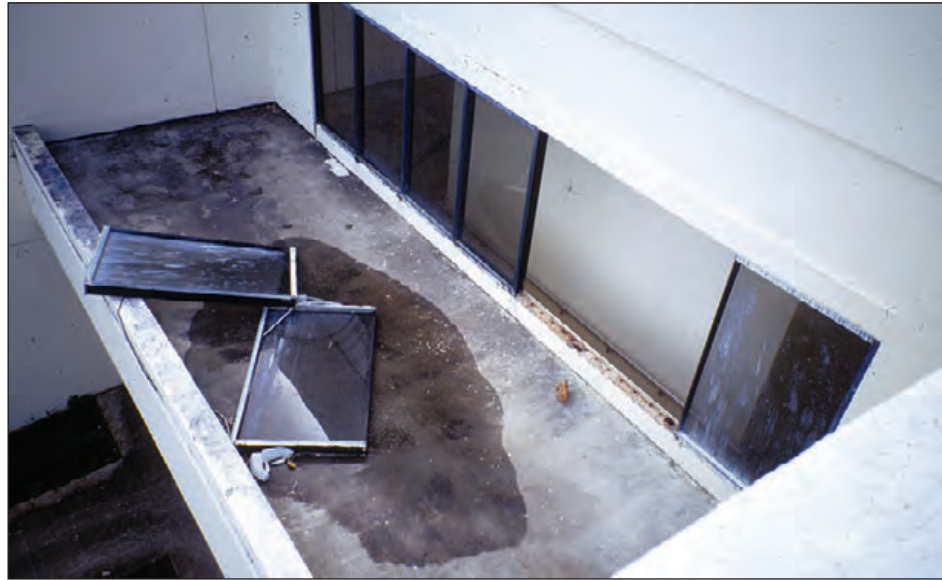
**Figure 6-50:**  
Two complete windows, including frames, blew out as a result of an inadequate number of fasteners. Typhoon Paka (Guam, 1997)

The IBC requires that windows, curtain walls, and skylight assemblies (i.e., the glazing, frame, and frame attachment to the wall or roof) have sufficient strength to resist the positive and negative design wind pressure (see Figure 6-50). Design professionals should specify that these assemblies

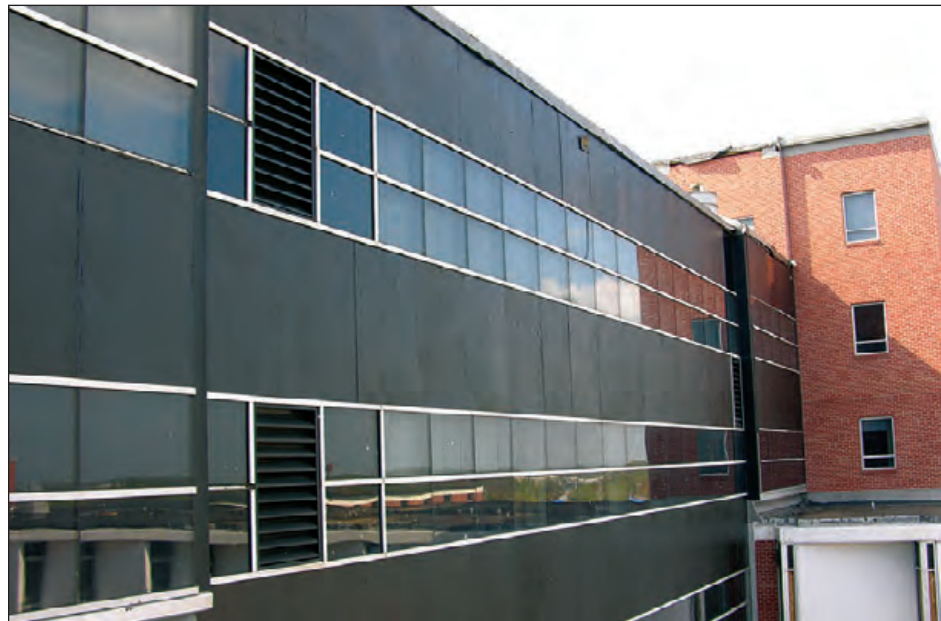
**Figure 6-53:** Plywood panels (black continuous bands) installed after the glass spandrel panels were broken by roof aggregate.<sup>19</sup> Estimated wind speed: 130 mph. Hurricane Katrina (Mississippi, 2005)

Exterior glazing that is not impact-resistant (such as laminated glass or polycarbonate) or protected by shutters is extremely susceptible to breaking if struck by wind-borne debris. Even small, low-momentum missiles can easily break glazing that is not protected. At the building shown in Figure 6-53, approximately 400 windows were broken. Most of the breakage was caused by wind-blown aggregate from the building's aggregate-ballasted single-ply membrane roofs, and aggregate from built-up roofs. With broken windows, a substantial amount of water can be blown into a building, and the internal air pressure can be greatly increased, which may damage the interior partitions and ceilings.

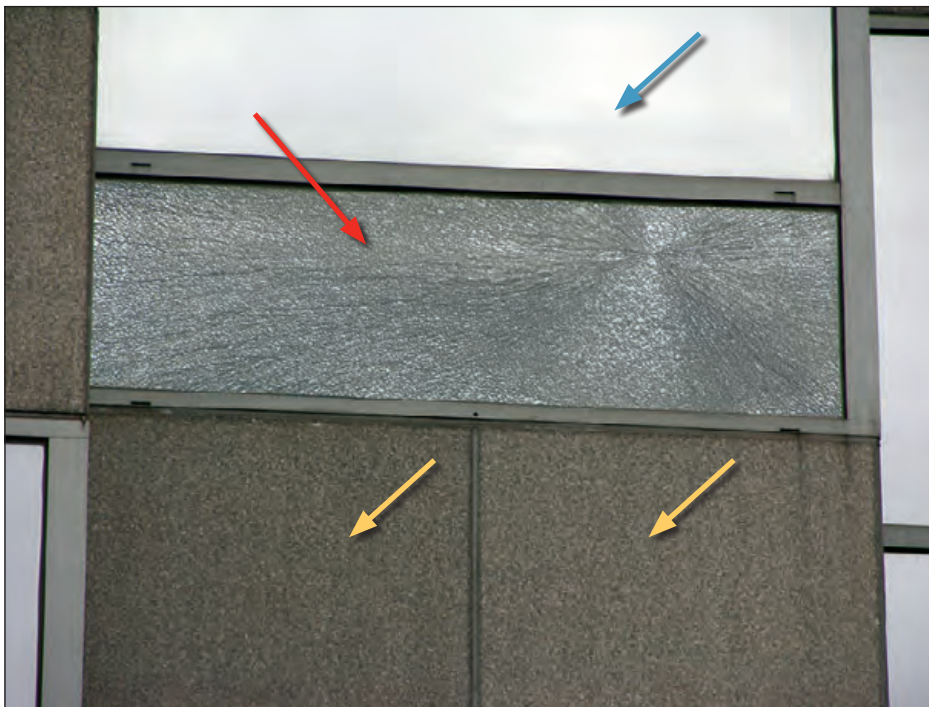
**Figure 6-54:** The red arrow shows a piece of laminated glass that was broken, but remained in the frame to protect the building's interior. The blue arrow shows unbroken laminated glass. The yellow arrows show granite wall panels. Estimated wind speed: 105 mph. Hurricane Katrina (Louisiana, 2005)

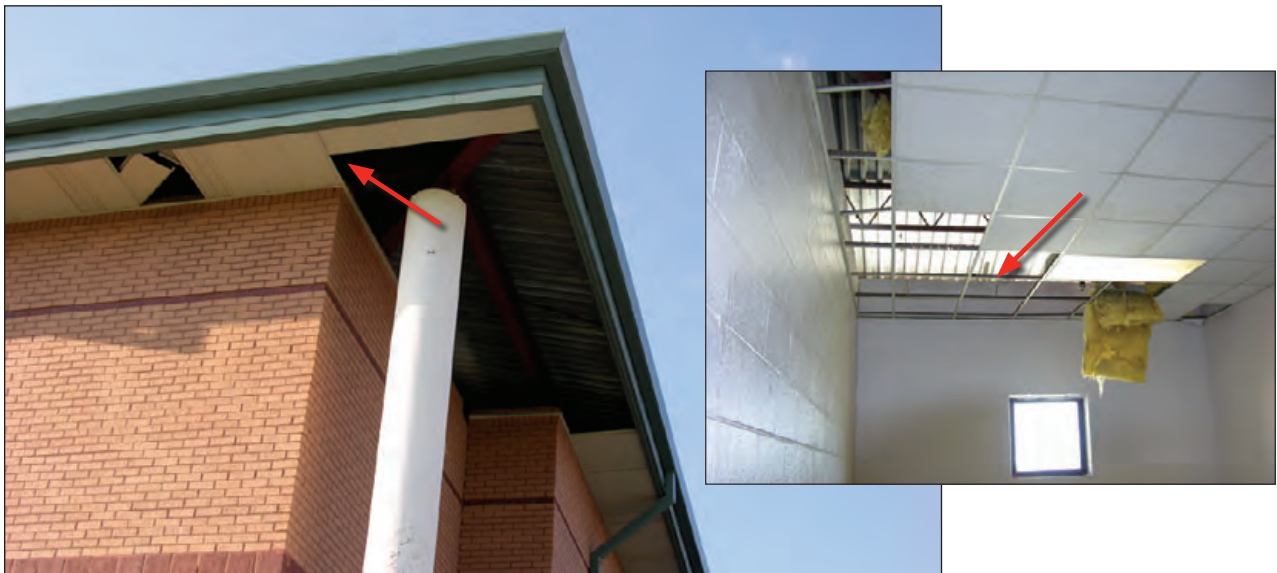
Figure 6-55:

The exterior wall stopped just above the soffit (red arrows). After the metal soffit panels blew away, wind-driven rain blew into the attic space, which saturated the fiberglass batt insulation and caused the ceiling boards to collapse. Estimated wind speed: 130 mph. Hurricane Katrina (Mississippi, 2005)

Besides the cost of repairing the damaged soffits, wind-borne soffit debris can cause property damage and injuries. Failed soffits may also provide a convenient path for wind-driven rain to enter the building, as illustrated by Figure 6-55. This school had a steep-slope roof with a ventilated attic space. The exterior CMU/brick veneer wall stopped just above the soffit (red arrows at Figure 6-55). Wind-driven rain entered the attic space where the soffit had blown away. This and other storm-damage research has shown that water blown into attic spaces after the loss of soffits can cause significant damage and the collapse of ceilings. Even in instances where soffits remain in place, water can penetrate through soffit vents and cause damage.

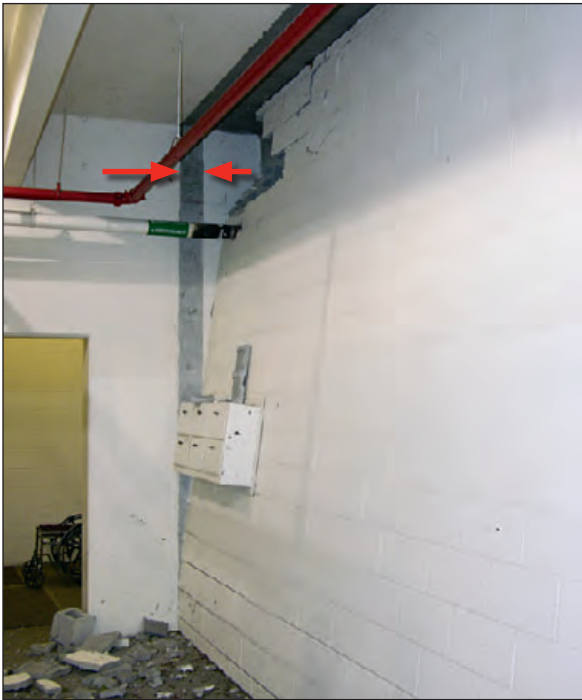
**Figure 6-56:** The red arrows show the original location of a CMU wall that nearly collapsed following a rolling door failure. Estimated wind speed: 140–160 mph. Hurricane Charley (Florida, 2004)

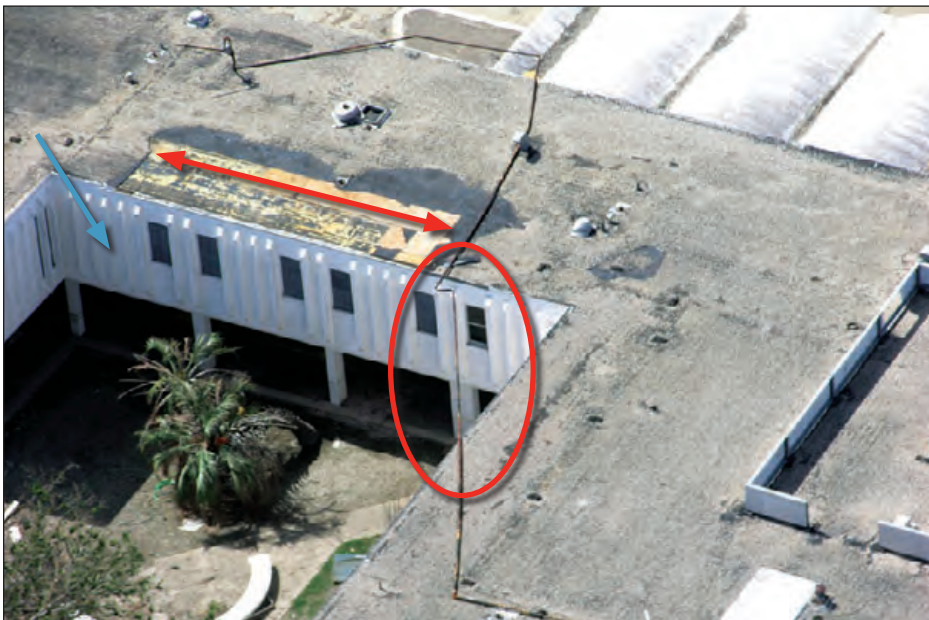
**Figure 6-57:** Although uncommon for schools, precast wall panels were attached to the structural frame of this school. This type of wall typically offers excellent wind performance. Note the roof covering damage and displaced gas line. Estimated wind speed: Approximately 125–130 mph. Hurricane Katrina (Louisiana, 2005)

**Natural gas and condensate drain lines:** Natural gas lines and condensate drain lines serving rooftop HVAC units are seldom anchored to resist wind loads. Gas line rupture can be due to lack of line anchorage or due to HVAC unit blow-off (see Figures 6-57 and 6-99). Where the basic wind speed is greater than 120 mph,<sup>34</sup> it is recommended that gas line supports be designed and constructed to resist the design wind load (see Figure 6-100).
