# Design Guide

for Improving School Safety in Earthquakes, Floods,  
and High Winds

FEMA P-424 / December 2010

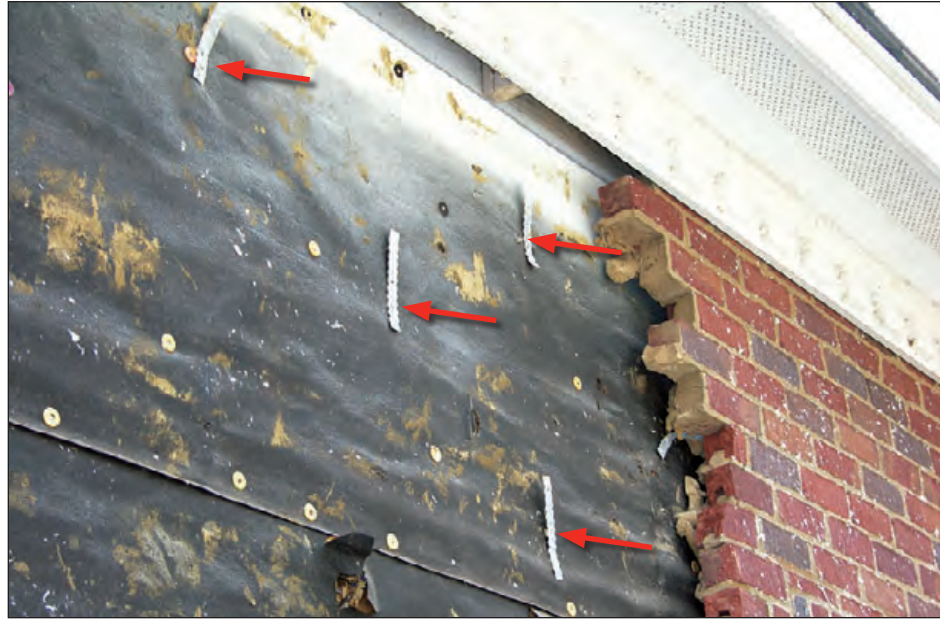
**Figure 6-58:**  
The four ties shown by the red arrows were not embedded into the mortar. Estimated wind speed: 105 mph. Hurricane Katrina, (Mississippi, 2005)

**Brick veneer:** Brick veneer is frequently blown off walls during high winds. When brick veneer fails, wind-driven water can enter and damage buildings, and building occupants can be vulnerable to injury from wind-borne debris (particularly if the walls are sheathed with plastic foam insulation or wood fiberboard in lieu of wood panels). Pedestrians in the vicinity of damaged walls can also be vulnerable to injury from falling veneer. Common failure modes include tie (anchor) fastener pull-out, failure of masons to embed ties into the mortar (Figure 6-58), poor bonding between ties and mortar, a mortar of poor quality, and tie corrosion.

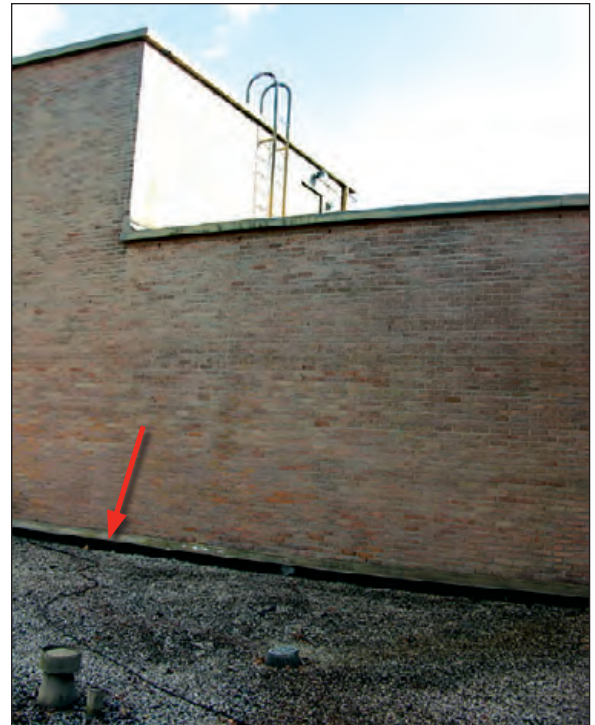
**Figure 6-59:** Water leaked inside along the base of the brick veneer walls (red arrow). Estimated wind speed: 115 mph. Hurricane Katrina (Louisiana, 2005)

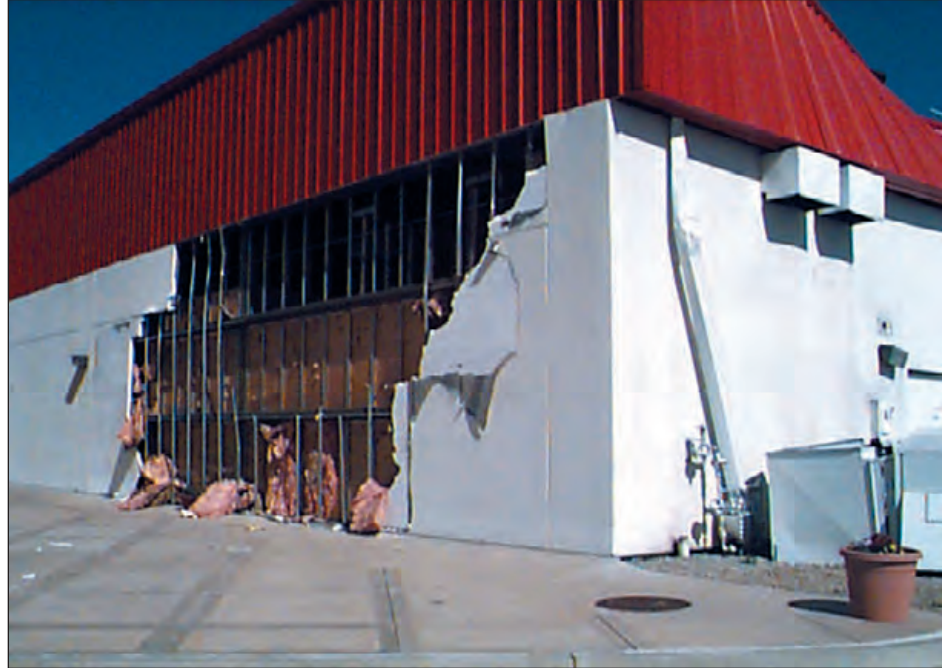
**Figure 6-61:**  
EIFS blow-off near a wall corner. At one area, the metal fascia was also blown in.

**EIFS:** Figure 6-60 shows typical EIFS assemblies. Figure 6-61 shows EIFS blow-off. In this case, the molded expanded polystyrene (MEPS) was attached to gypsum board, which in turn was attached to metal studs. The gypsum board detached from the studs, which is a common EIFS failure mode. When the gypsum board on the exterior side of the studs is blown away, it is common for gypsum board on the interior side to also be blown off. The opening allows the building to become fully pressurized and allows the entrance of wind-driven rain. Other common types of failure include wall framing failure (see Figure 6-63), separation of the MEPS from its substrate, and separation of the synthetic stucco from the MEPS.

To identify weak EIFS systems so that corrective action can be taken to avoid the type of damage shown in Figures 6-61 and 6-62, on-site testing in accordance with ASTM E 2359 can be conducted. (Note: This test method is not capable of evaluating the wind resistance of the wall framing.)

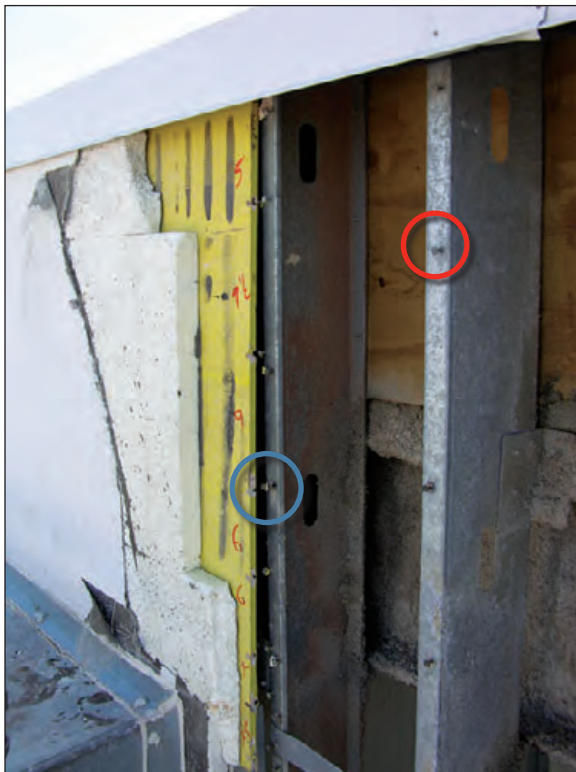
**Figure 6-62:**

At this EIFS failure, the screws attaching the gypsum board (yellow colored material) were too far apart (red circle). Additionally, at the board joint, the screws were too close to the board edge (blue circle). In this area, the screws were spaced at  $4\frac{1}{2}$ , 4, 6, 6, 9, and  $9\frac{1}{2}$  inches on center. Also, the adhesive between the gypsum board and MEPS was applied in rows rather than continuously over the gypsum board. Estimated wind speed: 120 mph. Hurricane Katrina (Mississippi, 2005)

Reliable wind performance of EIFS is very demanding on the designer and installer. It is particularly important to attach the gypsum board with a sufficient number of properly located fasteners and to properly apply the adhesive. At the newly constructed building shown in Figure 6-62, several of the gypsum boards blew off because of an inadequate number of screws. Also, at the gypsum board joint, there was insufficient fastener edge distance. Although not the primary failure mode, the adhesive between the MEPS and gypsum board was applied in rows, rather than continuously over the entire substrate with a notched trowel.

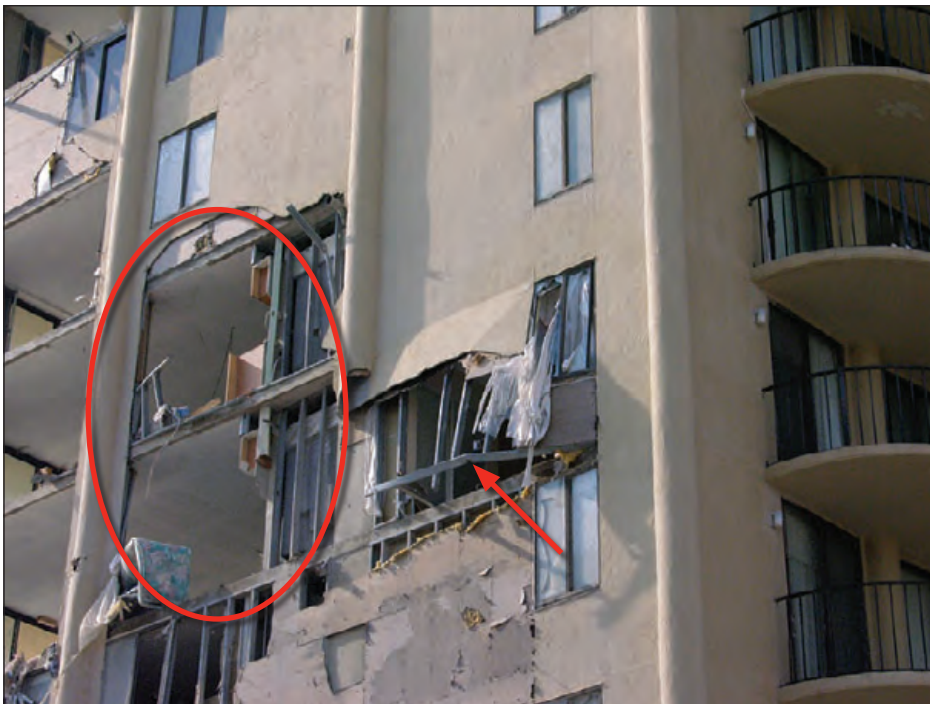
**Figure 6-63:** The stucco wall failure was caused by inadequate attachment between the stud tracks and the building's structure. All of the metal stud framing within the red oval blew away. The arrow shows a bottom stud track that detached and pulled away from the building. Estimated wind speed: 110–125 mph. Hurricane Ivan (Florida, 2004)

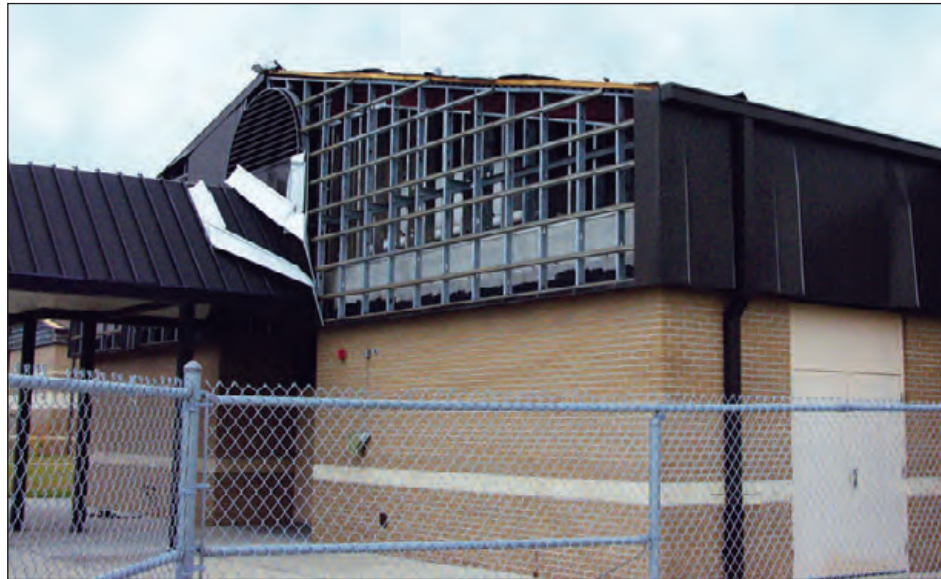
**Figure 6-64:**  
The loss of metal wall panels allowed a substantial amount of wind-driven rain to penetrate into the classroom. Estimated wind speed: 105–115 mph. Hurricane Ivan (Florida, 2004)

metal wall panels shown in Figure 6-64 been applied over a moisture barrier and sheathing, the amount of water entering the school would have likely been eliminated or greatly reduced, as is the case with the school shown in Figure 6-65.

**Parapets:** For low-sloped roofs, minimum 3-foot high parapets are recommended. With parapets of this height or greater, the uplift load in the corner region is substantially reduced (ASCE 7 permits treating the corner zone as a perimeter zone). Also, a high parapet (as shown in Figure 6-106) may intercept wind-borne debris and keep it from blowing off the roof and damaging other building components or injuring people. To protect base flashings from wind-borne debris damage and subsequent water leakage, it is recommended that metal panels on furring strips be installed over the base flashing (Figure 6-88). Exposed stainless steel screws are recommended for attaching the panels to the furring strips, because using exposed fasteners is more reliable than using concealed fasteners or clips (as were used for the failed panels shown in Figure 6-64).

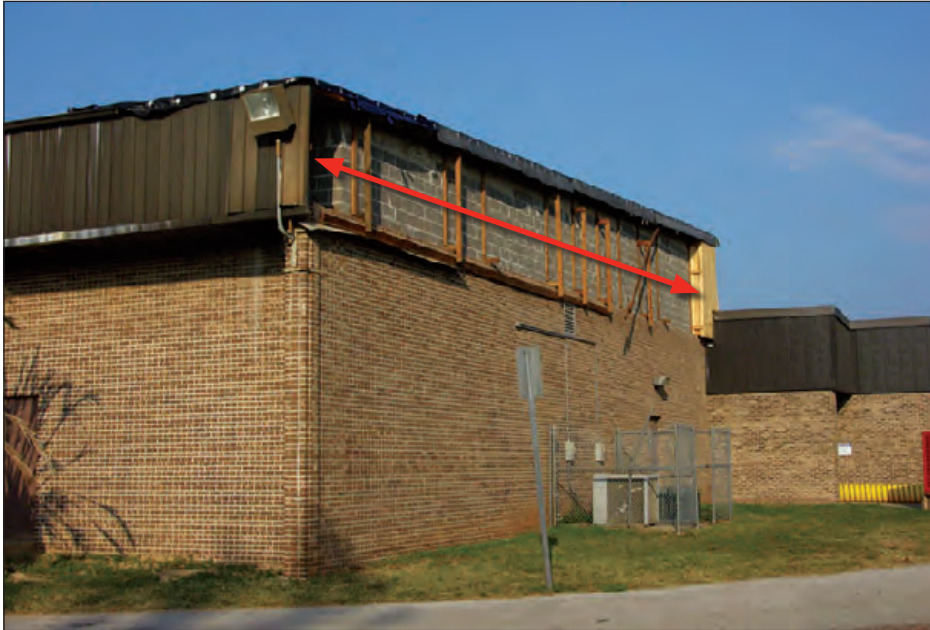
**Figure 6-65:**  
Blow-off of metal fascia panels due to inadequate attachment of wood furring to the CMU wall. Estimated wind speed: 85–95 mph. Hurricane Ivan (Florida, 2004)

Metal wall panel performance also depends on adequacy of the framing to which it is attached. At the school shown in Figure 6-65, the metal fascia panels were attached to wood furring that was inadequately attached to CMU. Unlike the condition at the school shown at Figure 6-64, with the CMU behind the metal panels, water was prevented from entering the school. However, wind-borne fascia debris can cause damage or cause injury.

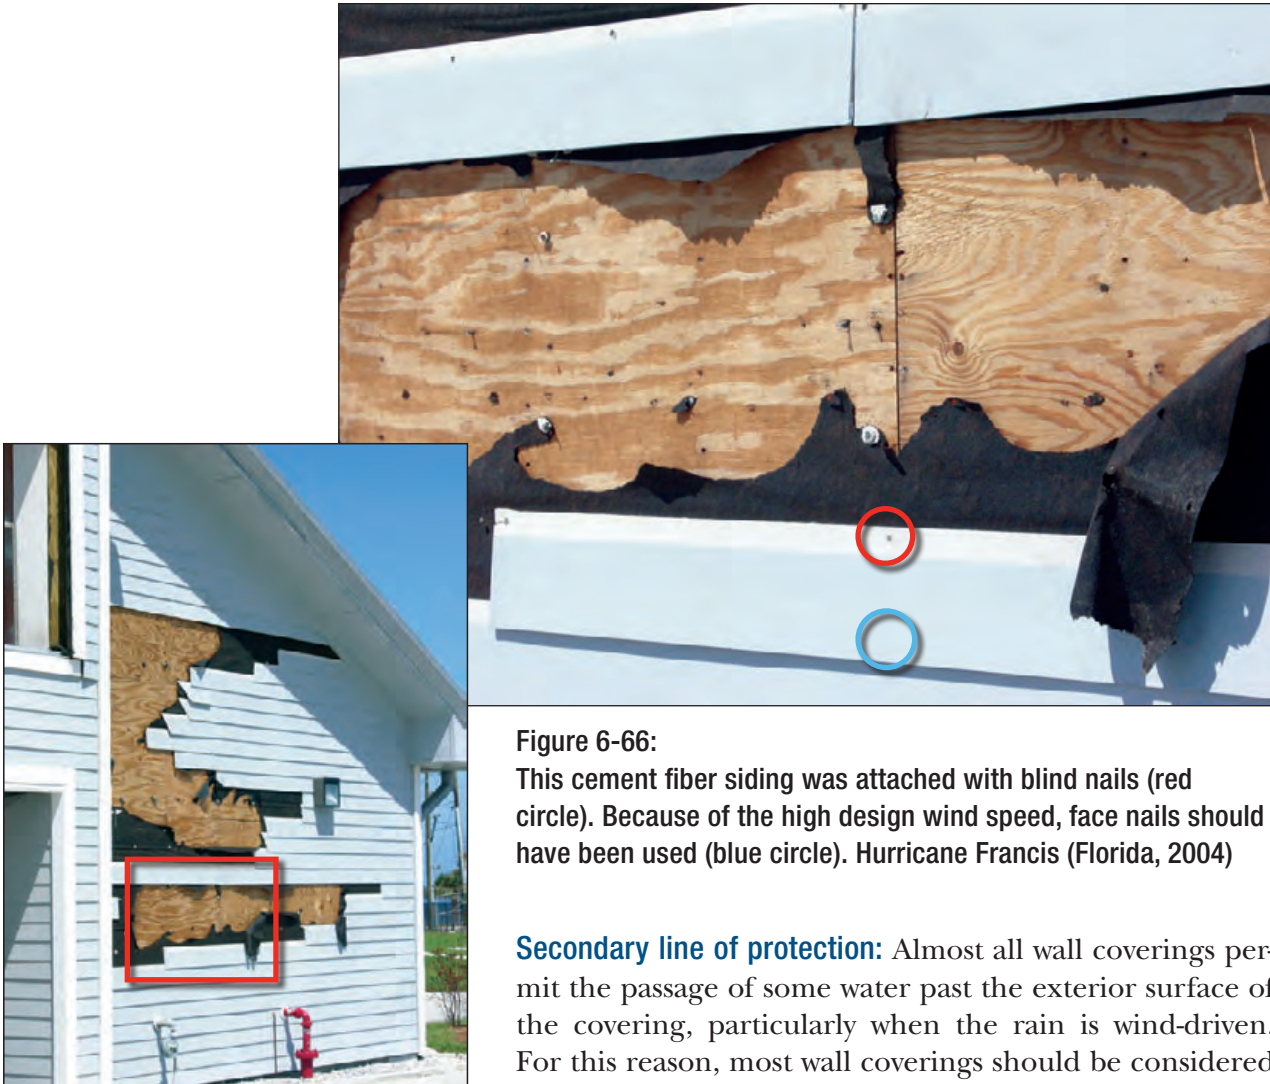
**Figure 6-66:**

This cement fiber siding was attached with blind nails (red circle). Because of the high design wind speed, face nails should have been used (blue circle). Hurricane Francis (Florida, 2004)

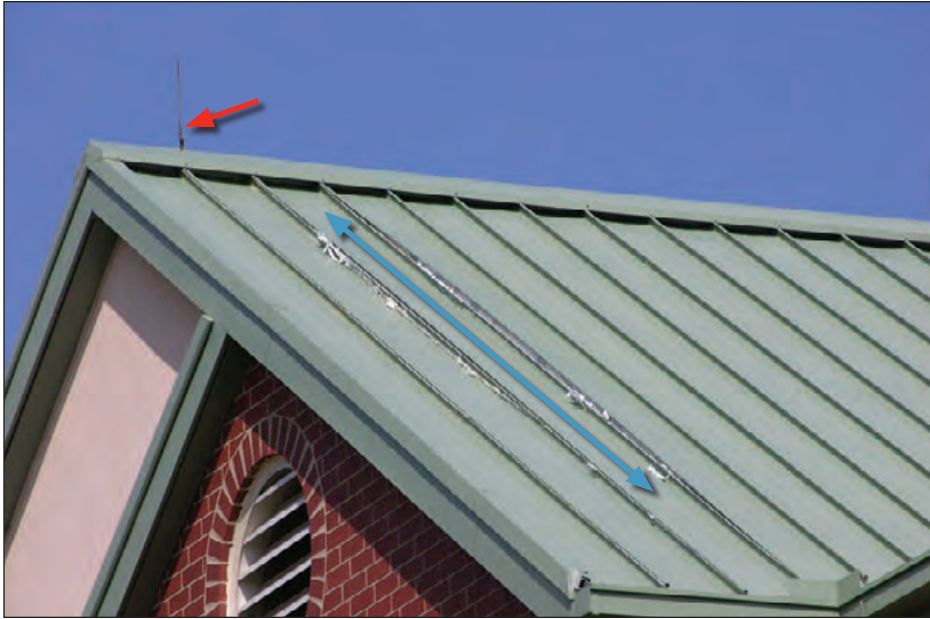
**Figure 6-67:**  
Three of the panel ribs opened up (one to the right of the blue arrow and two to the left). The LPS conductor serving the air terminal (red arrow) ran underneath the ridge flashing. Estimated wind speed: 105–115 mph. Hurricane Ivan (Florida, 2004)

For structural metal panel systems, the IBC requires test methods UL 580 or ASTM E 1592. It is recommended that design professionals specify use of E 1592, because it gives a better representation of the system's uplift performance capability. At the building shown in Figure 6-67, three of the standing seams opened up (unlatched). In the opened condition, the panels were very susceptible to progressive failure, and they were no longer in a watertight condition. At other roof areas, several panels were blown off. ASTM E 1592 is more suitable than UL 580 for assessing the potential for panels to unlatch. Note the air terminal ("lightning rod") shown by the red arrow. The lightning protection system (LPS) conductor ran underneath the ridge flashing. By being concealed underneath the ridge flashing, the conductor was shielded from the wind, (as recommended in Section 6.3.4.4) and was therefore not susceptible to blow-off.

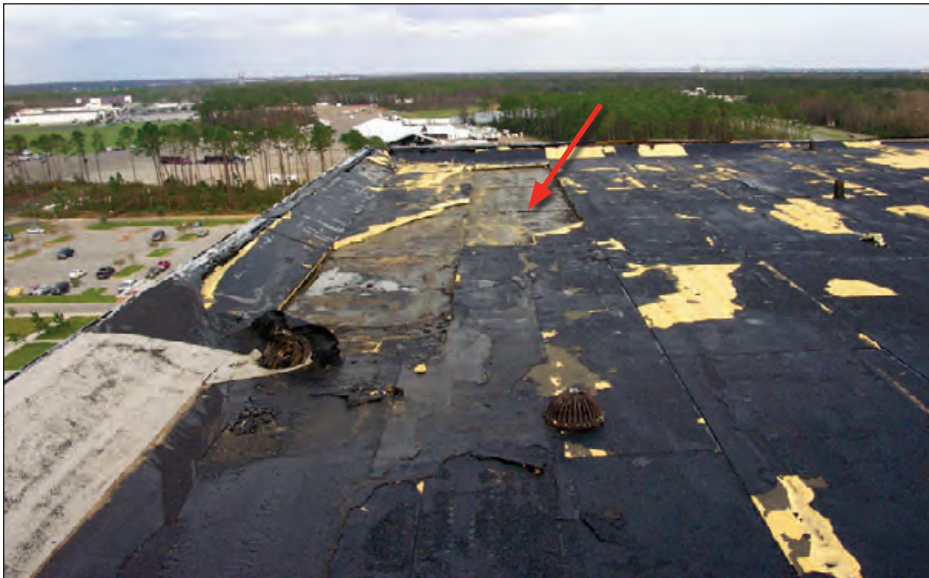
**Figure 6-68:** The blown off insulation (red arrow) may have initiated blow-off of the roof membrane. Estimated wind speed: 105–115 mph. Hurricane Ivan (Florida, 2004)

When fully adhering insulation boards, it is recommended that the boards be no larger than 4 feet by 4 feet. It is also recommended that the board thickness not exceed 2 inches (1½ inches is preferable). Use of small thin boards makes it easier for the contractor to conform the boards to the substrate. At the building shown in Figure 6-68, 4-foot by 8-foot insulation boards were set in hot asphalt over a concrete deck. A few of the boards detached from the deck. The boards may have initiated the membrane blow-off, or the membrane blow-off may have been initiated by lifting and peeling of the metal edge flashing, in which case, loss of the insulation boards was a secondary failure.

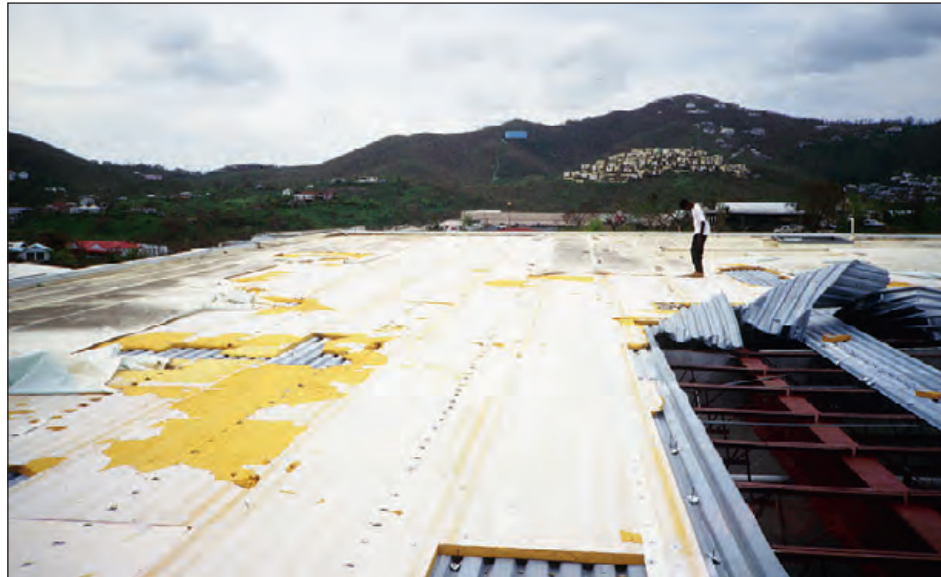
**Figure 6-69:**  
The orientation of the membrane fastener rows led to blow-off of the steel deck. Hurricane Marilyn (U.S. Virgin Islands, 1995)

When specifying a mechanically attached single-ply membrane, if a steel deck is selected, it is critical to specify that the membrane fasteners be attached in rows perpendicular to the steel flanges to avoid overstressing the attachment of the deck to the deck support structure. At the school shown in Figure 6-69, the fastener rows of the mechanically attached single-ply membrane ran parallel to the

top flange of the steel deck. The deck fasteners were overstressed and a portion of the deck blew off and the membrane progressively tore. When membrane fasteners run parallel to the flange, the flange with membrane fasteners essentially carries the entire uplift load because of the deck's inability to transfer any significant load to adjacent flanges. Hence, at the joists shown in Figure 6-68, the deck fasteners on either side of the flange with the membrane fasteners are the only connections to the joist that are carrying substantial uplift load.

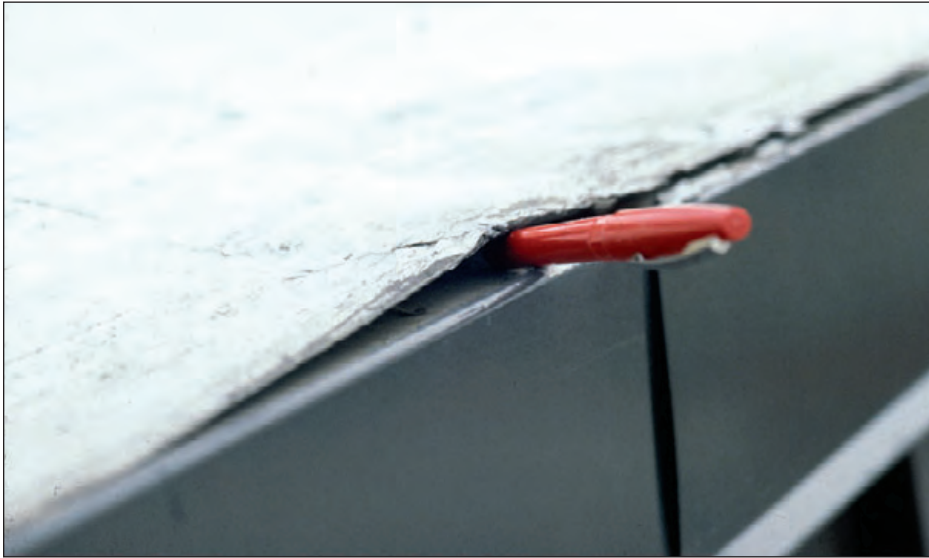
**Figure 6-70:**  
The ink pen shows an opening that the wind can catch to cause lifting and peeling of the membrane.

Roof membrane blow-off is almost always a result of lifting and peeling of the metal edge flashing or coping, which serves to clamp down the membrane at the roof edge. Therefore, it is important for the design professional to carefully consider the design of metal edge flashings, copings, and the nailers to which they are attached. The metal edge flashing on the modified bitumen membrane roof shown in Figure 6-70 was installed

underneath the membrane, rather than on top of it, and then stripped in. In this location, the edge flashing was unable to clamp the membrane down. At one area, the membrane was not sealed to the flashing. An ink pen was inserted into the opening prior to photographing to demonstrate how wind could catch the opening and lift and peel the membrane.

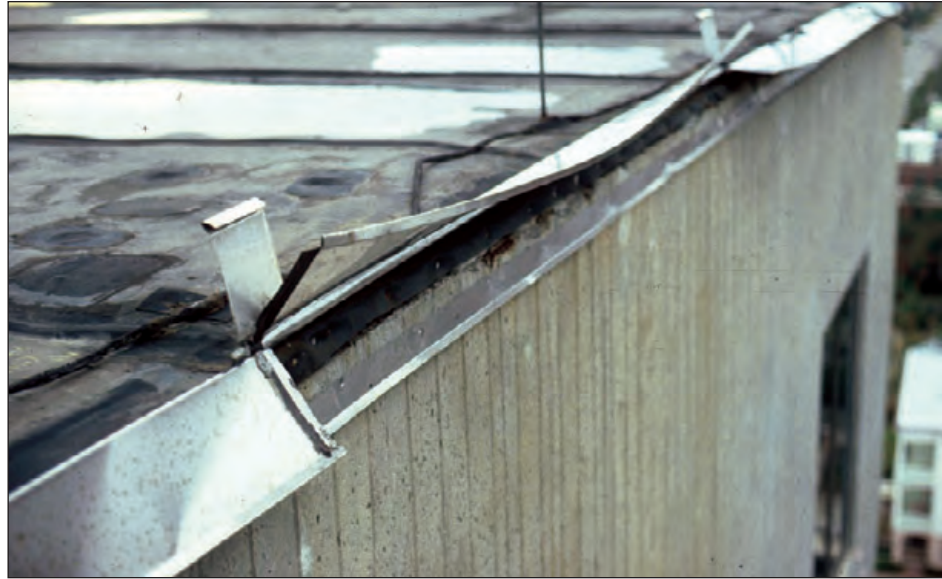
**Figure 6-71:**  
The metal edge flashing on this building disengaged from the continuous cleat and the vertical flange lifted. Hurricane Hugo (South Carolina, 1989)

The traditional edge flashing/coping attachment method relies on concealed cleats that can deform under wind load and lead to disengagement of the flashing/coping (see Figure 6-71) and subsequent lifting and peeling of the roof membrane. When a vertical flange disengages and lifts up, the edge flashing and membrane are very susceptible to failure. Normally, when a flange lifts, the failure continues to propagate and the metal edge flashing and roof membrane blows off.

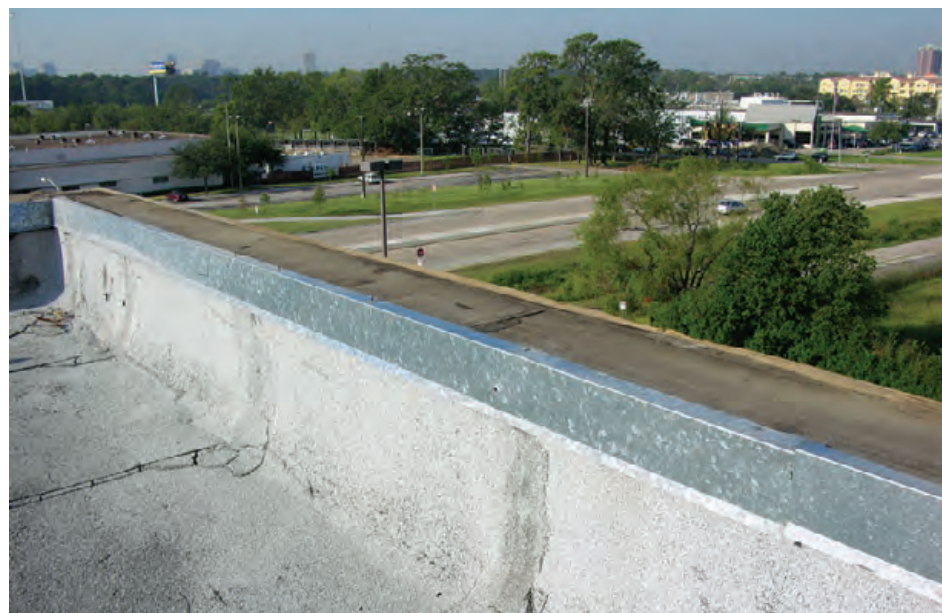
At the building shown in Figure 6-72, the cleat nailing provided very little resistance to outward deflection of the cleat and coping. While most of the continuous inner and outer cleats remained on the building, several sections of coping and at least one cleat blew off once the amount of deflection was sufficient for the coping to disengage from the cleat. In this case, the roof membrane did not lift and peel as often happens when the coping blows off. However, the coping debris did gouge the roof membrane. Note that the base flashing was stopped at the top of the parapet. It should have been run across the top of the nailer and turned down and nailed so as to provide greater watertight protection in the event of coping leakage or coping blow-off.

**Figure 6-72:**  
The coping blew off because of inadequate attachment of the cleats. Estimated wind speed: 92 mph. Hurricane Ike (Texas, 2008)

**Figure 6-104:**  
Leaf debris and ponding near a scupper (red and blue arrows). The yellow arrow indicates a piece of coping that blew off an upper roof shown in Figure 6-72. Estimated wind speed: 92 mph. Hurricane Ike (Texas, 2008)

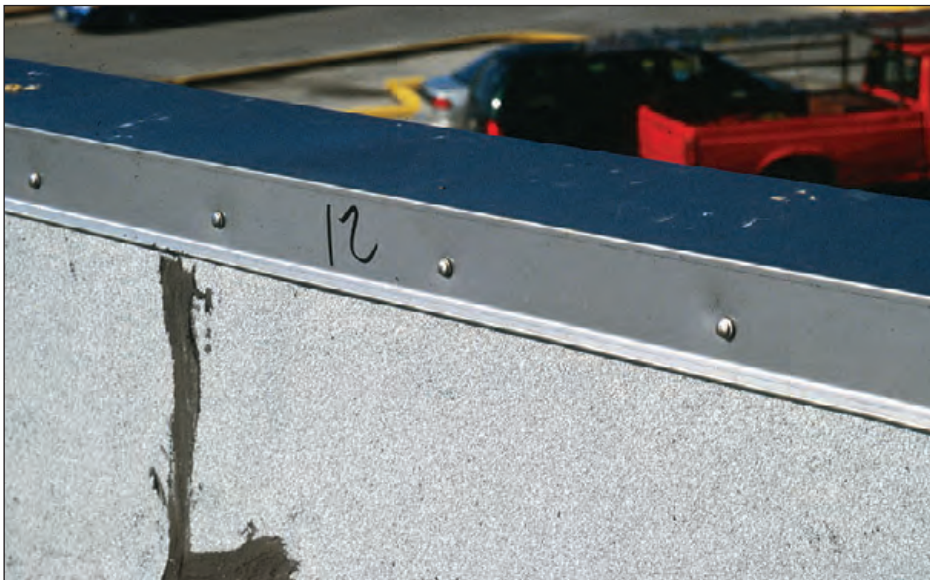
Storm-damage research has revealed that, in lieu of cleat attachment, the use of exposed fasteners to attach the vertical flanges of copings and edge flashings is a very effective and reliable attachment method. The coping shown in Figure 6-73 was attached with ¼-inch diameter stainless steel concrete spikes at 12 inches on center. When the fastener is placed in wood, #12 stainless steel screws with stainless steel washers are recommended. The fasteners should be more closely spaced in the corner areas (the spacing will depend upon the design wind loads). ANSI/SPRI ES-1 provides guidance on fastener spacing and thickness of the coping and edge flashing.

**Figure 6-73:** Both vertical faces of the coping were attached with exposed fasteners instead of concealed cleats. Typhoon Paka (Guam, 1997)

For roofs with weak metal edge flashing or coping attachment, face-attachment of the edge flashing/coping (as shown in Figure 6-73) is a cost-effective approach to greatly improve the wind-resistance of the roof system. To improve the wind resistance of weak gutters, a cost-effective approach is to install straps as shown in Figure 6-77. Alternatively, if the gutter bracket attachment is sufficient to resist rotational force (as discussed in Section 6.3.3.6), but the gutter is not anchored to the brackets, fasteners can be installed to anchor the gutter to the bracket as shown in Figure 6-76.

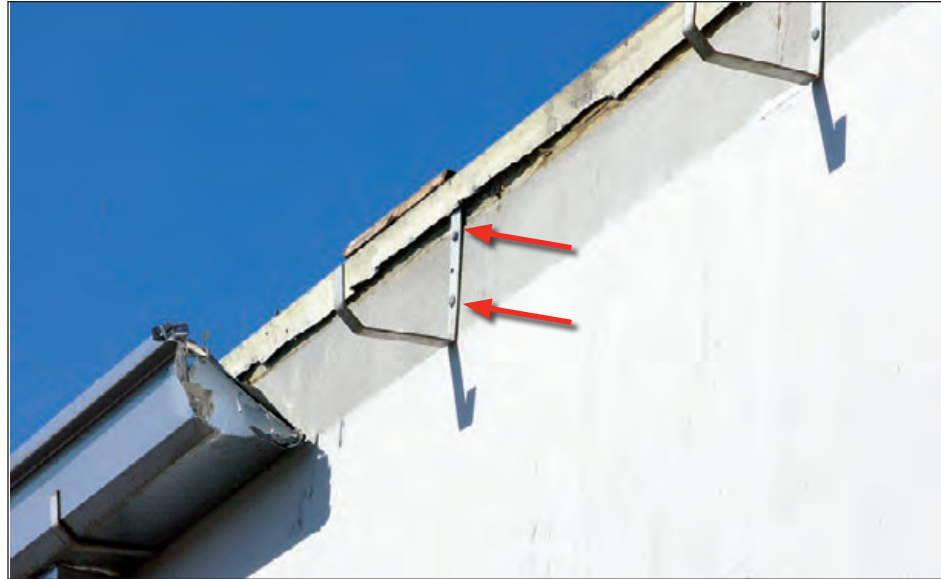
Storm-damage research has shown that gutters are seldom designed and constructed to resist wind loads. At the school shown in Figure 6-74, the gutter brackets were attached with a fastener near the top and bottom of the bracket. Hence, the fasteners prevented the brackets from rotating out from the wall. However, because the gutter was not attached to the brackets, the gutter blew away. When a gutter lifts, it typically causes the edge flashing that laps into the gutter to lift as well. Frequently, this results in a progressive lifting and peeling of the roof membrane. The membrane blow-off shown in Figure 6-75 was initiated by gutter uplift. The gutter was similar to that shown in Figure 6-74. The membrane blow-off caused significant interior water damage.

Figure 6-74: Because this gutter was not attached to the bracket, wind lifted the gutter along with the metal edge flashing that lapped into the gutter. Bracket fasteners are indicated by the red arrows. Hurricane Francis (Florida, 2004)

- Gravity-support brackets can be designed to resist uplift loads. In these cases, in addition to being attached at its top, the bracket should also be attached at its low end to the wall (as was the case for the brackets shown in Figure 6-74). The gutter also needs to be designed so it is attached securely to the bracket in a way that will effectively transfer the gutter uplift load to the bracket (see Figure 6-76). Bracket spacing

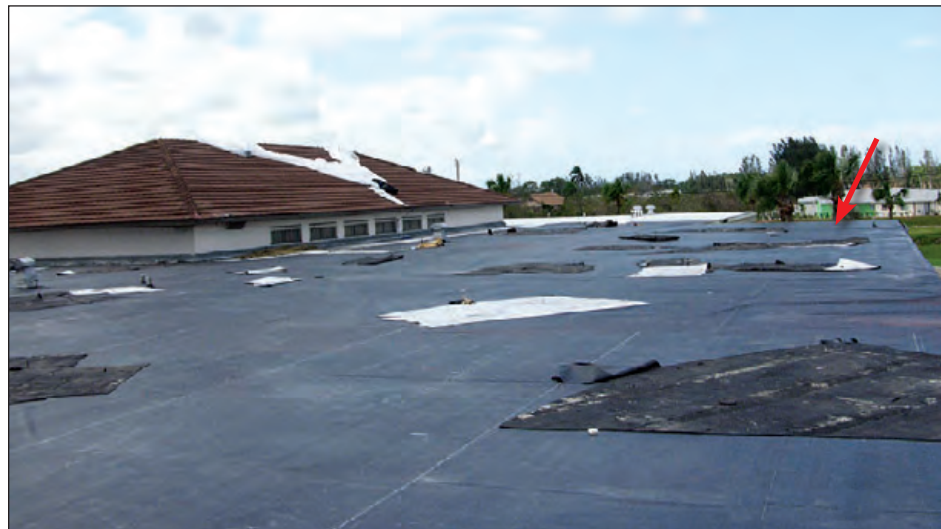
Figure 6-75: The original modified bitumen membrane was blown away after the gutter lifted in the area shown by the red arrow (the black membrane is a temporary roof). Hurricane Francis (Florida, 2004)

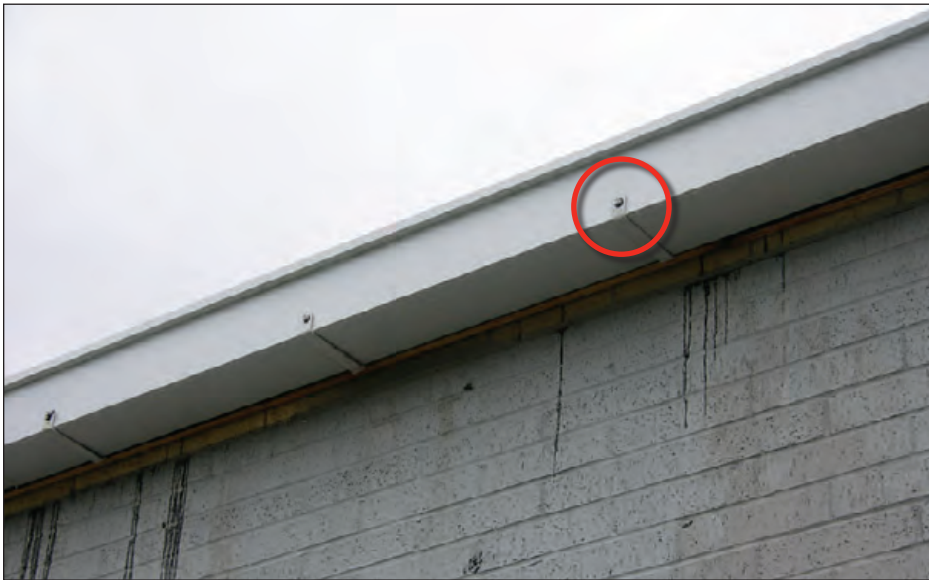
**Figure 6-76:** At this gutter, a fastener connected the bracket to the gutter. Note: To avoid leakage at the fasteners between the bracket and gutter, the bracket should extend near or to the top of the gutter so that the fastener would be above the waterline. Estimated wind speed: 95 mph. Hurricane Ike (Texas, 2008)

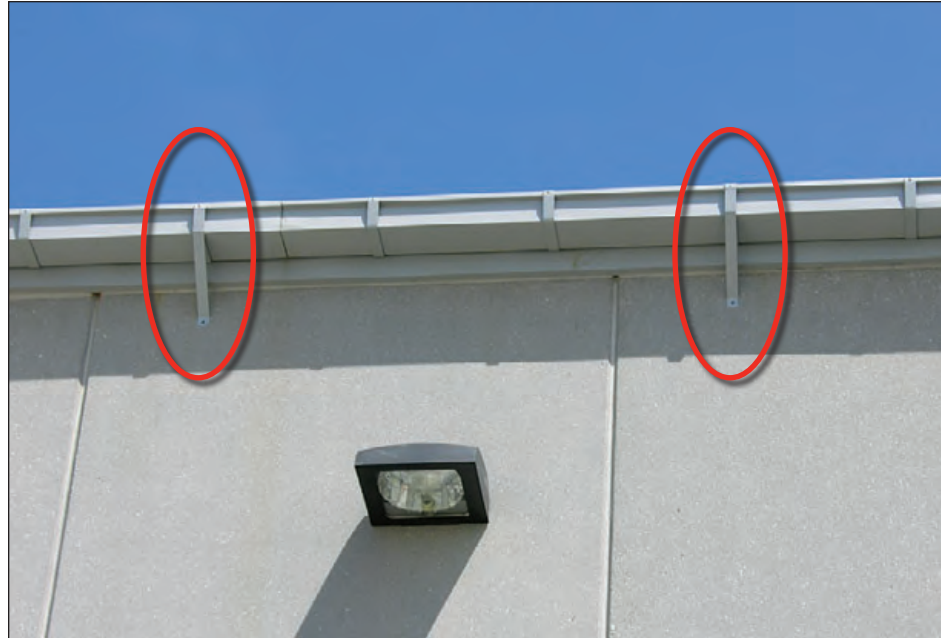
- The other option is to use gravity-support brackets only to resist gravity loads, and use separate sheet-metal straps at 45-degree angles to the wall to resist uplift loads (Figure 6-77). Strap spacing will depend on the gutter uplift load and strength of the connections between the gutter/strap and the strap/wall. Note that FMG Data Sheet 1-49 recommends placing straps 10 feet apart. However, at that spacing with wide gutters, fastener loads induced by uplift are quite high. When straps are spaced at 10 feet, it can be difficult to achieve sufficiently strong uplift connections.

**Figure 6-77:**  
Sheet metal straps  
were attached to an  
existing gutter that  
lacked sufficient uplift  
resistance.

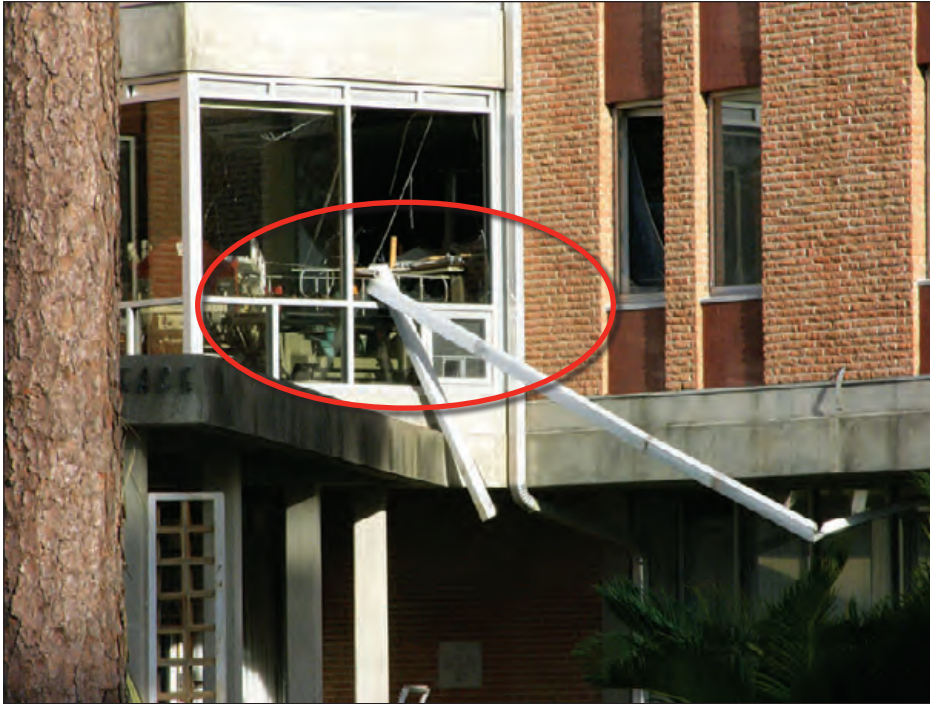
**Figure 6-78:**  
Blow-off of this downspout resulted in glazing breakage. Estimated wind speed: 105–115 mph. Hurricane Ivan (Florida, 2004)

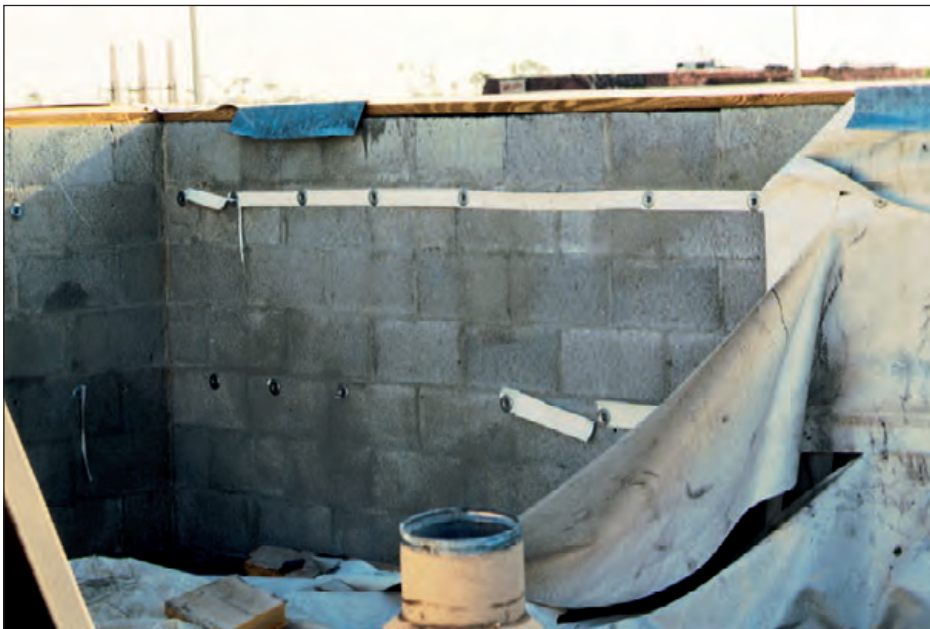
**Figure 6-79:**  
If mechanically attached base flashings have an insufficient number of fasteners, the base flashing can be blown away. Hurricane Andrew (Florida, 2004)

When the roof membrane is specified to be adhered, it is recommended that fully adhered base flashings be specified in lieu of mechanically attached base flashings. Otherwise, if the base flashing is mechanically attached, ballooning of the base flashing during high winds can lead to lifting and progressive peeling of the roof membrane.

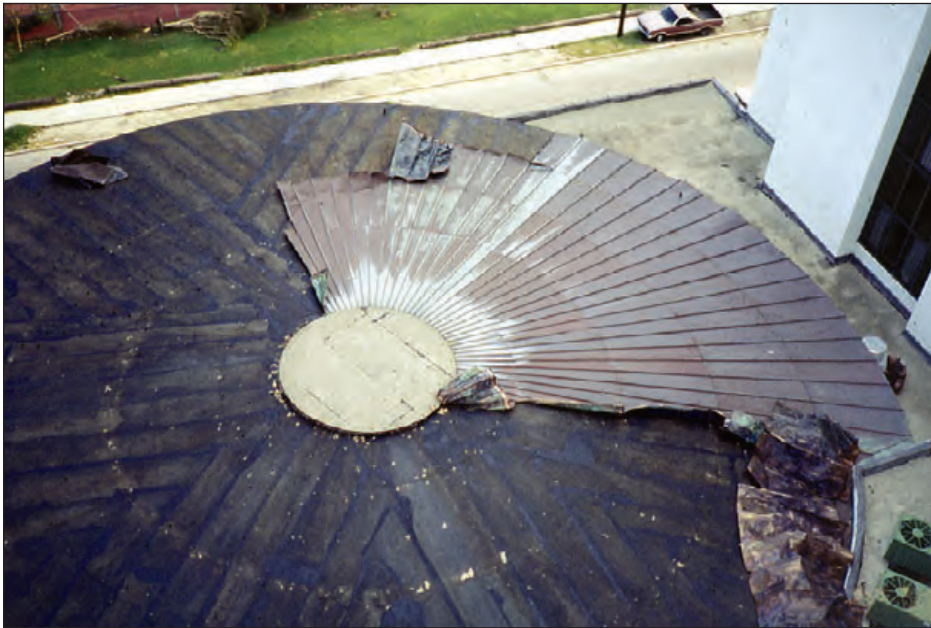
The purpose of the insulation and gypsum roof board is to absorb missile energy. If the primary membrane is punctured or blown off during a storm, the secondary membrane should provide watertight protection unless the roof is hit with missiles of very high momentum that penetrate the insulation and secondary membrane. Figure 6-80 illustrates the merit of specifying a secondary membrane. Although the copper roof blew off, fortunately there was a very robust underlayment (a built-up membrane) that remained in place. The minor leakage that occurred did not impair building operations.

**Figure 6-80:**  
The secondary membrane prevented significant leakage into the building after the copper roof blew off. Hurricane Andrew (Florida, 1992)

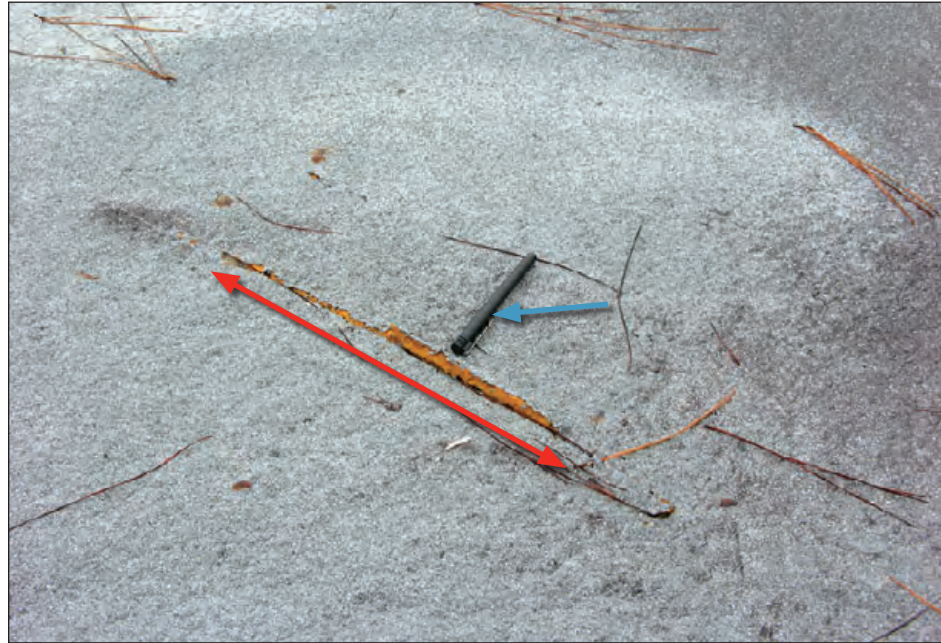
With SPF, missiles can gouge the foam (as shown in Figure 6-81), but it is rare for missiles to completely penetrate through the foam. When a quality SPF is gouged, only an insignificant amount of moisture is absorbed into the foam cells at the gouged area, even if the gouge is not repaired for several months.

**Figure 6-81:**  
Although a missile cut into the SPF, the roof was still watertight. The ink pen (blue arrow) shows the relative size of the impact area. Estimated wind speed: 110 mph. Hurricane Ike (Texas, 2008)

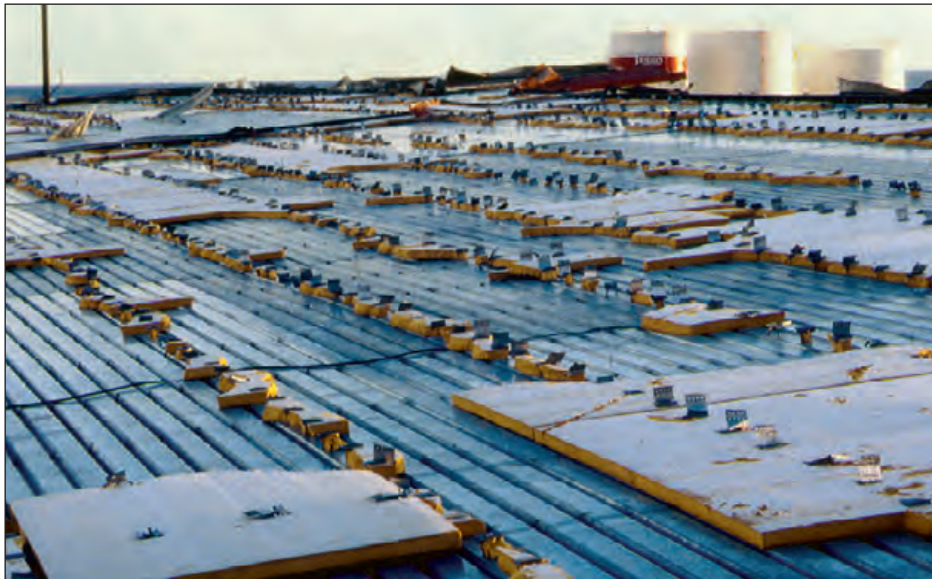
If the metal panels are blown off or punctured during a hurricane, the secondary membrane should provide watertight protection unless the roof is hit with missiles of very high momentum. At the roof shown in Figure 6-82, the structural standing seam panel clips bore on rigid insulation over a steel deck. Had a secondary membrane been installed over the steel deck, the membrane would have likely prevented significant interior water damage and facility disruption.

**Figure 6-82: Significant interior water damage and facility interruption occurred after the standing seam roof blew off. Hurricane Marilyn (U.S. Virgin Islands, 1995)**

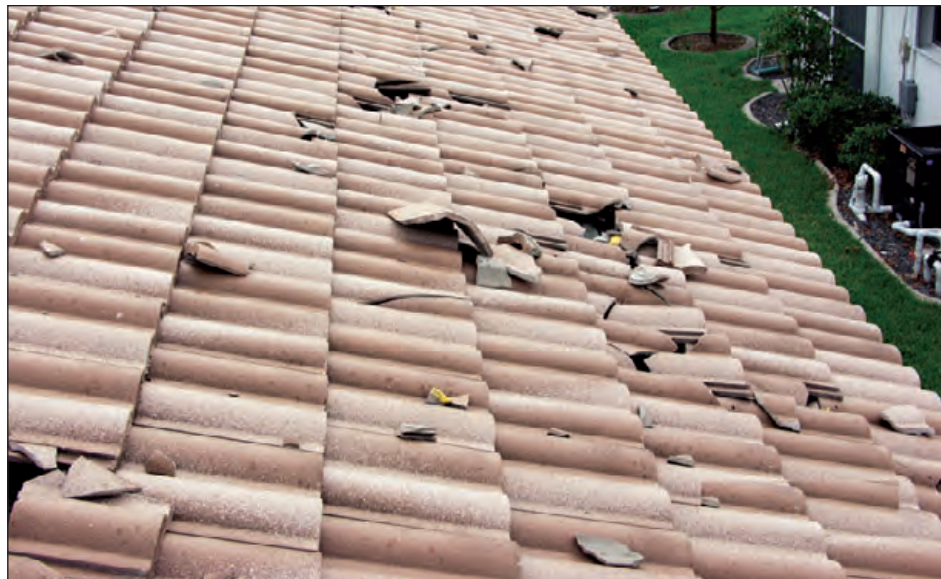
The tiles shown in Figure 6-83 were attached with the foam-adhesive (adhesive-set) method. The tiles shown in Figure 6-84 were attached with the wire-tied method (an uncommon method in the eastern portion of the United States). In addition to the wire attachments, the tiles were also attached with stainless steel clips at the first three rows from the eave. All of the tiles had tail hooks, and adhesive was used between the tail and head of all tiles. Except for the three perimeter rows which were clipped, the wires did not prevent the tiles from lifting a short distance above the concrete deck. The failure was attributed to tiles lifting and then slamming back down on the deck, where upon they broke and the tile fragments blew away.

**Figure 6-83:**  
Brittle roof coverings, like slate and tile, can be broken by missiles, and tile debris can break other tiles. Estimated wind speed: 140–160 mph. Hurricane Charley (Florida, 2004)

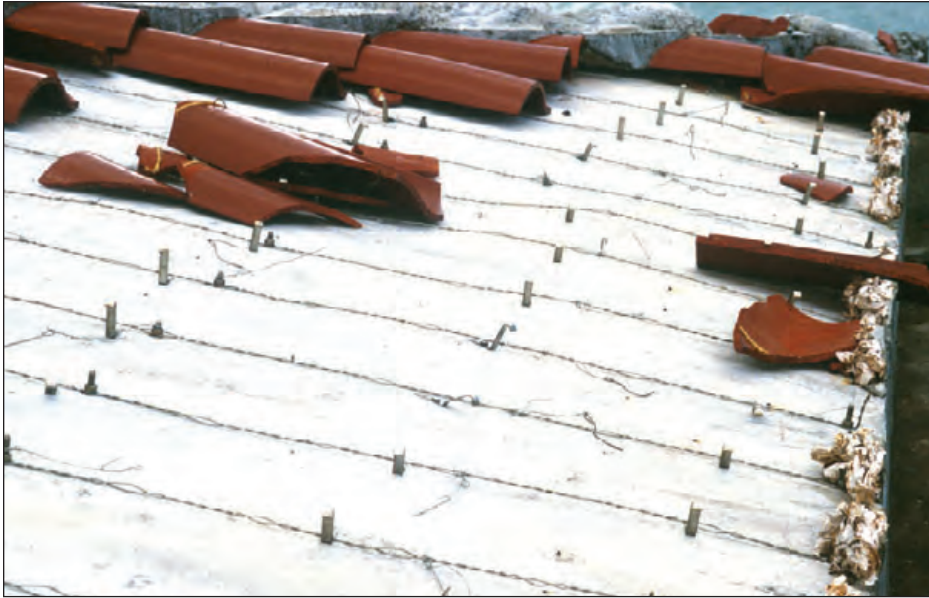
**Figure 6-84**  
These wire-tied tiles were installed over a concrete deck. The failure was attributed to lack of vertical restraint, which allowed the tiles to lift and then be broken when they slammed back down onto the deck. Typhoon Paka (Guam, 1997)

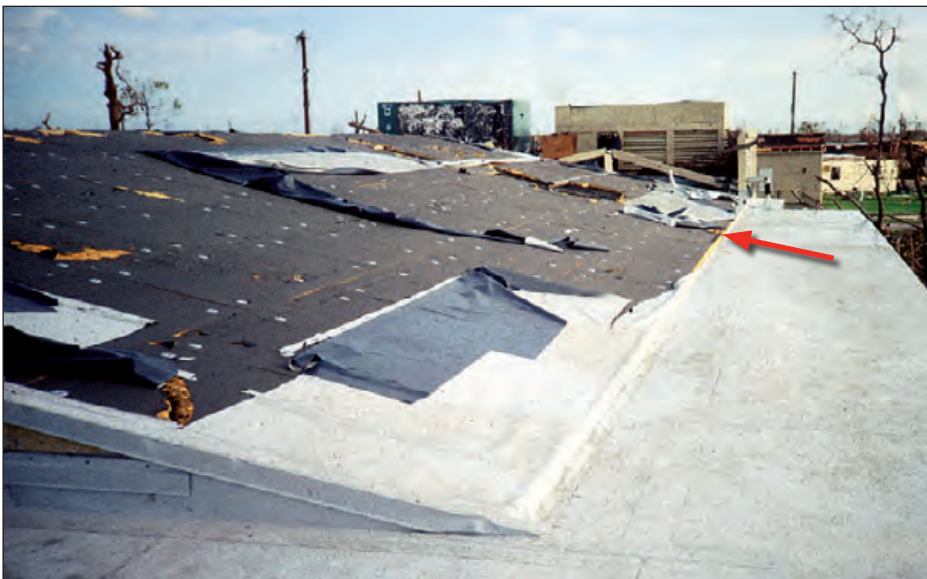
Mechanically attached and air-pressure equalized single-ply membrane systems are susceptible to massive progressive failure after missile impact, and are therefore not recommended for schools in hurricane-prone regions. At the school shown in Figure 6-85, a missile struck the fully adhered low-sloped roof and slid into the steep-sloped reinforced mechanically attached single-ply membrane in the vicinity of the red arrow. A large area of the mechanically attached membrane was blown away as a result of progressive membrane tearing. Fully adhered single-ply membranes are very vulnerable to missile puncture and are not recommended unless they are ballasted with pavers.

**Figure 6-85:** This mechanically attached single-ply membrane progressively tore after being cut by wind-borne debris. Hurricane Andrew (Florida, 1992)

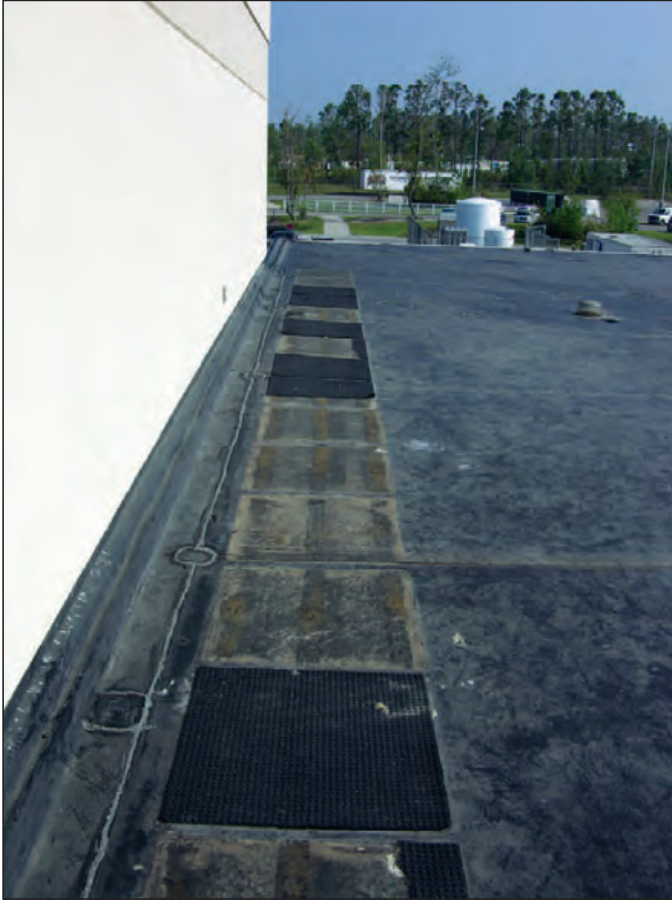
**Figure 6-87:**  
Several rubber walkway pads were blown off the single-ply membrane roof. Estimated wind speed: 130 mph. Hurricane Katrina (Mississippi, 2005)
