# Design Guide

for Improving School Safety in Earthquakes, Floods,  
and High Winds

FEMA P-424 / December 2010

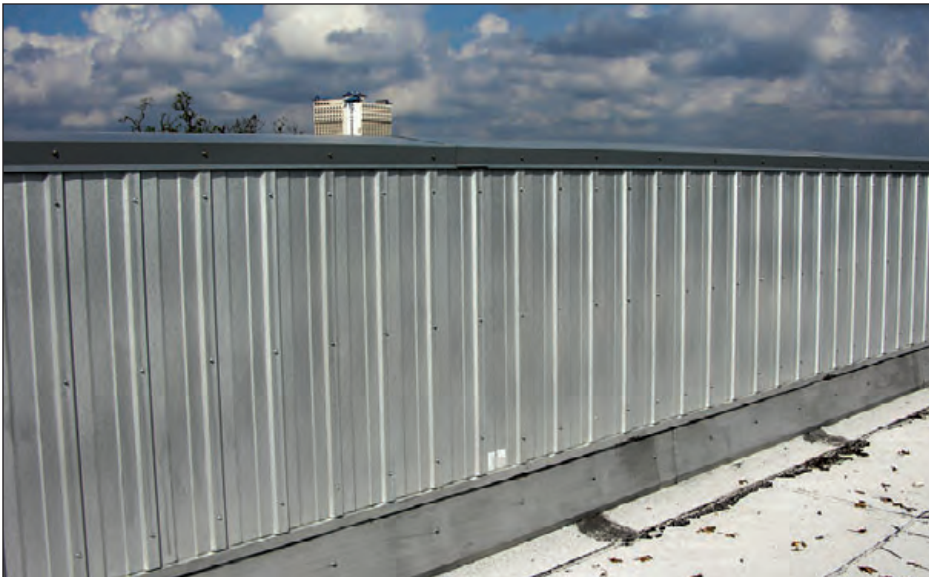
**Figure 6-88:**  
Base flashing protected by metal wall panels attached with exposed screws. Estimated wind speed: 120 mph. Hurricane Katrina (Mississippi, 2005)

- For a PMR, it is recommended that pavers weighing a minimum of 22 psf be specified. In addition, base flashings should be protected with metal (such as shown in Figure 6-88) to provide debris protection. Parapets with a 3-foot minimum height (or higher if so indicated by ANSI/SPRI RP-4) are recommended at roof edges. This manual recommends that PMRs not be used for schools in hurricane-prone regions where the basic wind speed exceeds 175 mph.<sup>28</sup>
- For structural metal roofs, it is recommended that a roof deck be specified, rather than attaching the panels directly to purlins as is commonly done with pre-engineered metal buildings. If panels blow off buildings without roof decking, wind-borne debris and rain are free to enter the building.

If the roof has a parapet, it is recommended that the inside of the parapet be properly prepared to receive the new base flashing. In many instances, it is prudent to re-skin the parapet with sheathing to provide a suitable substrate. Base flashing should not be applied directly to brick parapets because they have irregular surfaces that inhibit good bonding of the base flashing to the brick (see Figure 6-133). Also, if moisture drives into the wall from the exterior side of the parapet with base flashing attached directly to brick, the base flashing can inhibit drying of the wall. Therefore, rather than totally sealing the parapet with membrane base flashing, the upper portion of the brick can be protected by metal panels (as shown in Figure 6-88), which permits drying of the brick.

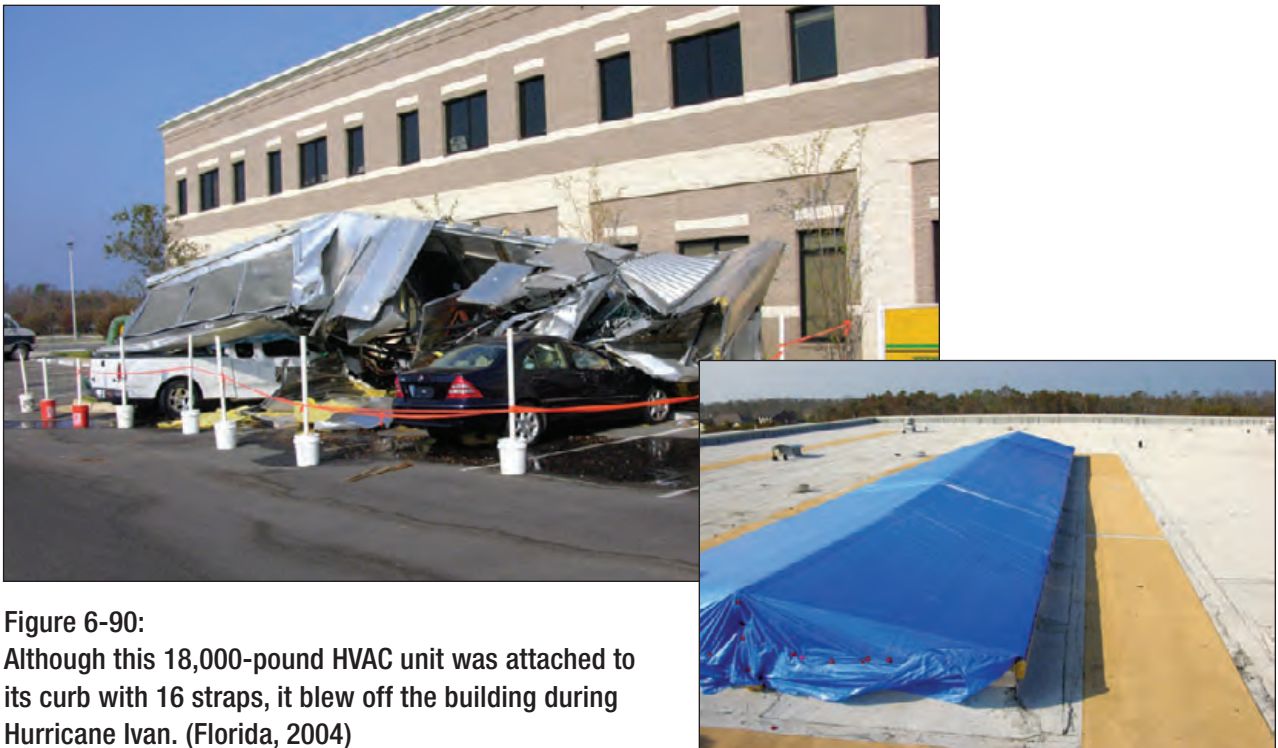
**Figure 6-90:**  
Although this 18,000-pound HVAC unit was attached to its curb with 16 straps, it blew off the building during Hurricane Ivan. (Florida, 2004)

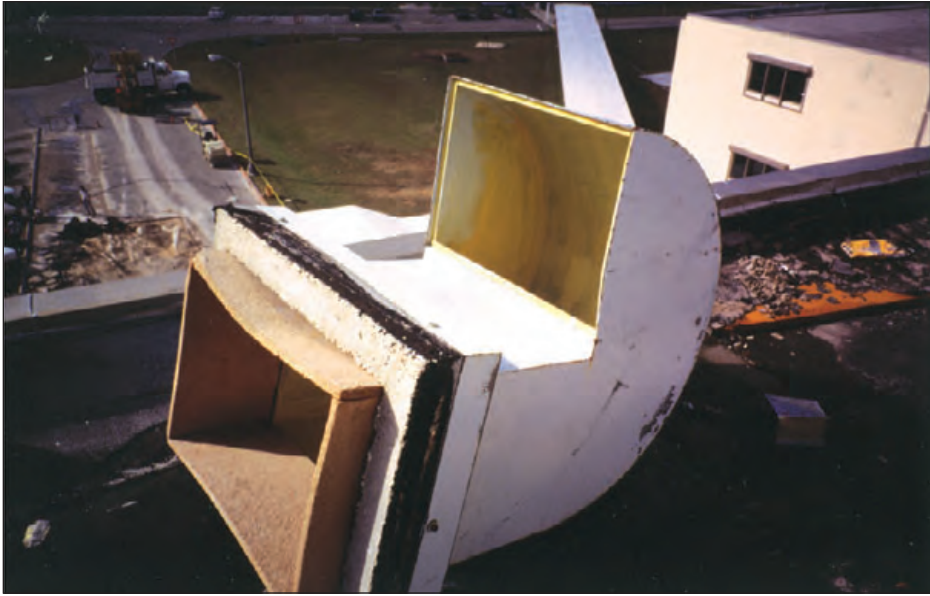
To anchor fans, small HVAC units, and relief air hoods, the minimum attachment schedule provided in Table 6-1 is recommended. The attachment of the curb to the roof deck also needs to be designed and constructed to resist wind loads. The cast-in-place concrete curb shown in Figure 6-91 was cold-cast over a concrete roof deck. Dowels were not installed between the deck and curb, hence a weak connection occurred.

**Figure 6-91:**  
The gooseneck on this building remained attached to the curb, but the curb detached from the deck. Typhoon Paka (Guam, 1997)

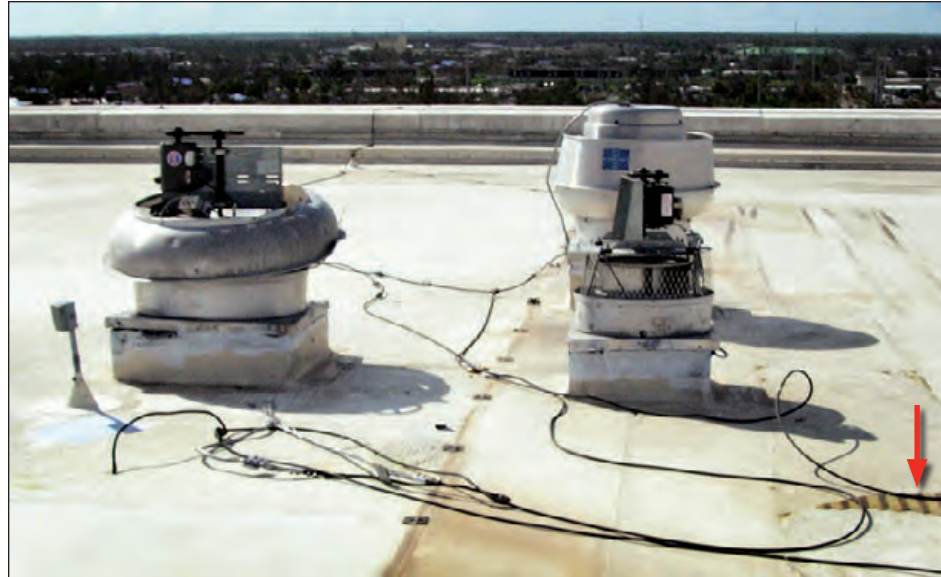
**Fan cowling attachment:** Fans are frequently blown off their curbs because they are poorly attached. When fans are well attached, the cowlings frequently blow off during high winds (see Figure 6-92). Blown-off cowlings can tear roof membranes and break glazing. Unless the fan manufacturer specifically engineered the cowling attachment to resist the design wind load, cable tie-downs (see Figure 6-93) are recommended to avoid cowling blow-off where the basic wind speed is greater than 120 mph.<sup>31</sup> For fan cowlings less than 4 feet in diameter,  $\frac{1}{8}$ -inch diameter stainless steel cables are recommended. For larger cowlings, use  $\frac{3}{16}$ -inch diameter cables. When the basic wind speed is 165 mph or less, specify two cables.<sup>32</sup> Where the basic wind speed is greater than 165 mph, specify four cables. To minimize leakage potential at the anchor point, it is recommended that the cables be adequately anchored to the equipment curb (rather than anchored to the roof deck). The attachment of the curb itself also needs to be designed and specified.

**Figure 6-92:**  
Cowlings blew off two of the three fans. Note also the loose LPS conductors and missing walkway pad (red arrow). Estimated wind speed: 140–160 mph. Hurricane Charley (Florida, 2004)

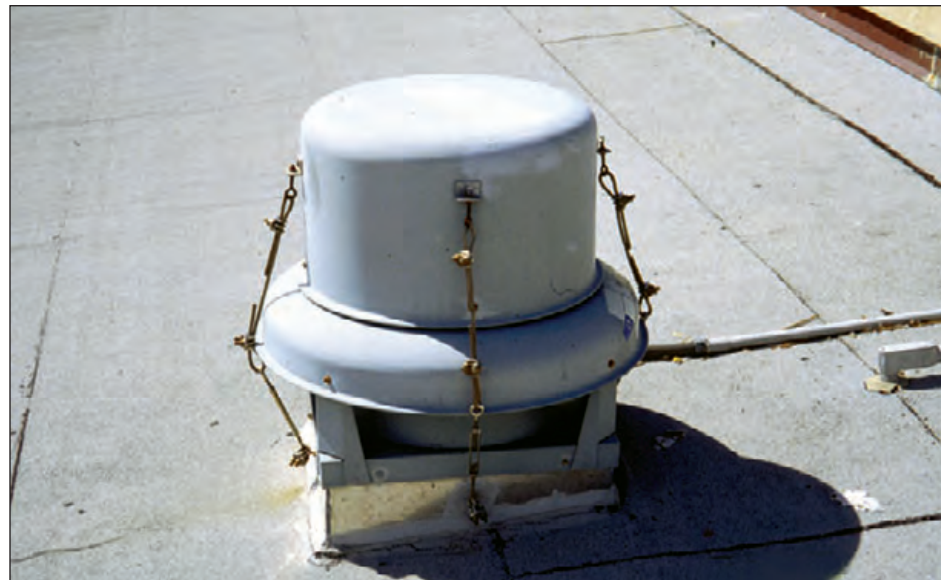
**Figure 6-93:**  
Cables were attached to prevent the cowling from blowing off. Typhoon Paka (Guam, 1997)

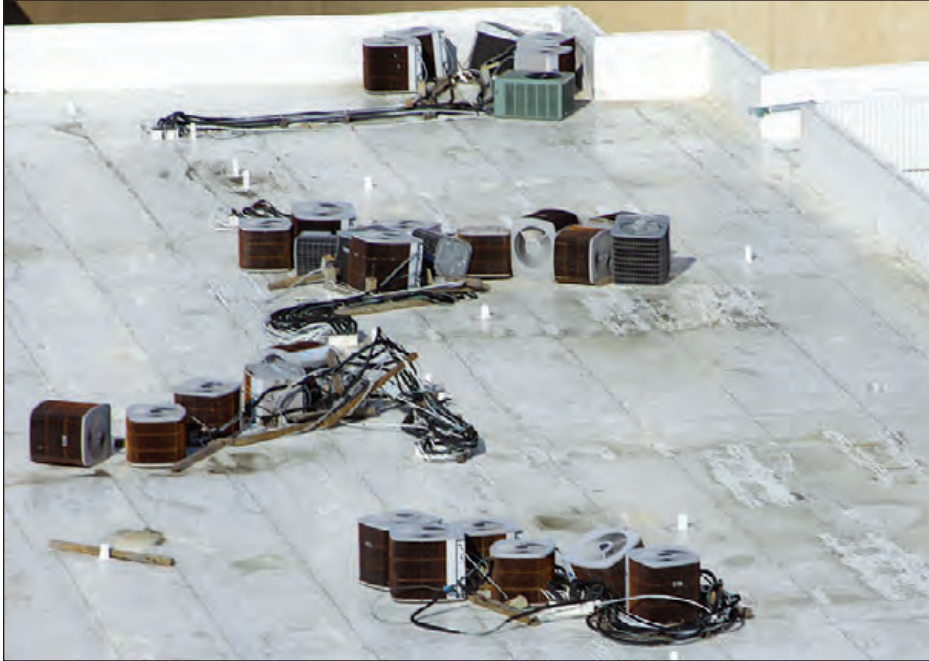
**Figure 6-94:** These condensers were blown off their sleepers. Displaced condensers can rupture roof membranes and refrigerant lines. Estimated wind speed: 120 mph. Hurricane Katrina (Mississippi)

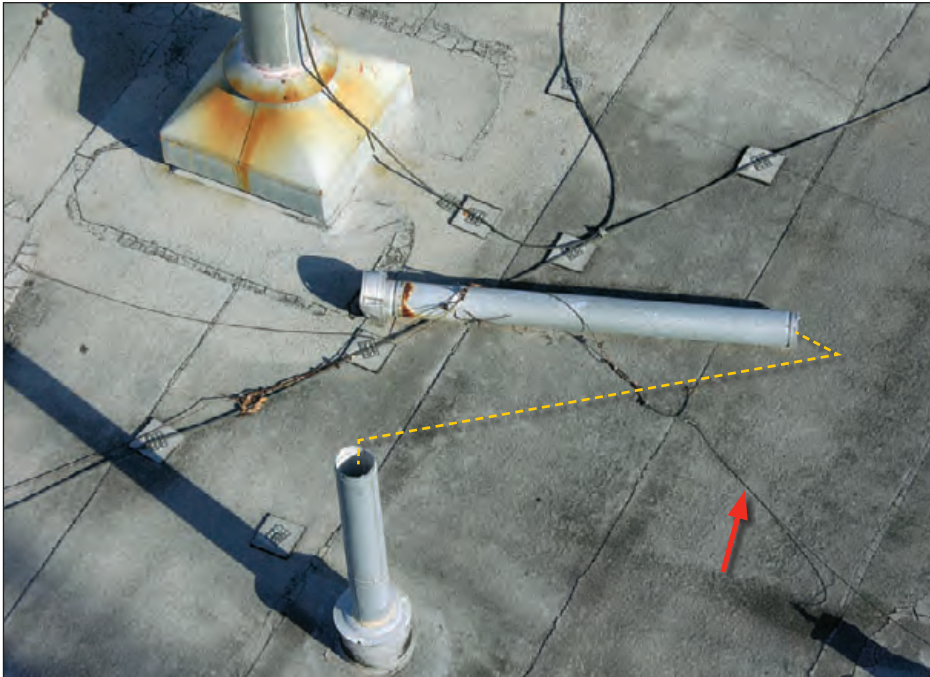
**Figure 6-97:** Guyed flue blew over (red arrow indicates one of the guys). Estimated wind speed: 92 mph. Hurricane Ike (Texas, 2008)

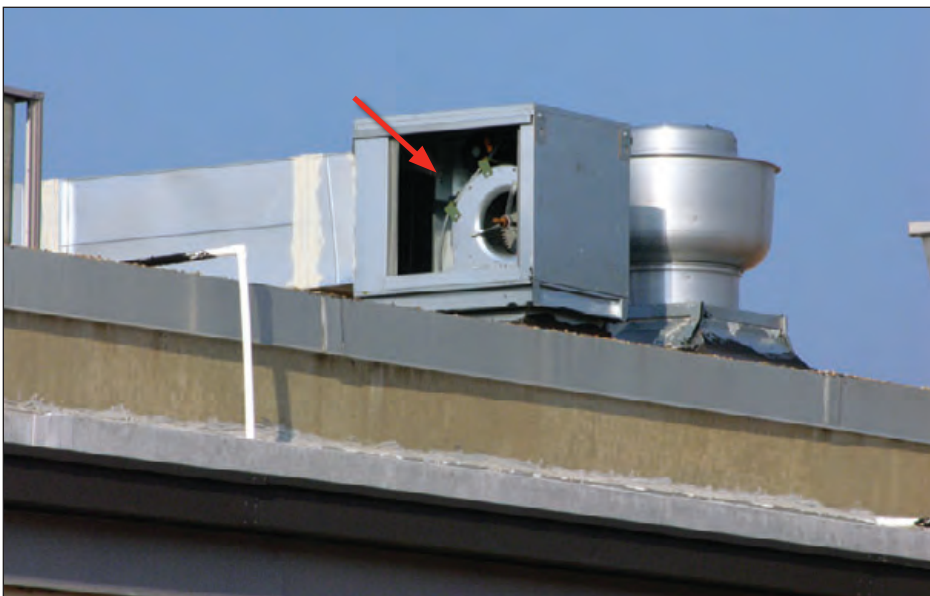
**Figure 6-98:** The school shown in Figure 6-65 also had an access panel blow off. Blown-off panels can puncture roof membranes, break glazing, and cause injury. Estimated wind speed: 85–95 mph. Hurricane Ivan (Florida, 2004)

**Access panel attachment:** Equipment access panels frequently blow off (see Figure 6-98). Unless the equipment manufacturer specifically engineered the panel attachment to resist the design wind load, job-site modifications, such as attaching hasps and locking devices like carabiners, are recommended. The modification details need to be customized. Detailed design may be needed after the equipment has been delivered to the job site. Modification details should be approved by the equipment manufacturer.

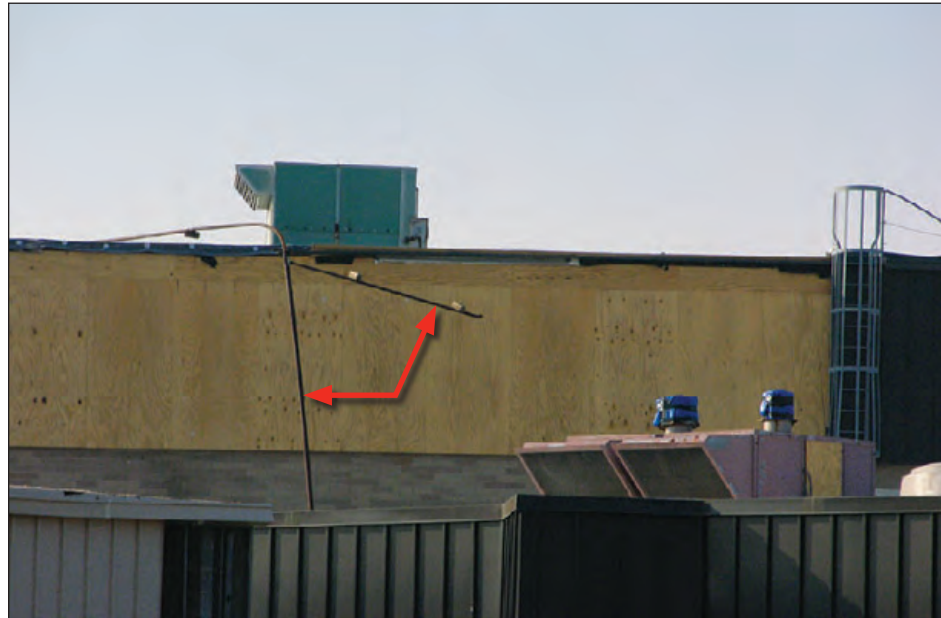
**Figure 6-99:**  
The school shown in Figures 6-65 and 6-98 also experienced gas line rupture (shown by the lines dangling over the side of the building). Estimated wind speed: 85–95 mph. Hurricane Ivan (Florida, 2004)

**Natural gas and condensate drain lines:** Natural gas lines and condensate drain lines serving rooftop HVAC units are seldom anchored to resist wind loads. Gas line rupture can be due to lack of line anchorage or due to HVAC unit blow-off (see Figures 6-57 and 6-99). Where the basic wind speed is greater than 120 mph,<sup>34</sup> it is recommended that gas line supports be designed and constructed to resist the design wind load (see Figure 6-100).

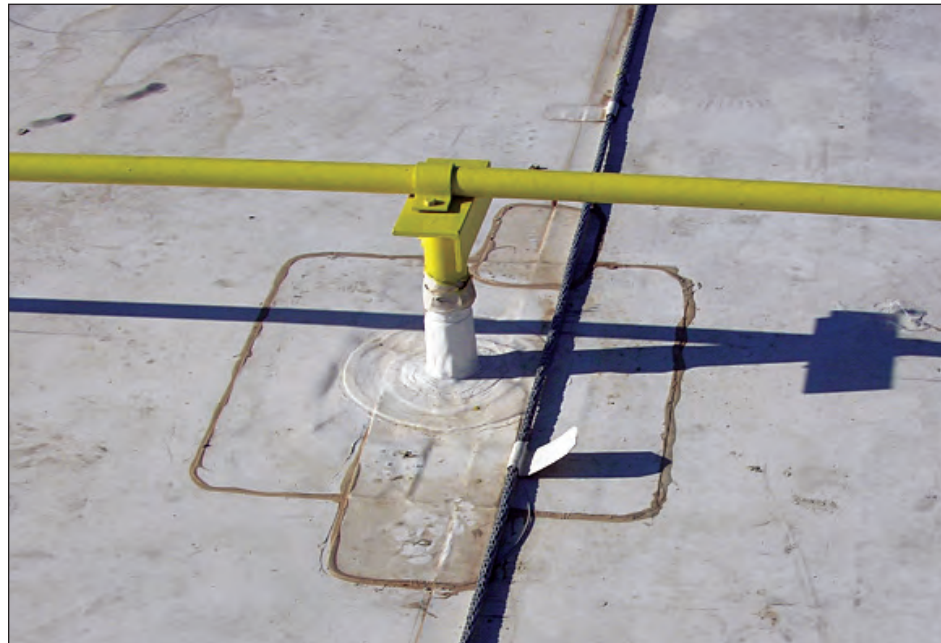
**Figure 6-100:**  
At a periodic gas line support on this roof, a steel angle was welded to a pipe that was anchored to the roof deck. A strap looped over the gas line and was bolted to the support angle. Such a connection provides resistance to lateral and uplift loads.

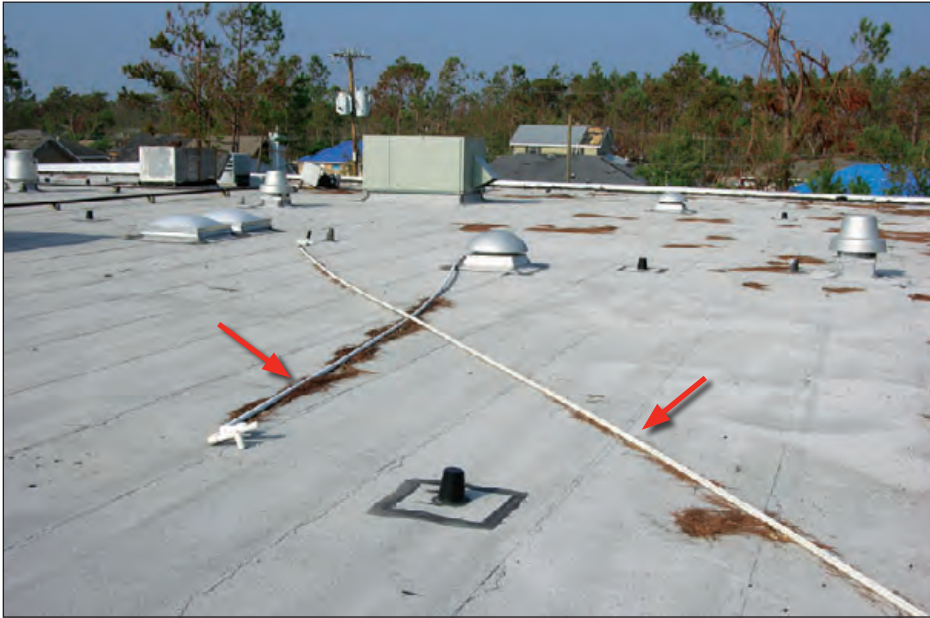
**Figure 6-101:** These two condensate drain lines detached from their HVAC units. They had not been anchored to the roof. Estimated wind speed: 125 mph. Hurricane Katrina (Mississippi, 2005)

Although blow-off of condensate drain lines is not as potentially catastrophic as rupture of gas lines, blown off condensate drain lines can puncture roof membranes, break glazing, and cause injury (see Figure 6-101). Where the basic wind speed is greater than 120 mph,<sup>35</sup> it is recommended that condensate drain line supports be designed and constructed to resist the design wind load.

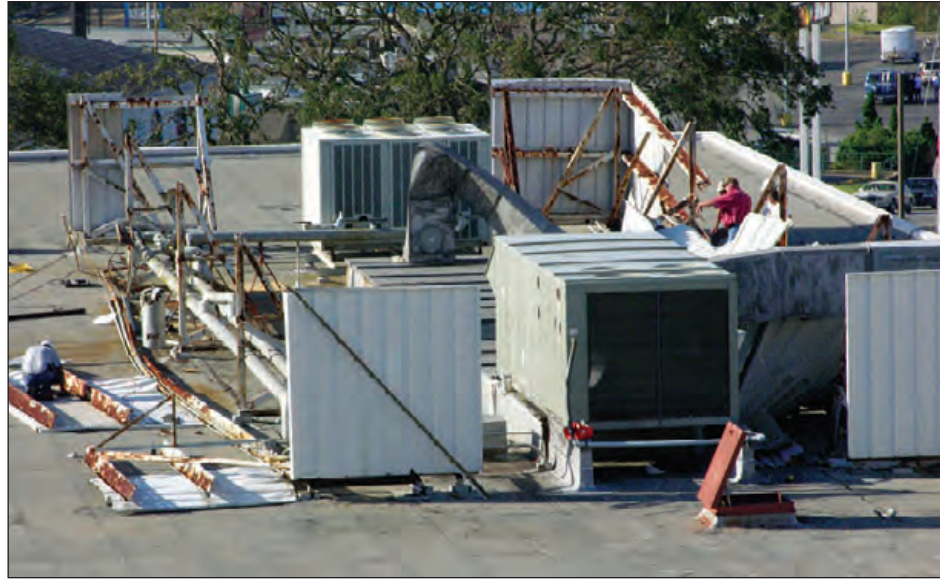
**Figure 6-102:**  
Equipment screen panels can puncture roof membranes, break glazing, and cause injury. Estimated wind speed: 105–115 mph. Hurricane Ivan (Florida, 2004)

**Equipment screens:** Screens around rooftop equipment are frequently blown away (see Figure 6-102). Screens should be designed to resist the wind load derived from ASCE 7. Since the effect of screens on equipment wind loads is unknown, the equipment attachment behind the screens should be designed to resist the design load.

**Mechanical Penthouses:** By placing equipment in mechanical penthouses rather than leaving them exposed on the roof, equipment can be shielded from high-wind loads and wind-borne debris (see Figure 6-103). Although screens (such as shown in Figure 6-102) could be designed and constructed to protect equipment from horizontally flying debris, they are not effective in protecting equipment from missiles that have an angular trajectory. It is therefore recommended that mechanical equipment be placed inside mechanical penthouses. The penthouse itself should be designed and constructed in accordance with the recommendations given in Sections 6.3.2.2, 6.3.3.5, and 6.3.3.7.

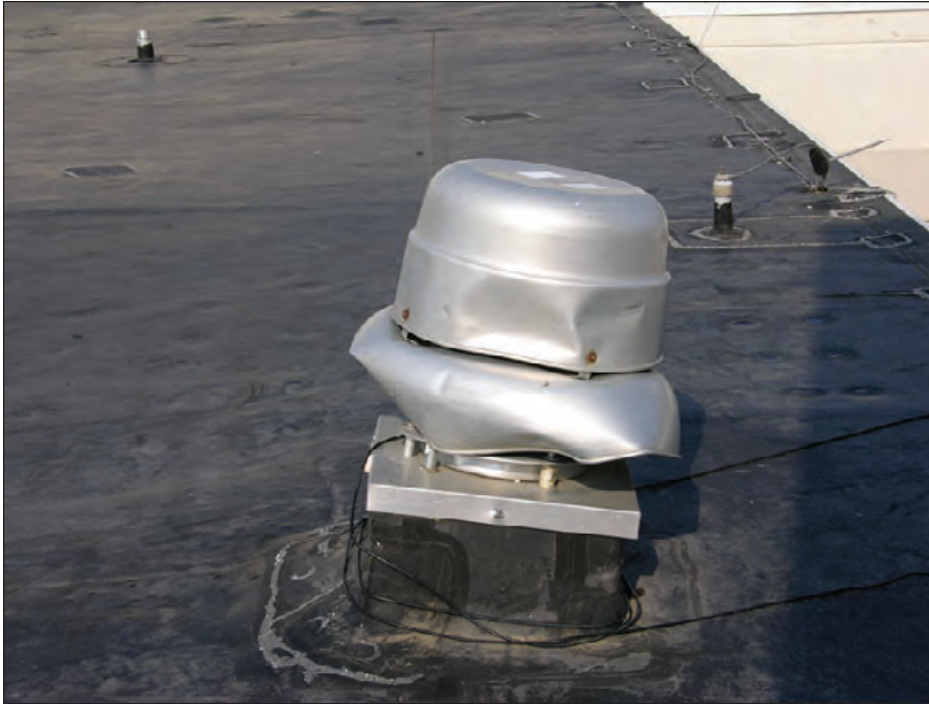
**Figure 6-103:** This exhaust fan was impacted by wind-borne debris. Although it is often impractical to place all equipment such as fans in penthouses, doing so to the extent possible avoids debris damage. Estimated wind speed: 130 mph. Hurricane Katrina (Mississippi, 2005)

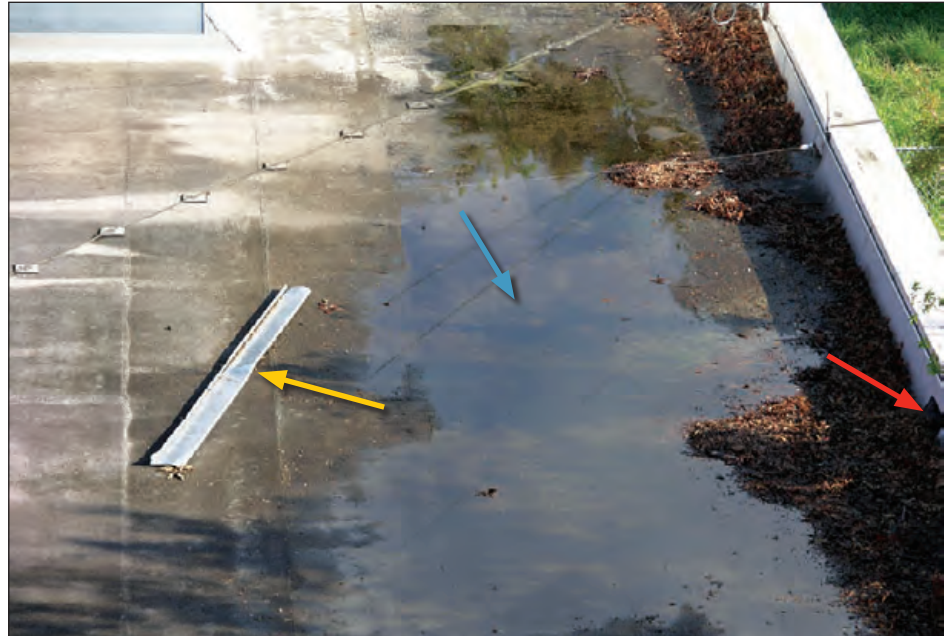
**Figure 6-104:**  
Leaf debris and ponding near a scupper (red and blue arrows). The yellow arrow indicates a piece of coping that blew off an upper roof shown in Figure 6-72. Estimated wind speed: 92 mph. Hurricane Ike (Texas, 2008)

**Roof drainage:** Roof drains and scuppers have the potential to be blocked by leaves, tree limbs, and other wind-borne debris during a hurricane (see Figure 6-104). If primary and overflow drains/scuppers become blocked, development of deep ponding water may inundate base flashings and cause leakage problems or lead to roof collapse. To avoid problems with blocked drains and scuppers, the following are recommended:

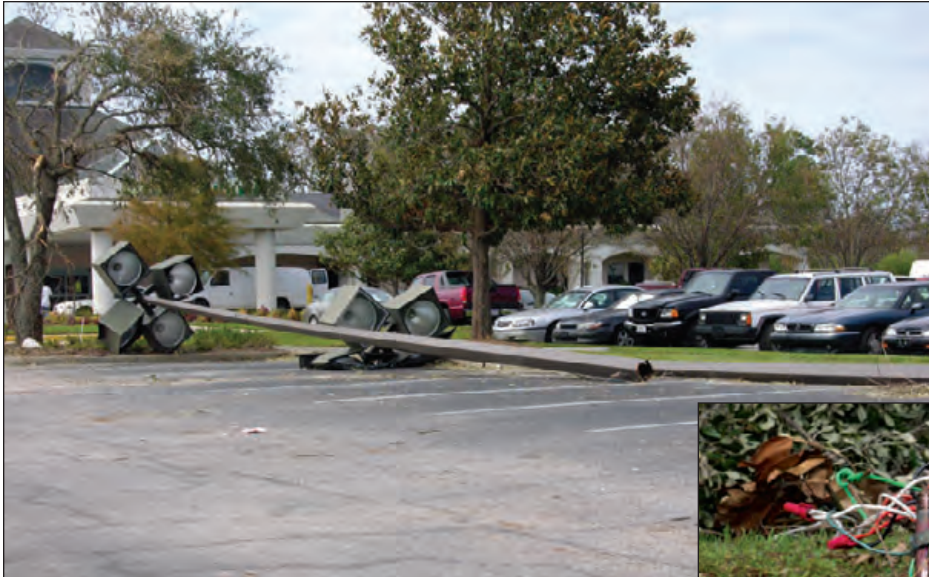
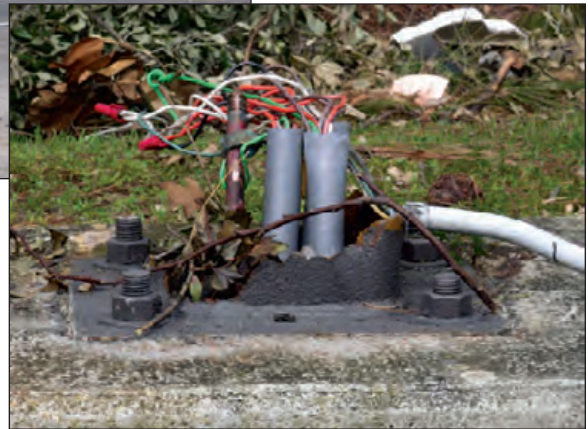
**Figure 6-105:** Collapsed light fixtures caused by severe corrosion (see inset). Estimated wind speed: 105–115 mph. Hurricane Ivan (Florida, 2004)

To avoid corrosion-induced failure (Figure 6-105), it is recommended that exterior-mounted mechanical, electrical, and communications equipment be made of nonferrous metals, stainless steel, or steel with minimum G-90 hot-dip galvanized coating for the equipment body, stands, anchors, and fasteners. When equipment with enhanced corrosion protection is not available, the designer should advise the building owner that periodic equipment maintenance and inspection is particularly important to avoid advanced corrosion and subsequent equipment damage during a windstorm.

Damage to exterior-mounted electrical equipment is infrequent, mostly because of its small size (e.g., disconnect switches). Exceptions include communication towers, surveillance cameras, electrical service masts, satellite dishes, and LPSs. The damage is typically caused by inadequate mounting as a result of failure to perform wind load calculations and anchorage design. Damage is also sometimes caused by corrosion (see Figure 6-105 and text box in Section 6.3.4.1 regarding corrosion).

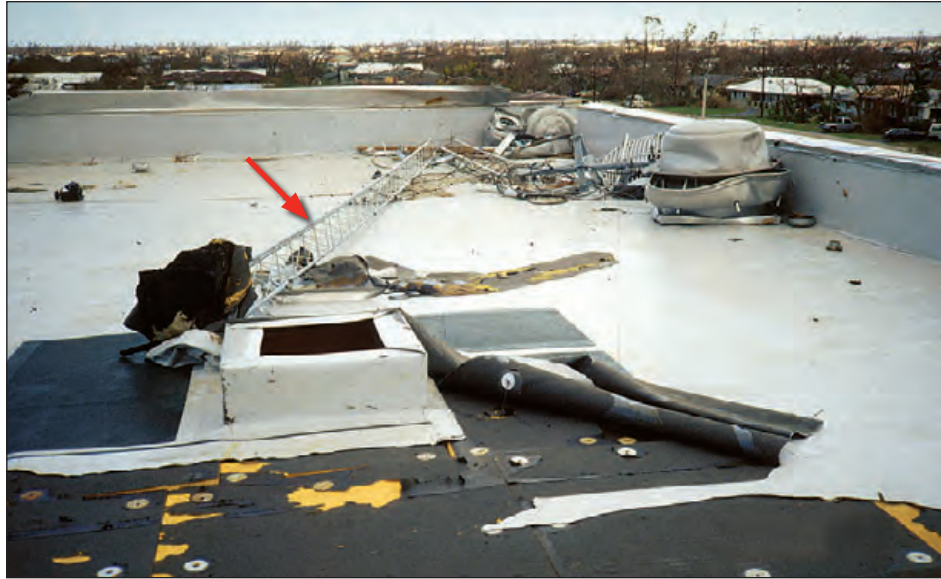
**Figure 6-106:**  
The collapse of the antenna tower at this school caused progressive peeling of the roof membrane. Also note that the exhaust fan blew off the curb, but the high parapet kept it from blowing off the roof. Hurricane Andrew (Florida, 1992)

**Parapets:** For low-sloped roofs, minimum 3-foot high parapets are recommended. With parapets of this height or greater, the uplift load in the corner region is substantially reduced (ASCE 7 permits treating the corner zone as a perimeter zone). Also, a high parapet (as shown in Figure 6-106) may intercept wind-borne debris and keep it from blowing off the roof and damaging other building components or injuring people. To protect base flashings from wind-borne debris damage and subsequent water leakage, it is recommended that metal panels on furring strips be installed over the base flashing (Figure 6-88). Exposed stainless steel screws are recommended for attaching the panels to the furring strips, because using exposed fasteners is more reliable than using concealed fasteners or clips (as were used for the failed panels shown in Figure 6-64).

Collapse of both large and small communication towers is quite common during high-wind events (see Figure 6-106). These failures often result in complete loss of communication capabilities. In addition to the disruption of communications, collapsed towers can puncture roof membranes and allow water leakage into the school, unless the roof system incorporated a secondary membrane (as discussed in Section 6.3.3.7). At the tower shown in Figure 6-106 the anchor bolts were pulled out of the deck, which resulted in a progressive peeling of the fully adhered single-ply roof membrane. Tower collapse can also injure or kill people.

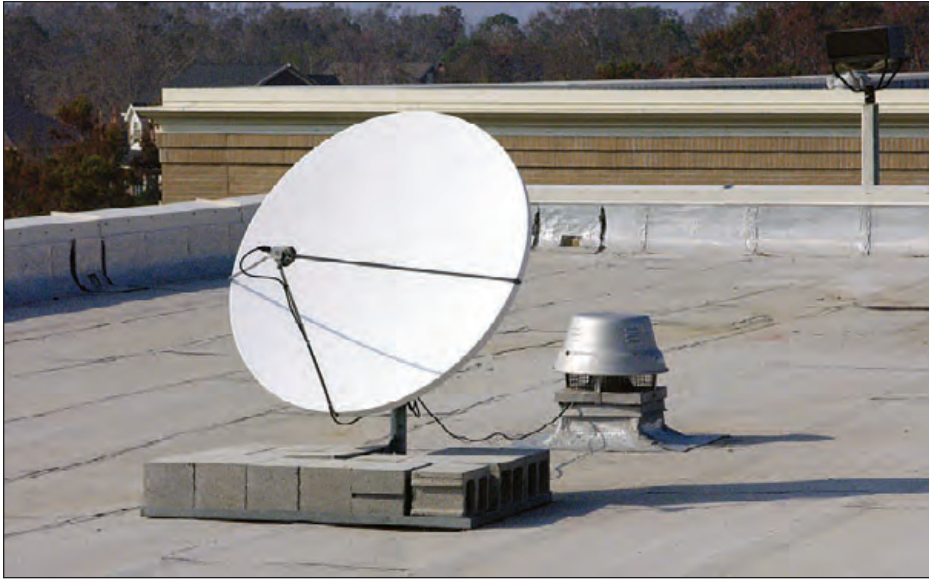
Figure 6-107: Common anchoring method for satellite dish. Estimated wind speed: 85–95 mph. Hurricane Ivan (Florida, 2004)

**Satellite dishes:** For the satellite dish shown in Figure 6-107, the dish mast was anchored to a large metal pan that rested on the roof membrane. CMU was placed on the pan to provide overturning resistance. This anchorage method should only be used where calculations demonstrate that it provides sufficient resistance. In this case, the wind approached the satellite dish in such a way that it experienced very little wind pressure. In hurricane-prone regions, use of this anchorage method is not recommended (see Figure 6-108).

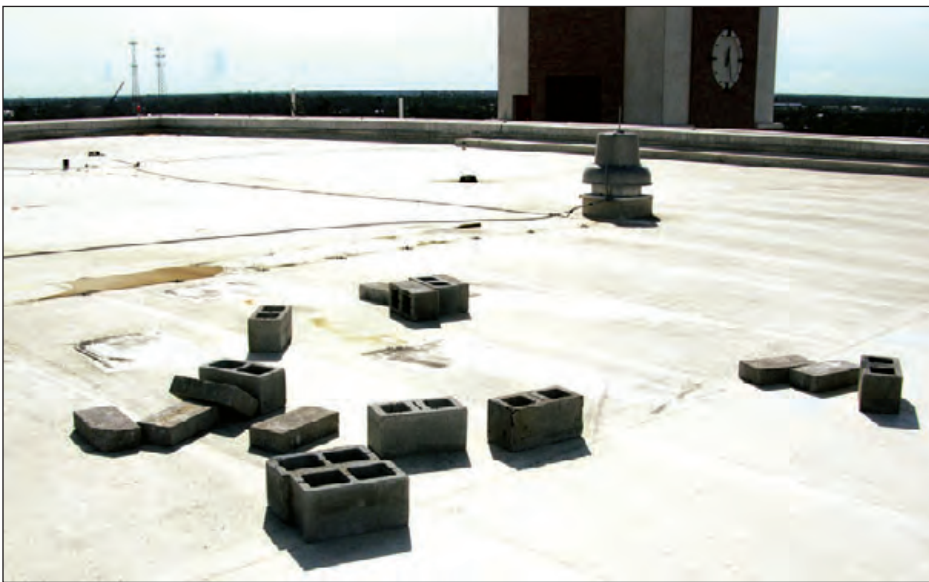
Figure 6-108: A satellite dish anchored similarly to that shown in Figure 6-107 was blown off this five-story building. Estimated wind speed: 140–160 mph. Hurricane Charley (Florida, 2004)

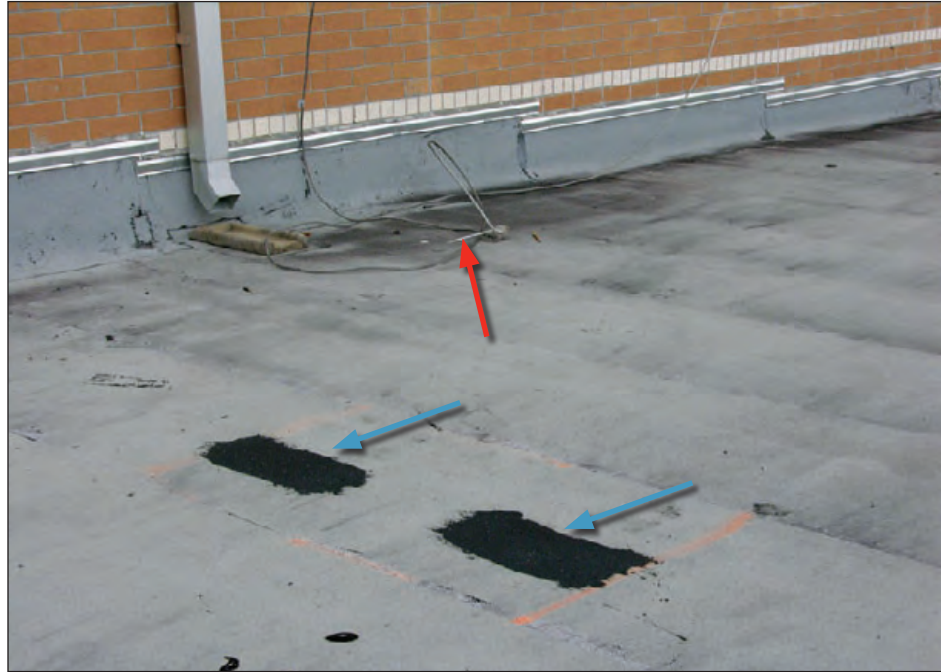
**Figure 6-110:**  
View of an end of a conductor that became disconnected. Estimated wind speed: 130 mph. Hurricane Katrina (Mississippi, 2005)

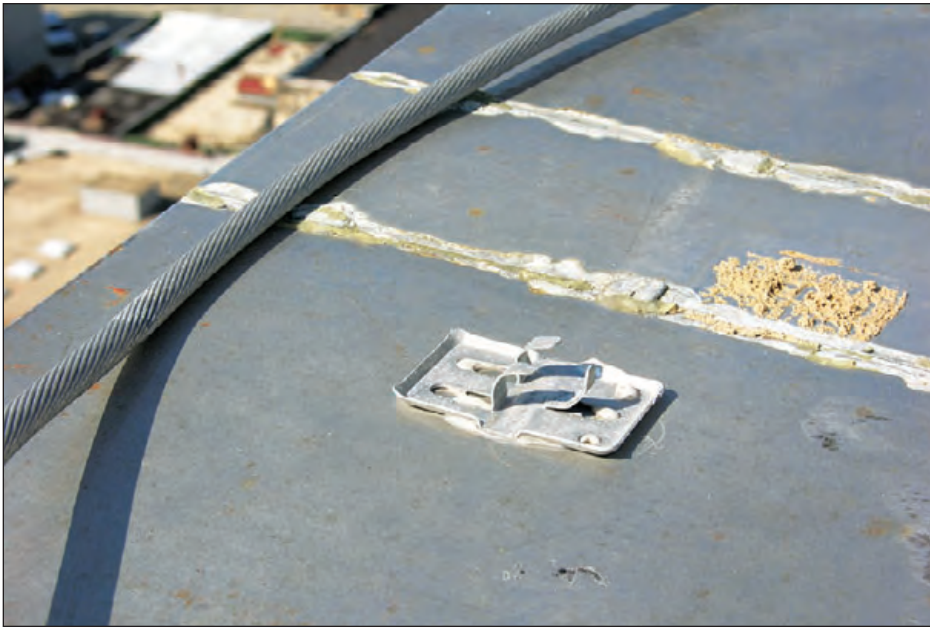
**Figure 6-111:** This conductor connector was adhered to the coping. The conductor deformed the connector prongs under wind pressure, and pulled away from the connector. Estimated wind speed: 130 mph. Hurricane Katrina (Mississippi, 2005)

roof surface, during high winds the conductor frequently bends back the malleable connector prongs (see Figure 6-111). Conductor connectors have also debonded from roof surfaces during high winds. Based on observations after Hurricane Ike and other hurricanes, it is apparent that pronged conductor connectors typically have not provided reliable attachment.

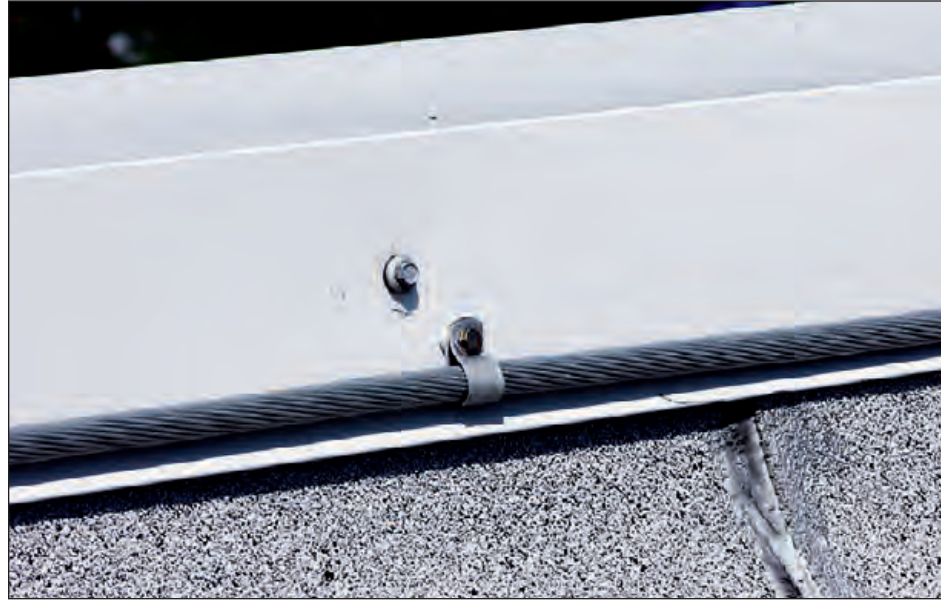
Figure 6-112:  
This conductor was  
attached to the  
coping with a looped  
connector. Estimated  
wind speed: 130 mph.  
Hurricane Katrina  
(Mississippi, 2005)

**Parapet attachment:** When the parapet is 12 inches high or greater, it is recommended that the air terminal base plates and conductor connectors be mechanically attached with #12 screws that have minimum 1¼-inch embedment into the inside face of the parapet nailer and be properly sealed for watertight protection. Instead of conductor connectors that have prongs, it is recommended that mechanically attached looped connectors be installed (see Figure 6-112).

**Standing seam metal roofs:** It is recommended that pre-manufactured, mechanically attached clips that are commonly used to attach various items to roof panels be used. After anchoring the clips to the panel ribs, the air terminal base plates and conductor connectors are anchored to the panel clips. In lieu of conductor connectors that have prongs, it is recommended that mechanically attached looped connectors be installed (see Figure 6-112).

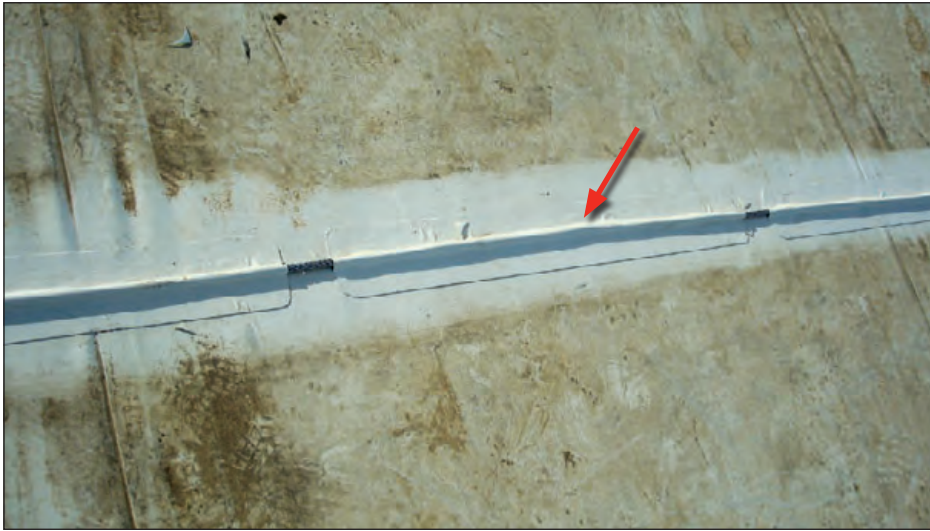
**Figure 6-114:**  
Use of intermittent  
membrane flashing  
strips to secure an LPS  
conductor, as illustrated  
in Figure 6-113

In lieu of attaching conductors with conductor connectors, it is recommended that conductors be attached with strips of membrane installed by the roofing contractor. For built-up and modified bitumen membranes, use strips of modified bitumen cap sheet, approximately 9 inches wide at a minimum. If strips are torch-applied, avoid overheating the conductors. For single-ply membranes, use self-adhering flashing strips, approximately 9 inches wide at a minimum. Start the strips approximately 3 inches from either side of the air terminal base plates. Use strips that are approximately 3 feet long, separated by a gap of approximately 3 inches (see Figures 6-113 and 6-114).

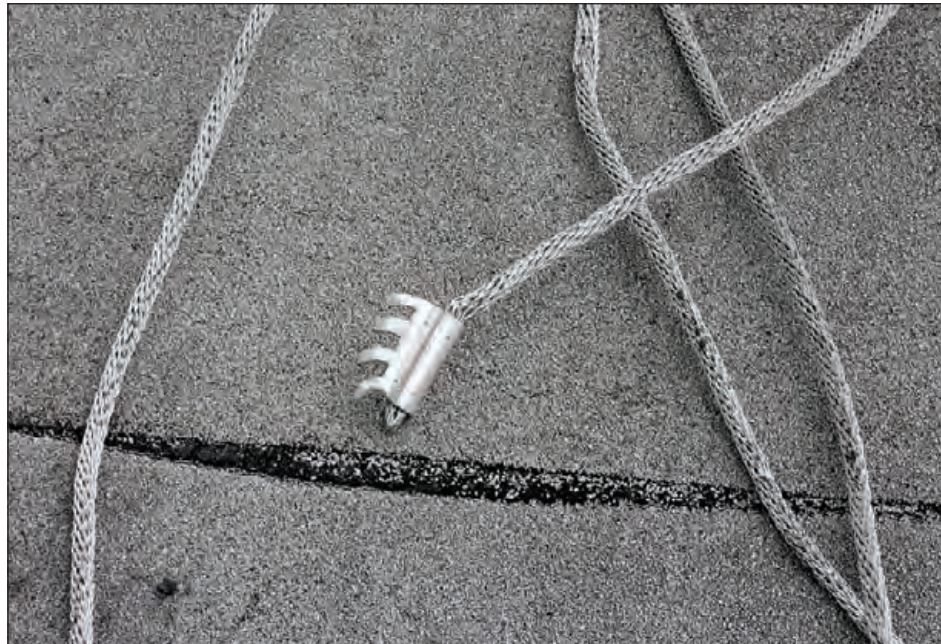
**Figure 6-116:**  
If conductors detach from the roof, they are likely to pull out from pronged splice connectors. Estimated wind speed: 90–100 mph. Hurricane Charley (Florida, 2004)

**Conductor splice connectors:** In lieu of pronged splice connectors (see Figure 6-116), bolted splice connectors are recommended because they provide a more reliable connection (see Figure 6-117). It is recommended that strips of flashing membrane (as recommended above) be placed approximately 3 inches from either side of the splice connector to minimize conductor movement and to avoid the possibility of the conductors becoming disconnected. To allow for observation during maintenance inspections, do not cover the connectors.

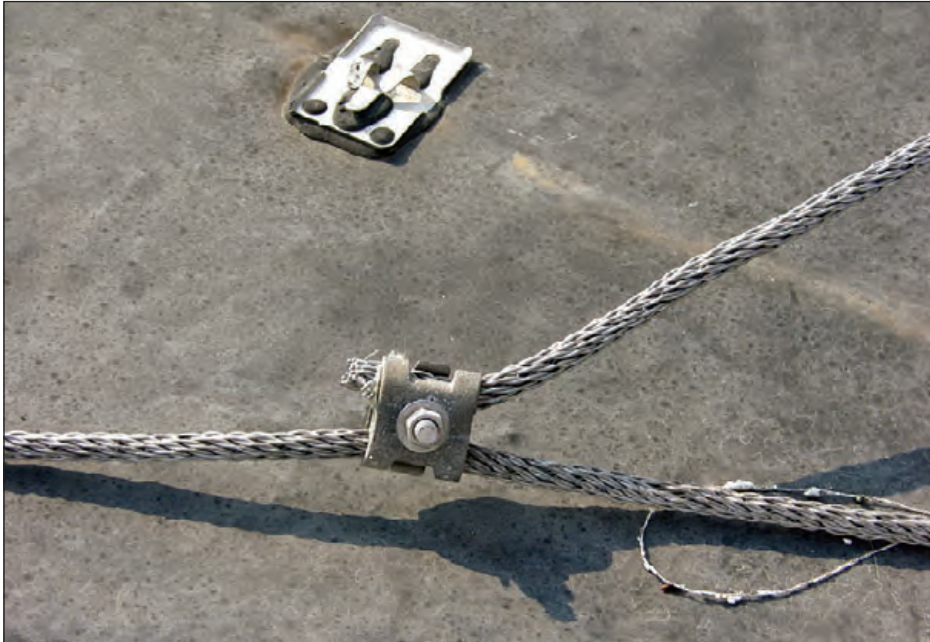
**Figure 6-117:** Bolted splice connectors are recommended to prevent free ends of connectors from being whipped around by wind. Estimated wind speed: 130 mph. Hurricane Katrina (Mississippi, 2005)

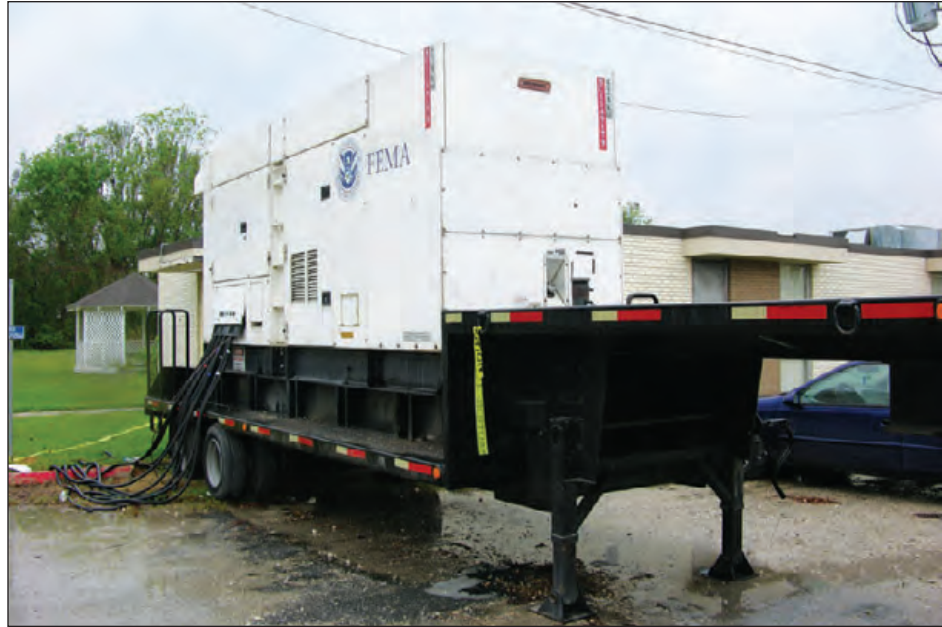
**Figure 6-118:**  
In lieu of permanent on-site emergency generators, portable generators can be an economical way to provide electrical power to schools used as hurricane recovery centers. Estimated wind speed: 108 mph. Hurricane Ike (Texas, 2008)

For schools that will be used as recovery centers after a hurricane, it is recommended that the schools be equipped with an emergency generator or have pre-hurricane arrangements for delivery of a portable generator to the school prior to the recovery center becoming operational (see Figure 6-118). (Note: It could take a few or several days for a portable generator to be delivered.) If a portable generator rather than a permanent

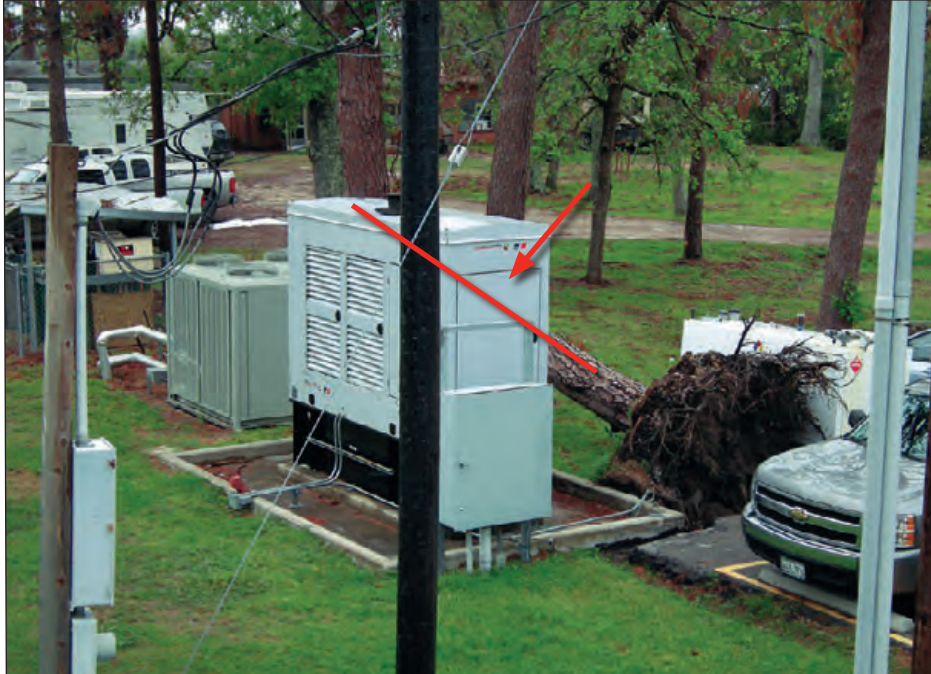
**Figure 6-119:**  
The tree shown by the red line nearly fell on the emergency generator (red arrow). Estimated wind speed: 110 mph. Hurricane Ike (Texas, 2008)

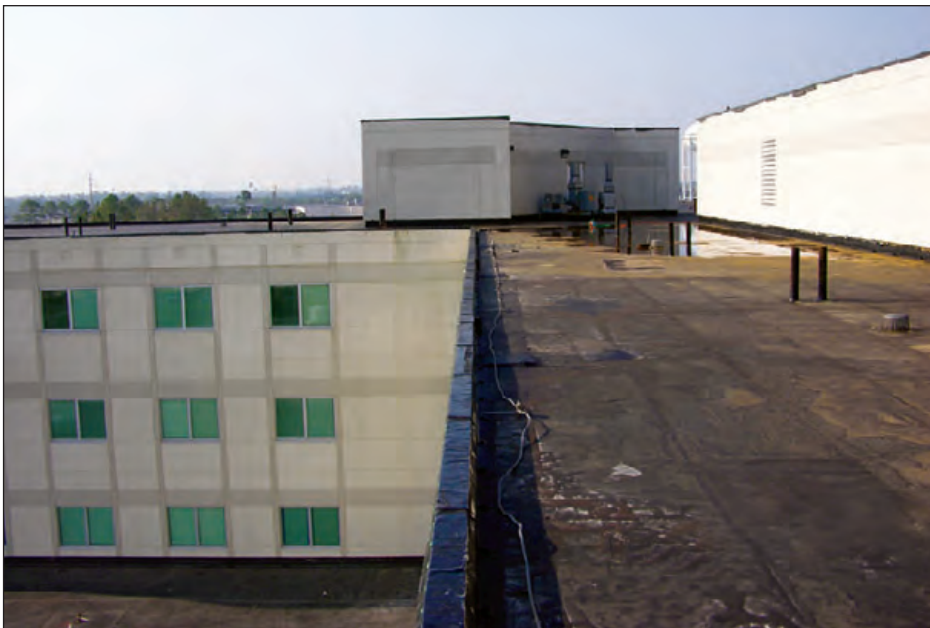
**Figure 6-120:** The roof and a portion of the EIFS on this 5-year-old building blew off. Water leaked into the floor below. The floor was taken out of service for more than a month. Estimated wind speed: 130 mph. Hurricane Katrina (Mississippi, 2005)

that shown in Figure 6-120 may identify weakness of the roof membrane and/or EIFS. Replacing weak components before a storm is much cheaper than replacing them and repairing consequential damages after a storm, and proactive work avoids the loss of use while repairs are made.

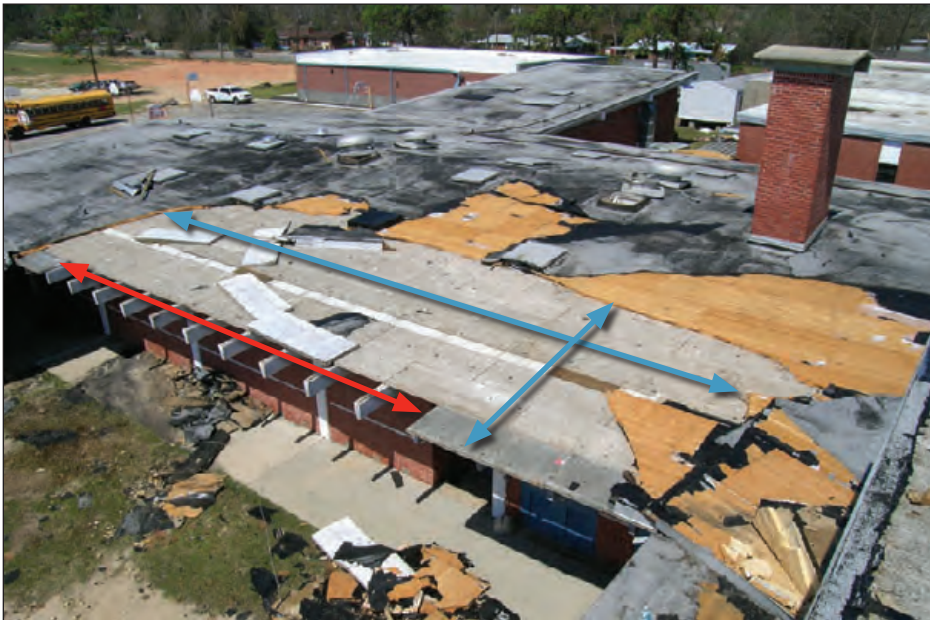
**Figure 6-121**  
The cementitious wood-fiber deck panels blew off of much of the overhang at this school. Deck panel failure resulted in lifting and peeling of the roof system over a large area, exposure of the decking in the area shown by the blue arrows, and extensive interior water infiltration. Estimated wind speed: 105–115 mph. Hurricane Ivan (Florida, 2004)

As discussed in Section 6.1.4.1, roof decks on many facilities designed prior to the 1982 edition of the SBC and UBC and the 1987 edition of the NBC are very susceptible to failure. Poorly attached decks that are not upgraded are susceptible to blow-off, as shown in Figure 6-121. Decks constructed of cementitious wood-fiber, gypsum, and lightweight insulating concrete over form boards were commonly used on schools built in the 1950s and 1960s. In that era, these types of decks, as well as precast concrete decks, typically had very limited uplift resistance due to weak connections to the support structure. Steel deck attachment is frequently not adequate because of an inadequate number of welds, or welds of poor quality. Older buildings with overhangs are particularly susceptible to blow-off, as shown in Figure 6-121, because older codes provided inadequate uplift criteria.

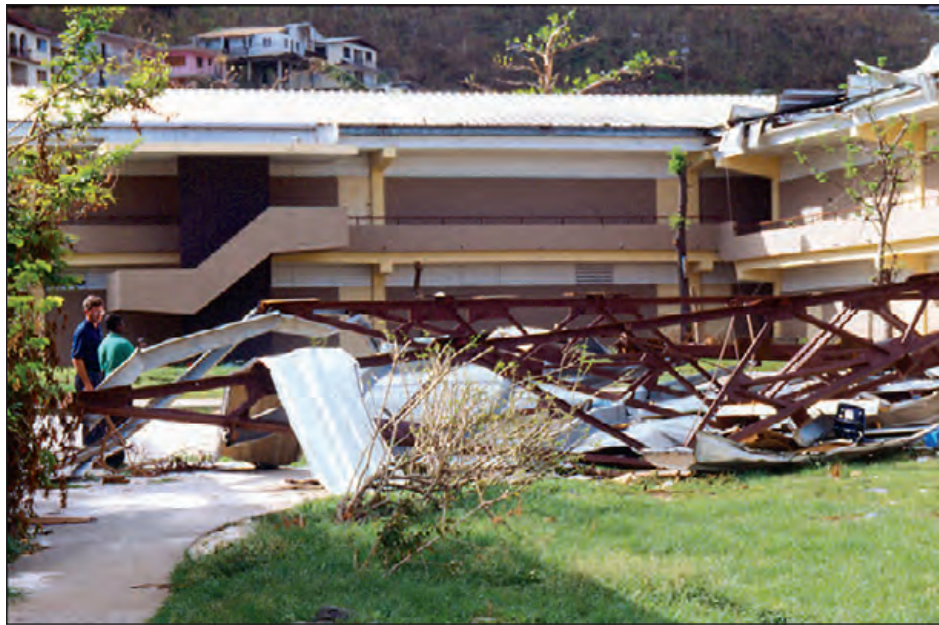
**Figure 6-122:**  
The steel truss superstructure installed on this school as part of a steep-slope conversion blew away because of inadequate attachment. Hurricane Marilyn (U.S. Virgin Islands, 1995)

If a low-slope roof is converted to a steep-slope roof, the new support structure should be engineered and constructed to resist the wind loads and avoid the kind of damage shown in Figure 6-122.
