# Design Guide

for Improving School Safety in Earthquakes, Floods,  
and High Winds

FEMA P-424 / December 2010

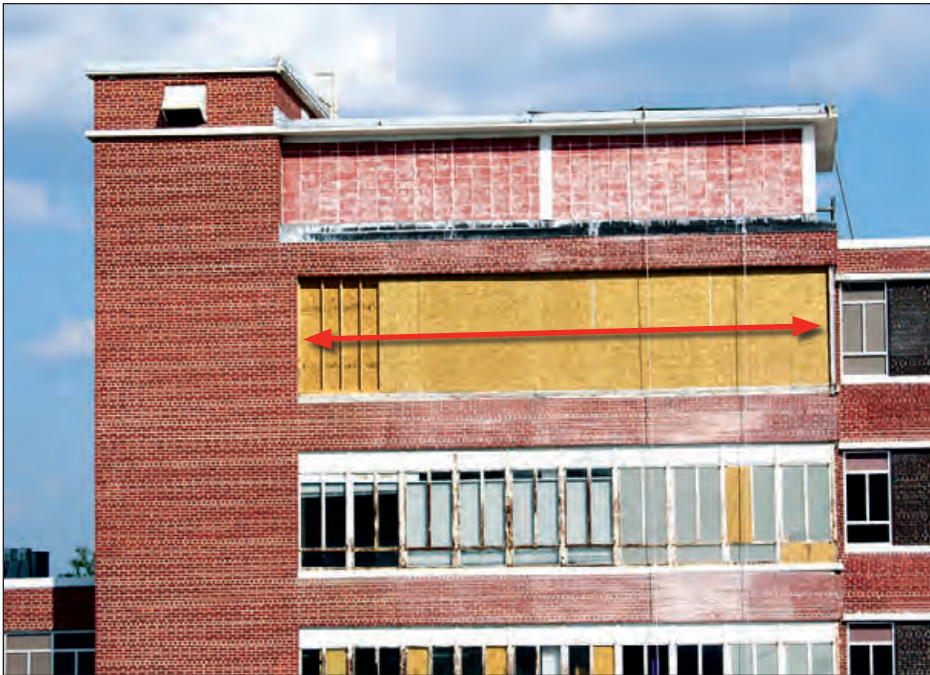
**Figure 6-123:** Wind pressure caused the window frames on the upper floors to fail (red arrow). Estimated wind speed: 130 mph. Hurricane Katrina (Mississippi, 2005)

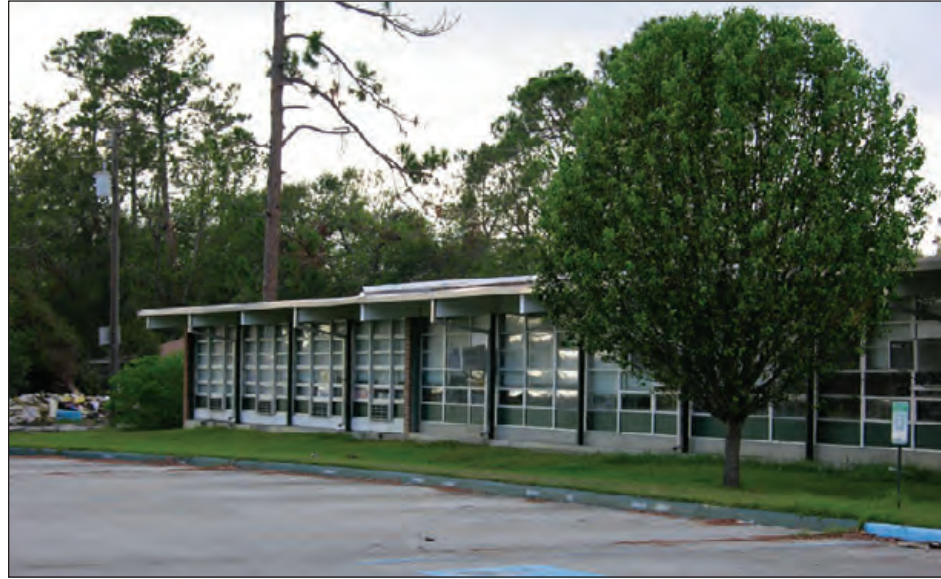
**Figure 6-124:**  
On-site water-spray testing in accordance with ASTM E 1105 can be used to evaluate wind-driven rain resistance. Older window assemblies such as the ones at this school are often quite susceptible to leakage. Estimated wind speed: 125 mph. Hurricane Katrina (Mississippi, 2005)

Some older window assemblies have sufficient strength to resist the design pressure, but are inadequate to resist wind-driven rain. If the lack of water resistance is due to worn glazing gaskets or sealants, replacing the gaskets or sealant may be viable. In other situations, replacing the existing assemblies with new, higher-performance assemblies may be necessary. On-site testing in accordance with ASTM E 1105 can be used to evaluate wind-driven rain resistance of suspect windows (see Figure 6-124). (Note: Shutters placed over windows to provide wind-borne debris protection should not be relied upon to protect against wind-driven rain. If existing windows are susceptible to debris and leakage, the windows should be replaced with new assemblies.)

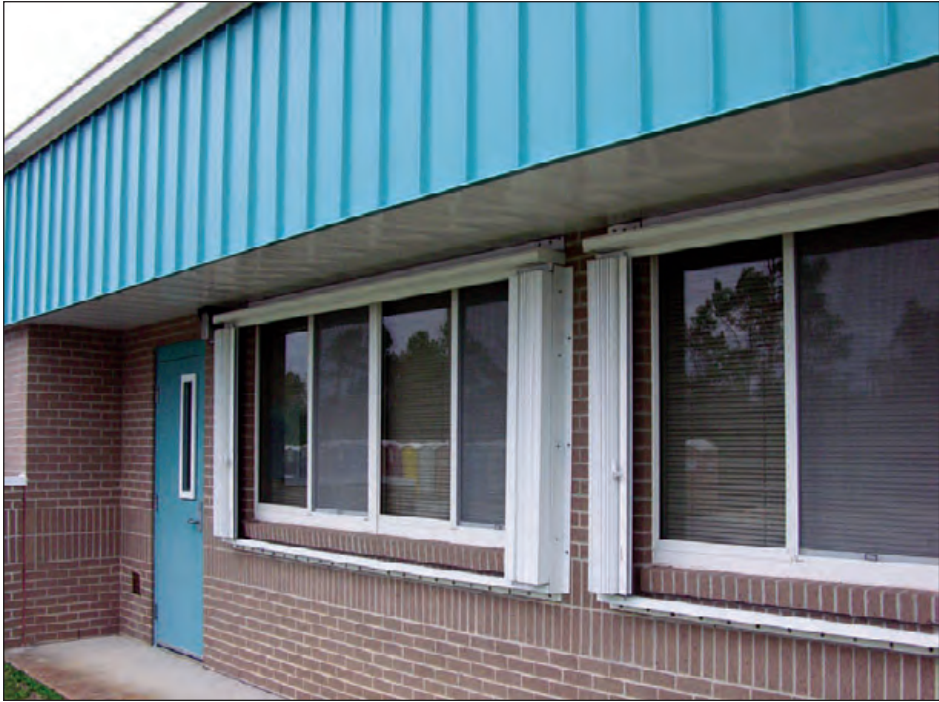
Figure 6-125:  
This school has  
accordion shutters.  
Estimated wind  
speed: 105–115 mph.  
Hurricane Ivan (Florida,  
2004)

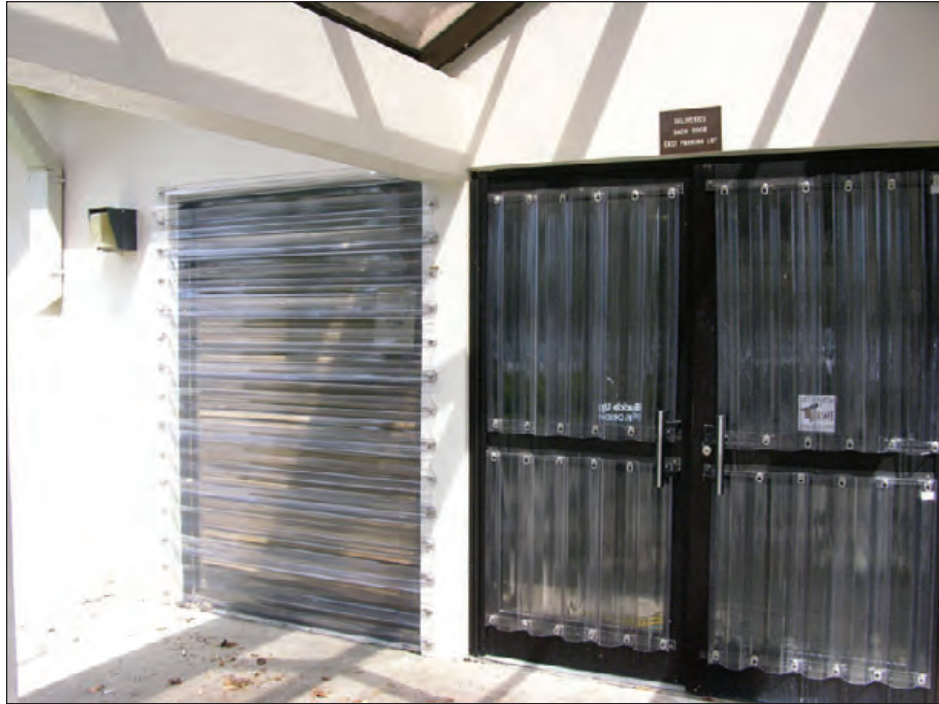
**Figure 6-127:**  
Polycarbonate shutters were temporary screwed to the doors and wall adjacent to the window opening. An advantage of polycarbonate is its translucence, which allows daylight to enter the building without removing the shutters. Hurricane Francis (Florida, 2004)

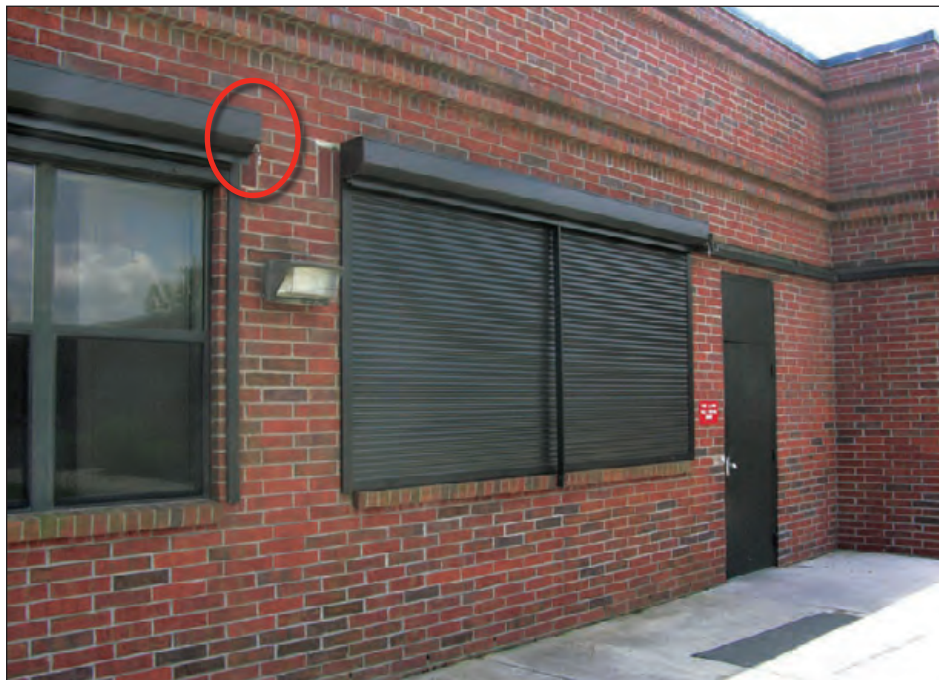
**Figure 6-128:**  
This school has roll-down shutters. The toggle in the red circle allows the shutter to be manually raised. Estimated wind speed: 130–140 mph. Hurricane Charley (Florida, 2004)

Deploying accordion or panel shutters a few stories above grade is expensive. Although motorized shutters have greater initial cost, their operational cost should be lower. Other options for providing missile protection on upper levels include replacing the existing assemblies with laminated glass assemblies, or installing permanent impact resistant screens. Engineered films are also available for application to the interior of the glass. The film needs to be anchored to the frame, and the frame needs to be adequately anchored to the wall. The film degrades over time and requires replacement (approximately every decade). Use of laminated glass or shutters/screens is recommended in lieu of engineered films.

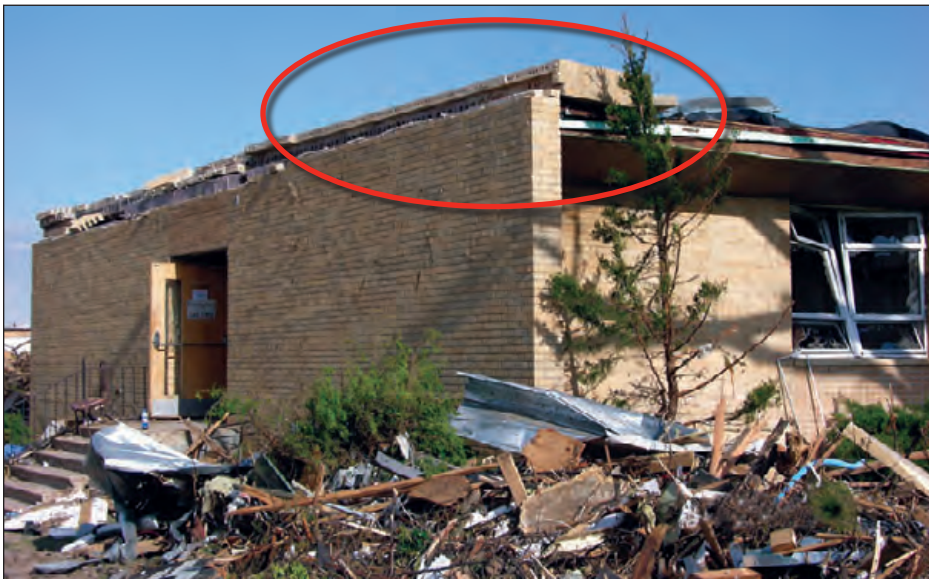
Figure 6-129:  
Collapsed unreinforced  
masonry parapet.  
Greensburg Tornado  
(Kansas, 2007)

If the parapet is constructed of masonry, it is recommended that its wind resistance be evaluated and strengthened if found to be inadequate. The masonry parapet shown in Figure 6-129 fell onto the roof. Had it fallen in the other direction, it would have blocked the entry and would have had the potential to cause injury.

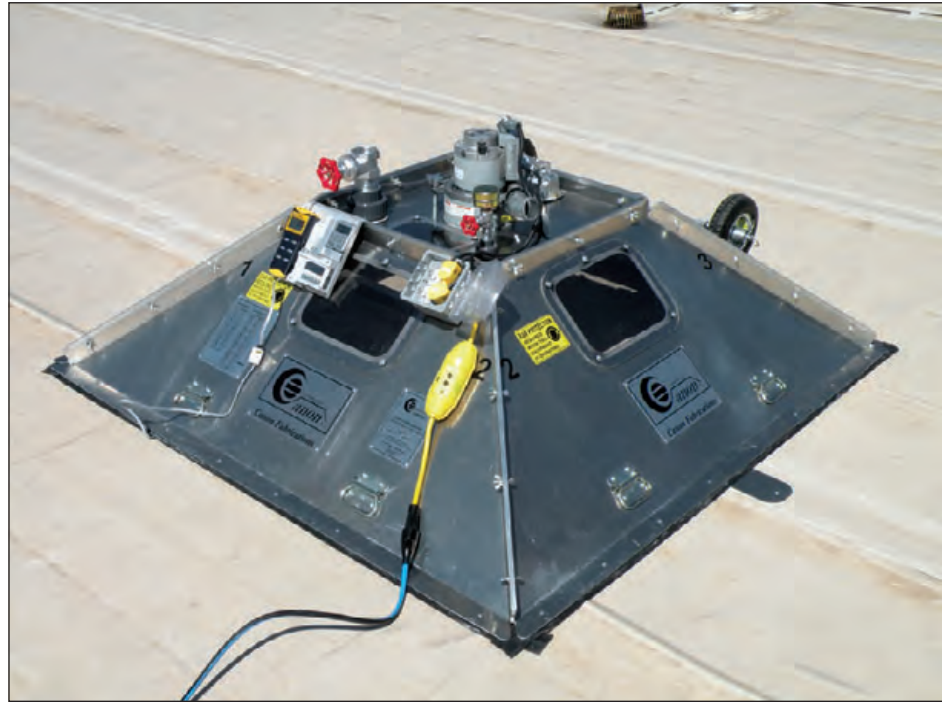
**Figure 6-130:**  
View of a 5-foot by 5-foot negative pressure chamber used to evaluate roof system uplift resistance.

On-site testing in accordance with ASTM E 907 can be used to evaluate the uplift resistance of roof systems that have fully adhered membranes (see Figure 6-130). (Note: This test method is not capable of evaluating the uplift resistance of the roof deck.)

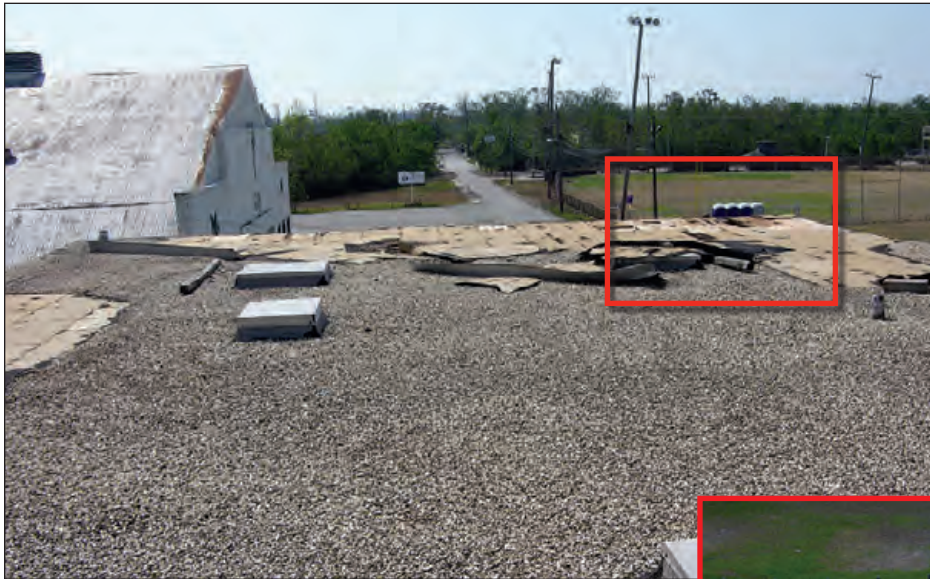
**Figure 6-131:**  
The built-up roof on this school was blown off after a few of the rotted wood planks detached from the joists. Estimated wind speed: 120 mph. Hurricane Katrina (Mississippi, 2005)

When planning the replacement of a roof covering, it is recommended that all existing roof covering be removed down to the deck rather than simply re-covering the roof. Tearing off the covering provides an opportunity to evaluate the structural integrity of the deck and correct deck attachment and other problems. For example, if a roof deck was deteriorated due to roof leakage (see Figure 6-131), the deterioration would likely not be identified if the roof was simply re-covered. By tearing off down to the deck, deteriorated decking like that shown in Figure 6-131 can be found and replaced. In addition, it is recommended that the attachment of the wood nailers at the top of parapets and roof edges be evaluated and strengthened where needed, to avoid blow-off and progressive lifting and peeling of the new roof membrane (see Figure 6-132).

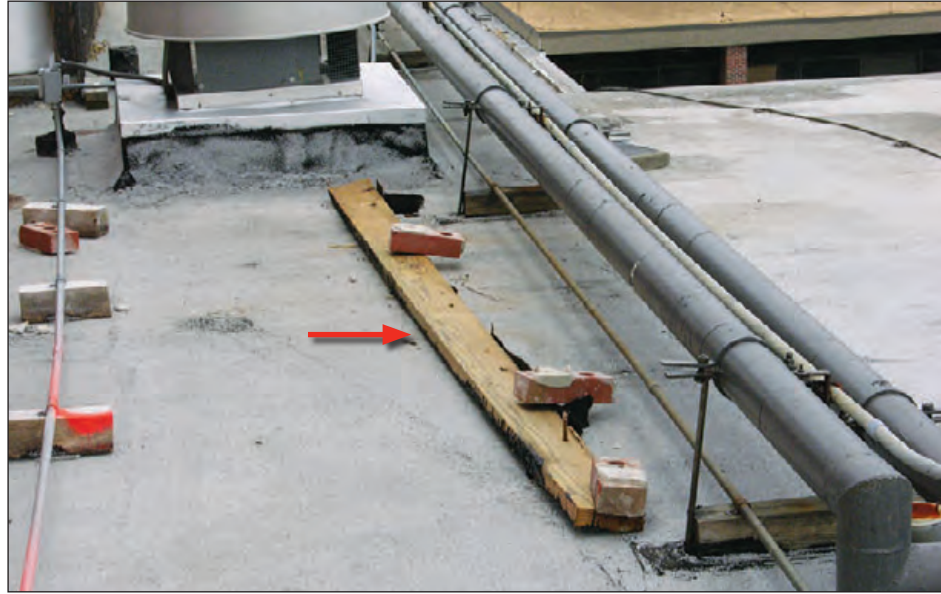
**Figure 6-133:**  
Failed base flashing adhered directly to the brick parapet. Estimated wind speed: 105 mph. Hurricane Katrina (Louisiana, 2005)

If the roof has a parapet, it is recommended that the inside of the parapet be properly prepared to receive the new base flashing. In many instances, it is prudent to re-skin the parapet with sheathing to provide a suitable substrate. Base flashing should not be applied directly to brick parapets because they have irregular surfaces that inhibit good bonding of the base flashing to the brick (see Figure 6-133). Also, if moisture drives into the wall from the exterior side of the parapet with base flashing attached directly to brick, the base flashing can inhibit drying of the wall. Therefore, rather than totally sealing the parapet with membrane base flashing, the upper portion of the brick can be protected by metal panels (as shown in Figure 6-88), which permits drying of the brick.

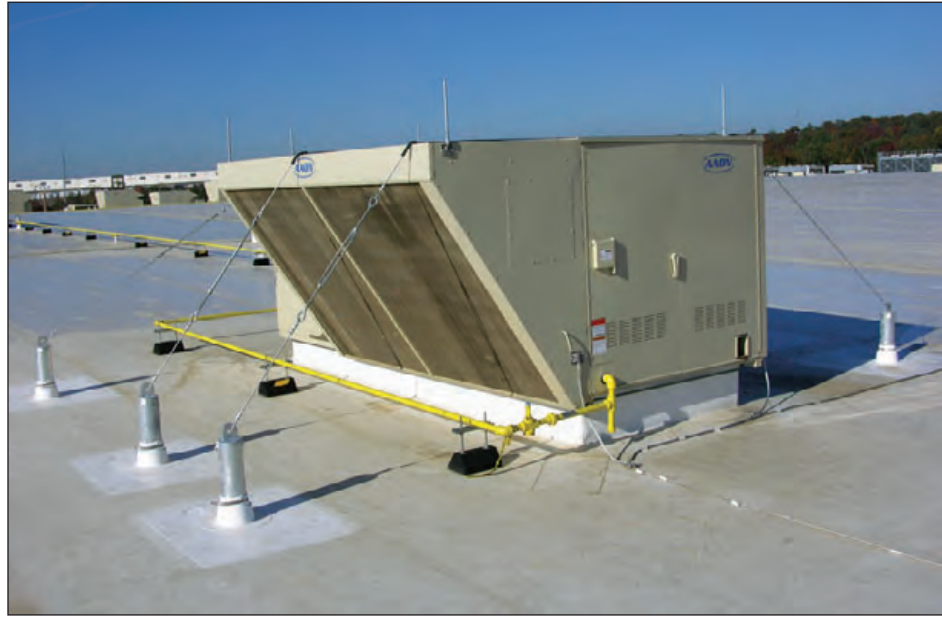
**Figure 6-136:**  
At this school, the hood on this HVAC unit was inadequately attached. A strap between the hood and unit can be economically installed to avoid this problem. Estimated wind speed: 110 mph. Hurricane Ike (Texas, 2008)

If HVAC units have inadequately attached sheet metal hoods (see Figure 6-136), sheet metal straps can be economically installed between the top of the hood and the side of the unit. Equipment access panels may also need to be modified to resist wind loads as discussed in Section 6.3.4.1. Besides avoiding damage to the unit, these types of retrofits can prevent blown-off hoods and panels from causing injury and damaging the roof membrane or other building components.

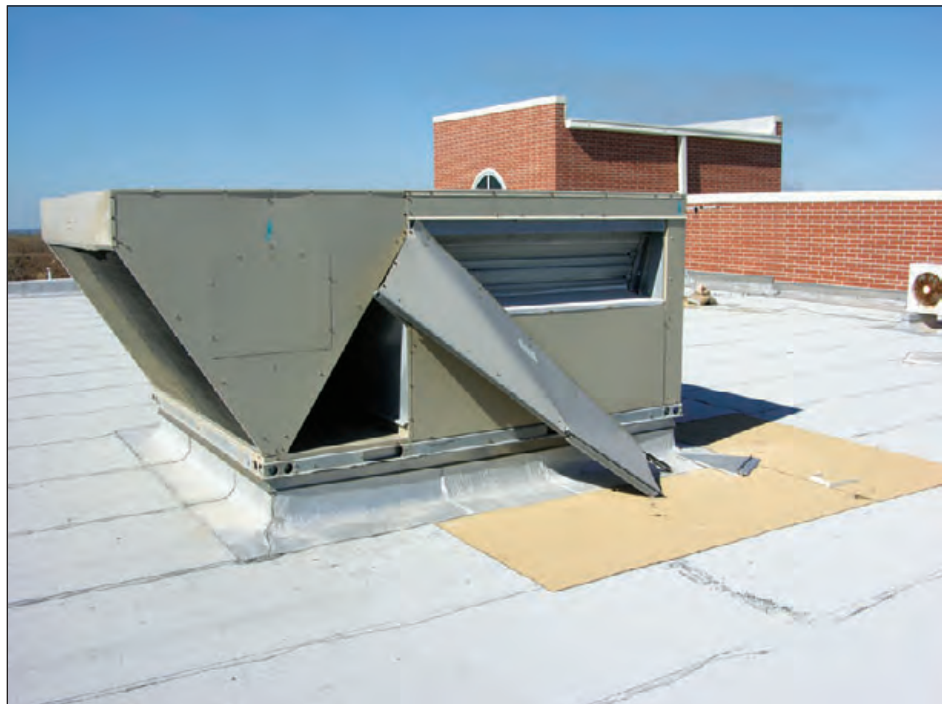
**Figure 6-137:** These condensers were simply mounted on wood sleepers that rested on the roof surface. Note the damaged exhaust stacks and missing rain caps (red oval). Estimated wind speed: 105 mph. Hurricane Katrina (Mississippi, 2005)

Where condensers are mounted to curbs that are adequately anchored to the deck, straps can be installed as shown in Figure 6-95 if the condenser attachment is inadequate. If condensers are mounted on sleepers (see Figure 6-137), then the condensers should be re-mounted and anchored to curbs or stands that are anchored to the roof deck.

If exhaust stacks such as those shown in Figure 6-137 are inadequately anchored, guys attached to pipe anchors such as those shown in Figure 6-135 should be installed. To avoid blow-off of rain caps as shown in Figure 6-137, additional straps or screws may need to be installed.

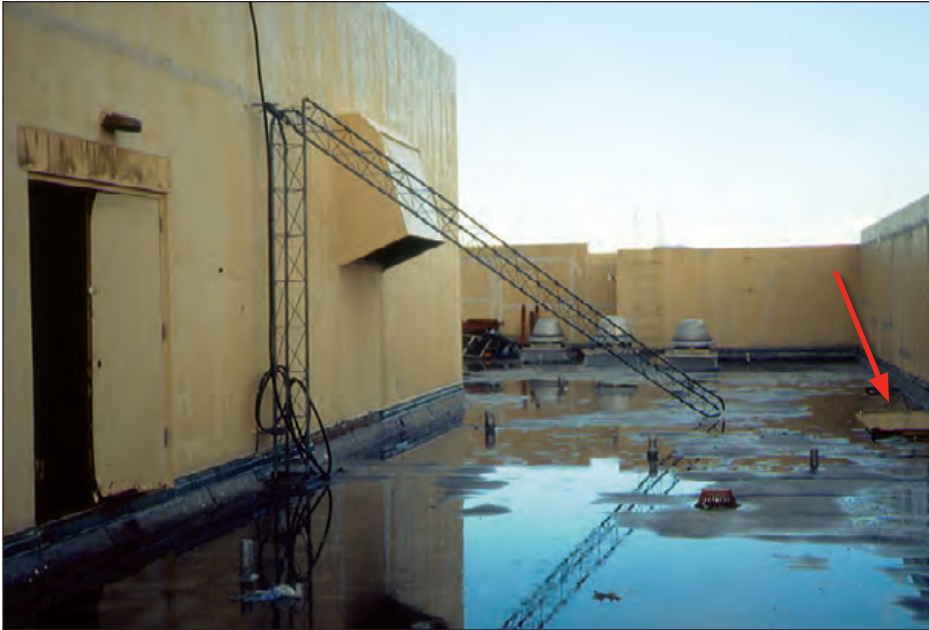
**Figure 6-139:**  
The antenna collapsed and was whipped back and forth across the roof membrane. Hurricane Andrew (Florida, 1992)

Antenna collapse is very common. Besides loss of communications, collapsed masts can puncture roof membranes or cause other building damage as shown in Figure 6-139. This case also demonstrates the benefits of a high parapet. Although the roof still experienced high winds that blew off this penthouse door, the parapet prevented the door from blowing off the roof (red arrow in Figure 6-139).

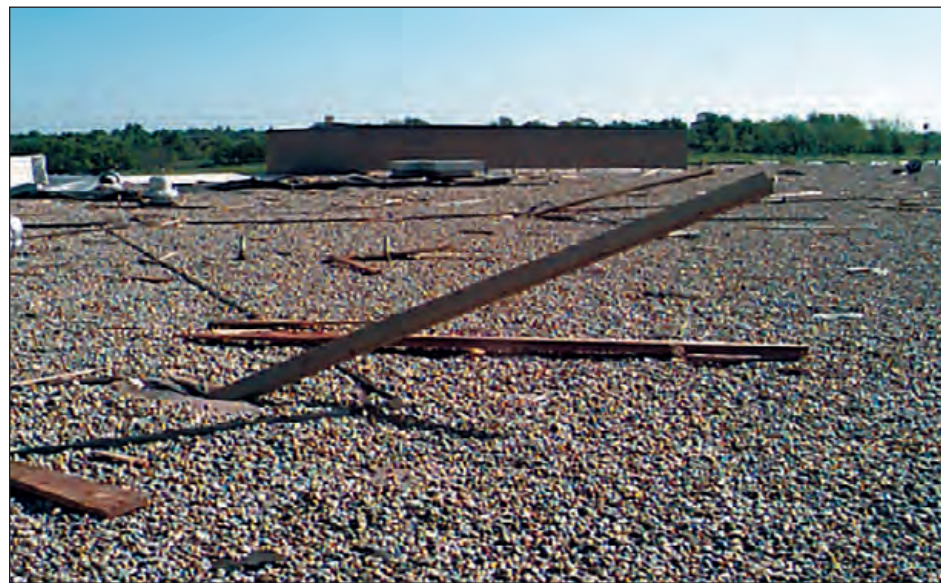
**Figure 6-141:**  
**A violent tornado**  
**showered the roof with**  
**missiles (Oklahoma,**  
**1999)**

Strong and violent tornadoes can generate very powerful missiles. Experience shows that large and heavy objects, including vehicles (see Figure 6-140), can be hurled into buildings at high speeds. The missile sticking out of the school roof in the foreground of Figure 6-141 is a double 2-inch by 6-inch wood member. The portion sticking out of the roof is 13 feet long. It penetrated a ballasted ethylene propylene diene monomer (EPDM) membrane, approximately 3 inches of polyisocyanurate roof insulation, and the steel roof deck. The missile lying on the roof just beyond is a 2-inch by 10-inch by 16-foot long wood member.

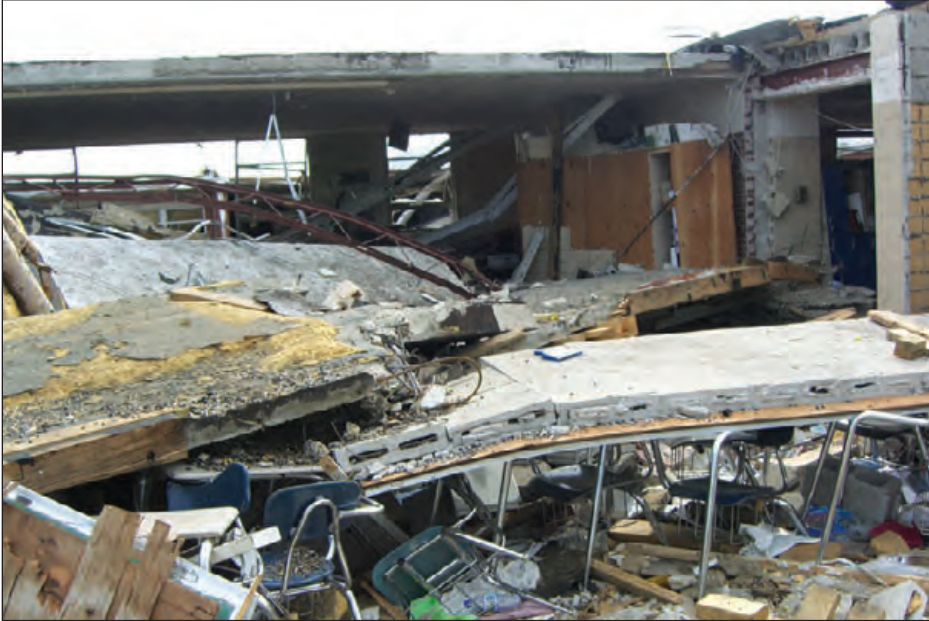
Figure 6-143 :  
Unreinforced masonry  
walls and hollow-core  
concrete roof planks  
collapsed. Enterprise  
Tornado (Alabama, 2007)
