Designing for Earthquakes

A Manual for Architects

FEMA 454 / December 2006

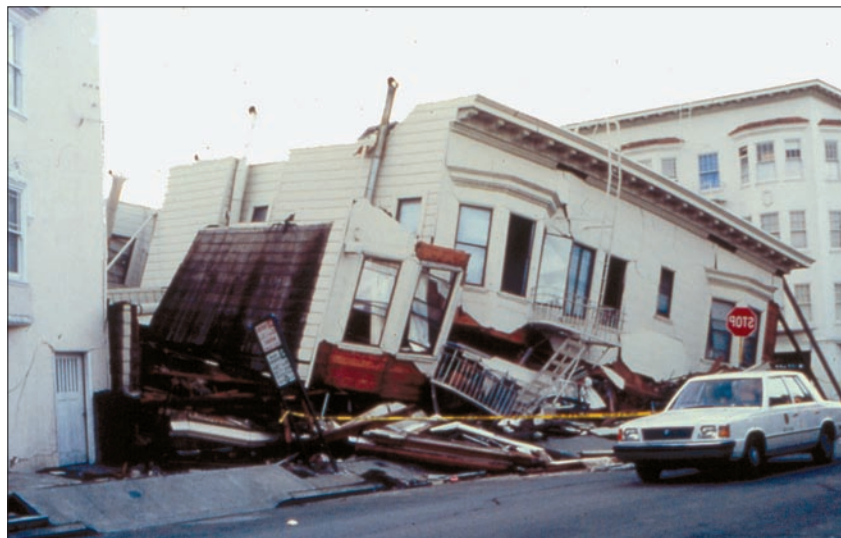
Collapsed apartment house in the Marina District of San Francisco, caused by a combination of amplified ground motion and a soft story.

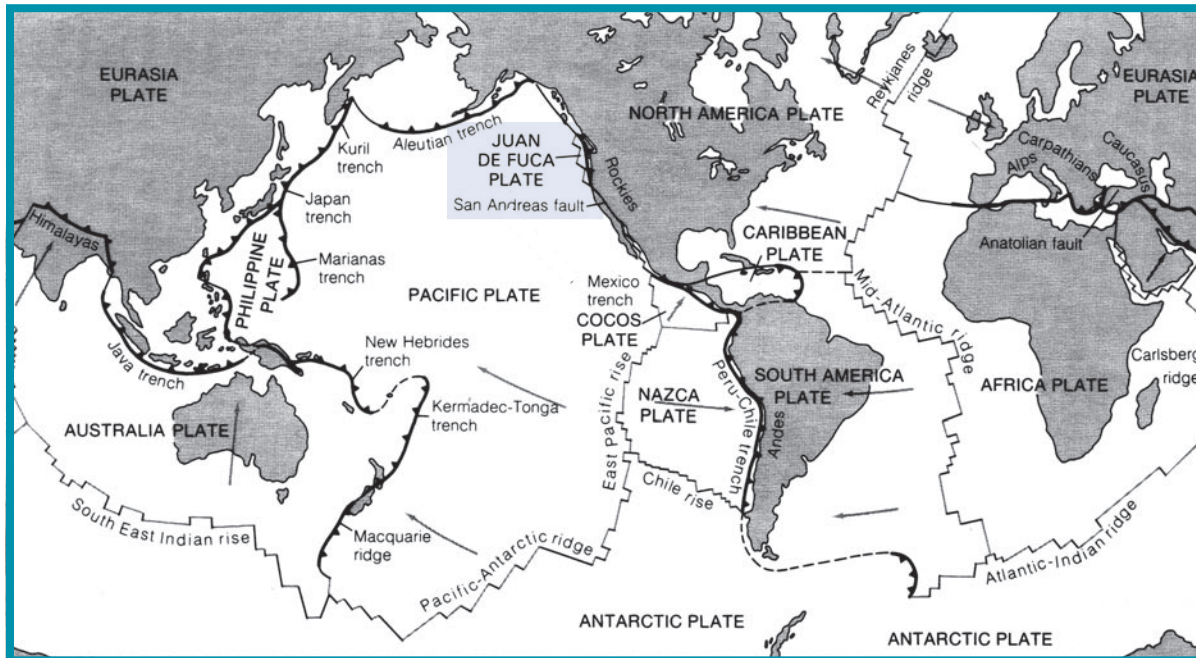
Figure 2-2: The major tectonic plates, midoceanic ridges, trenches and transform faults.

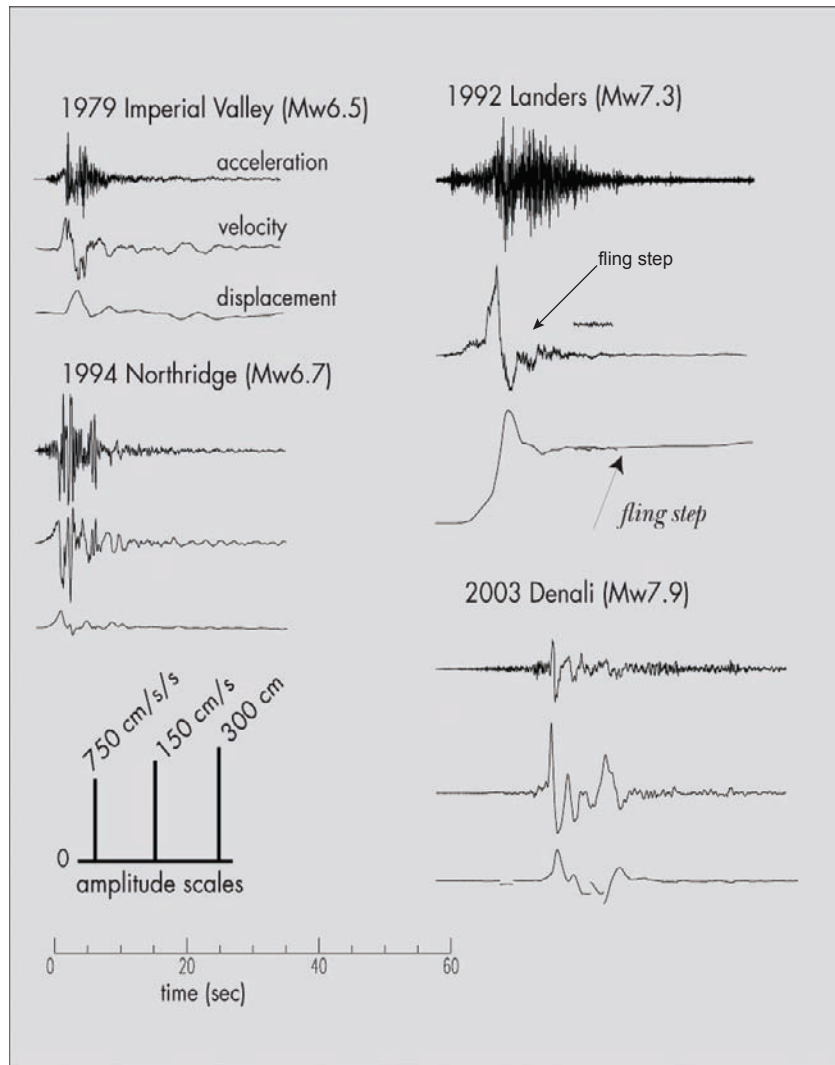
Figure 2-9: Examples of near-fault, large amplitude seismograms (time-histories).

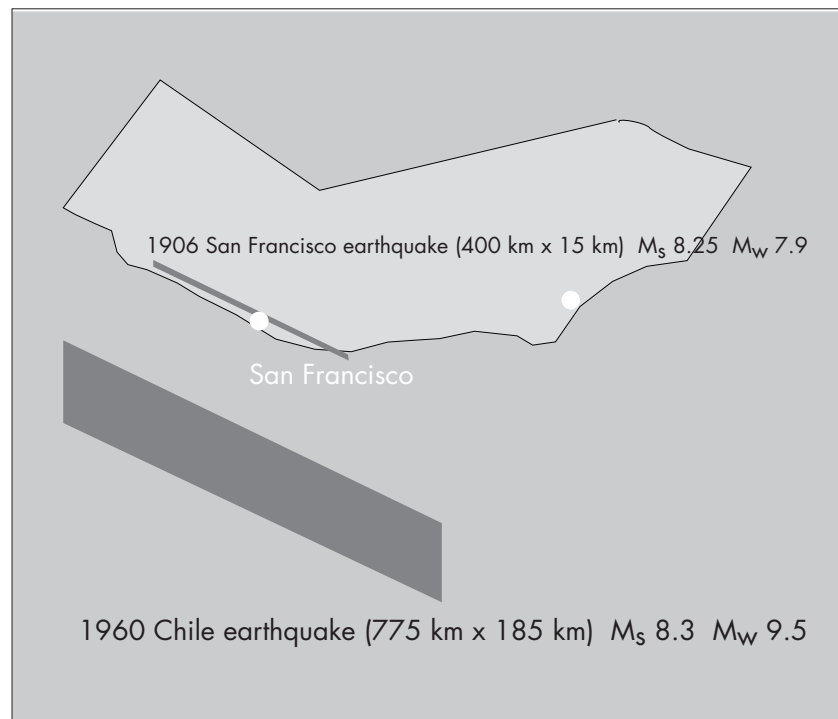
Figure 2-10: Two earthquakes may have equal magnitudes but be distinctly unequal in other respects.

The 1906 San Francisco, California, earthquake ruptured rock over a shorter length and shallower depth - only about 1/25 the area - as the 1960 Chilean earthquake. Although the surface wave magnitudes are the same, the moment magnitude for these two earthquakes (Table 2-1) are distinctly different. A sketch of the outline of California is shown for scale.

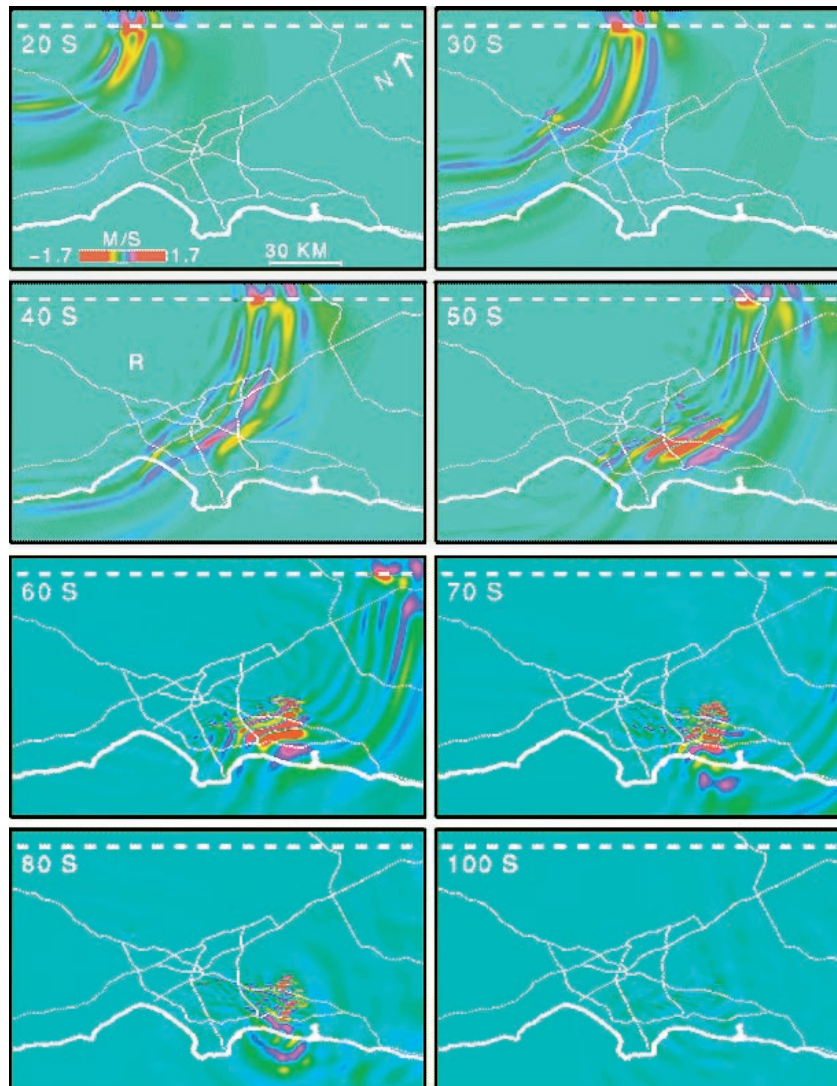
Figure 2-11: Aerial snapshots of a simulated wave propagation in the Los Angeles area.

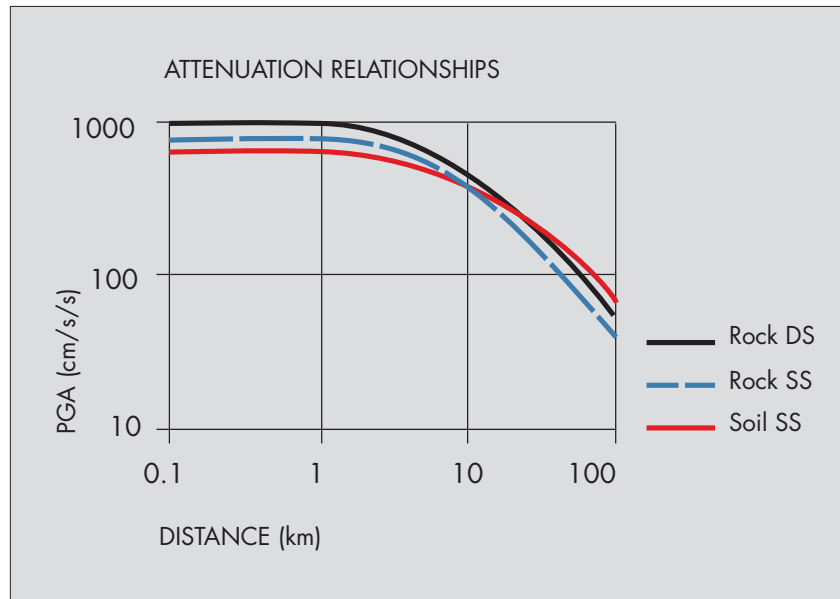
Figure 2-12: Examples of attenuation curves for a M_w7 earthquake obtained by data regression, illustrating the effects of a **site** type: rock (blue dashed) vs. deep soil (red), and **event** type: strike-slip fault (blue dashed) vs. reverse fault (black)

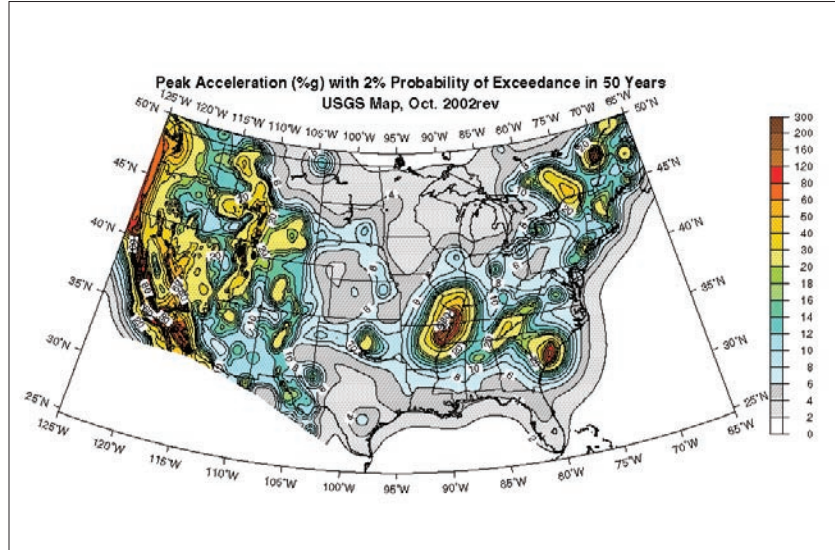
Figure 2-13: Spectral Acceleration values in %g with a 2% Probability of Exceedance in 50 years for the coterminous United States. The color scale to the right relates to the %g values.

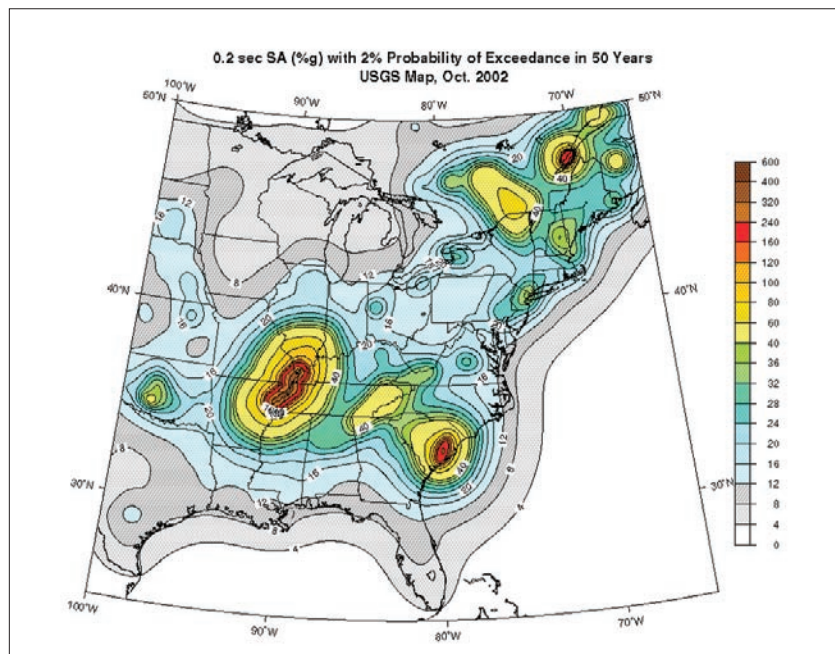
Figure 2-14: 0.2 second (short) period Spectral Acceleration values in %g with a 2% Probability of Exceedance in 50 years for Central and Southern United States.

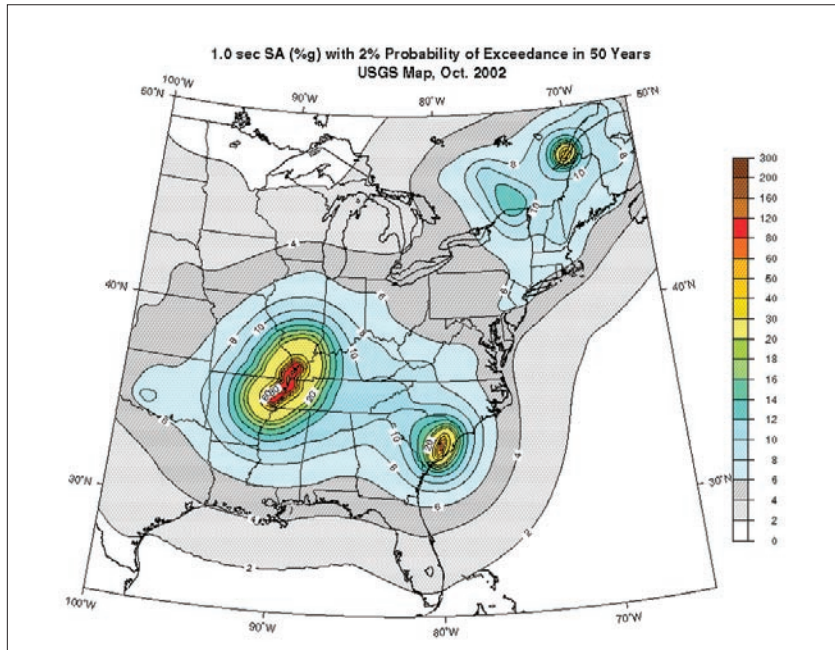
Figure 2-15: 1.0 second (long) period spectral acceleration values in %g with a 2% probability of exceedance in 50 years for central and southern United States.

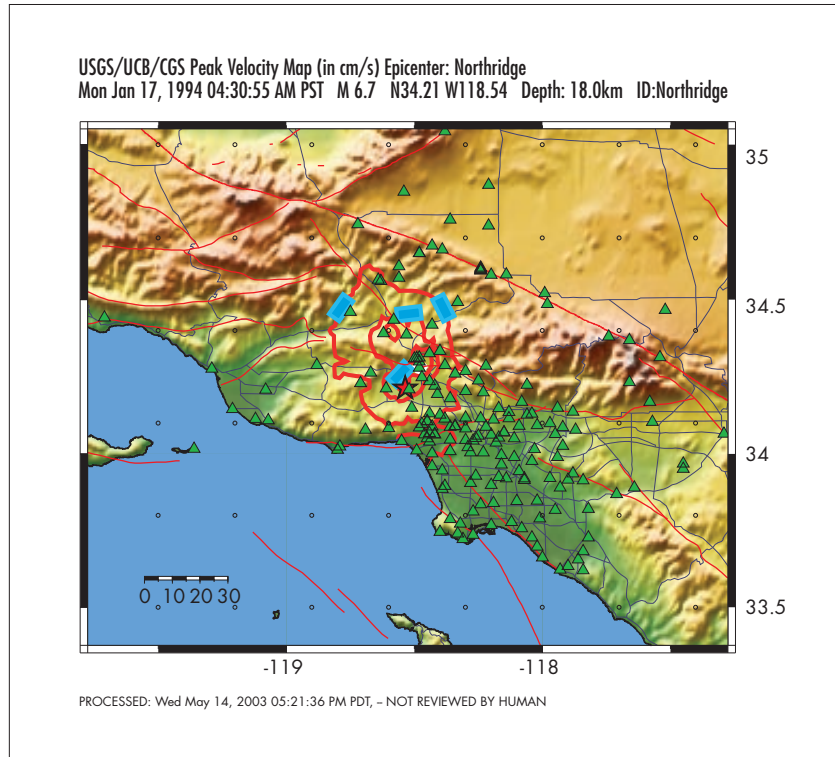
Figure 2-16: Example of a peak ground velocity (PGV) ShakeMap for the 1994 $M_w=6.7$ Northridge earthquake.

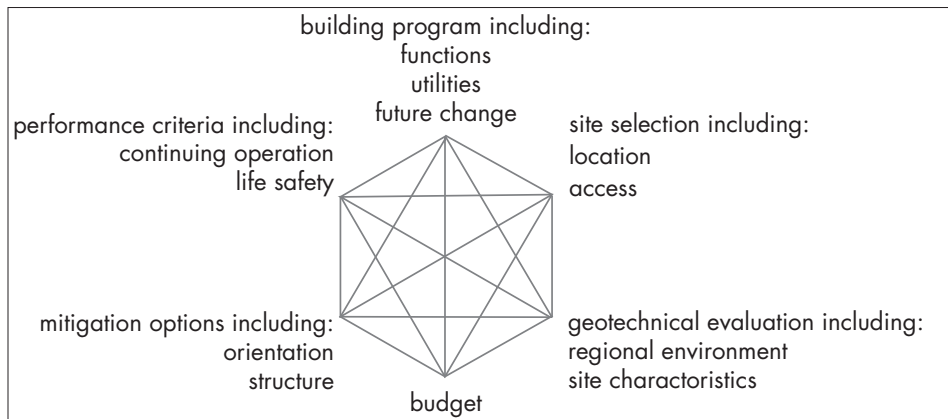
Figure 3-1: Interrelationships of performance expectations, building program and site characteristics.

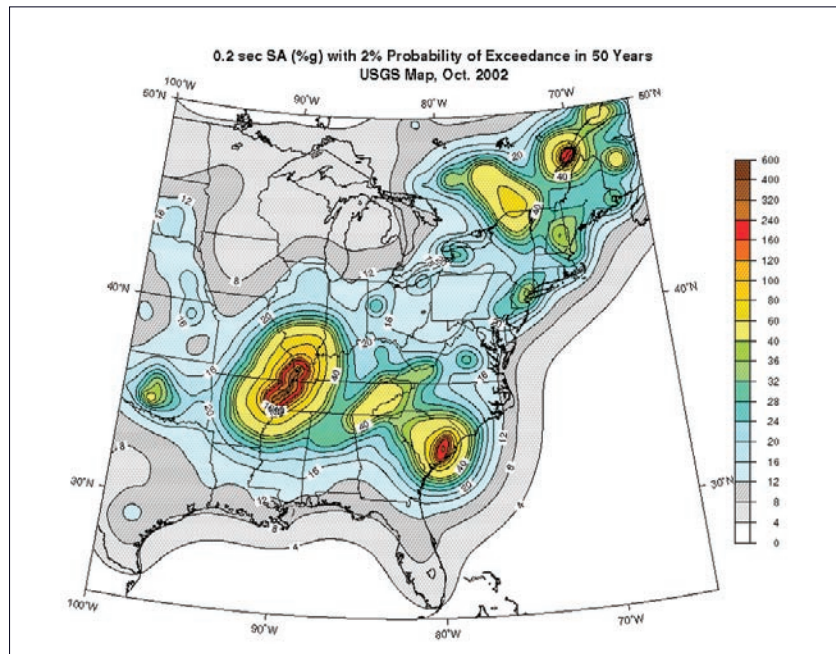
Figure 3-2: USGS Map of 0.2 sec spectral acceleration with a 2% Probability of Exceedance in 50 Years

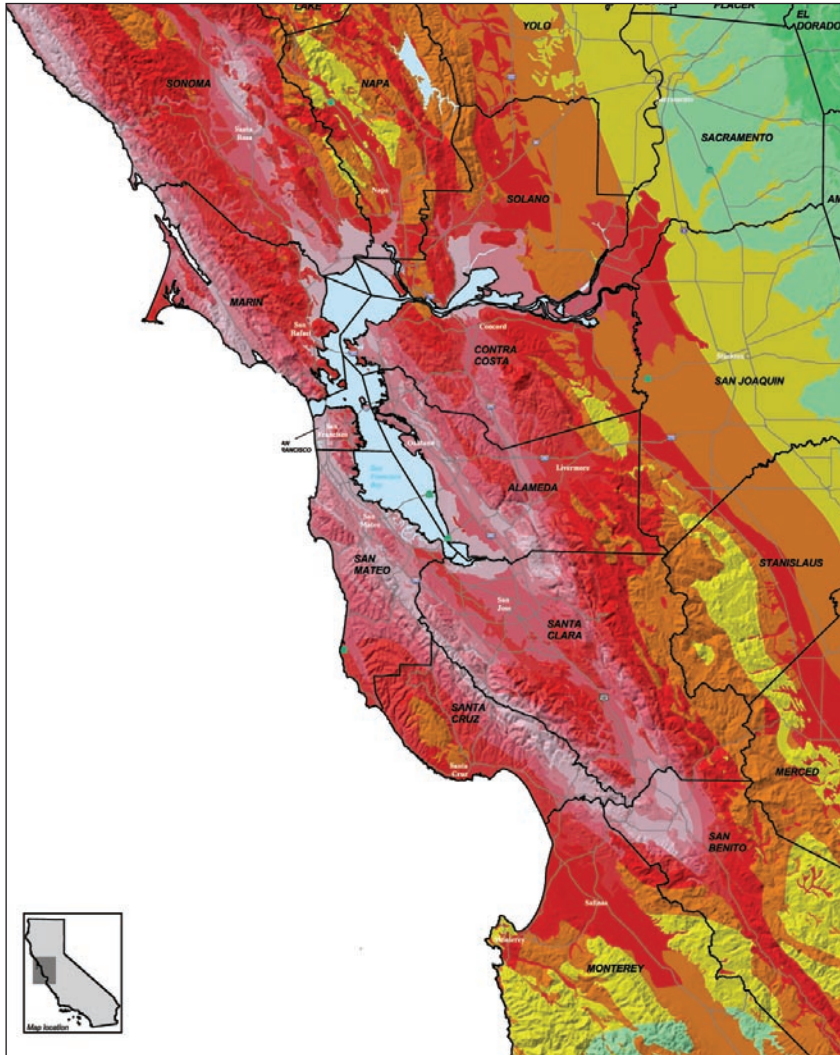
Figure 3-3: USGS and CGS Map of Relative PGA with a 2% Probability of Being Exceeded in 50 Years

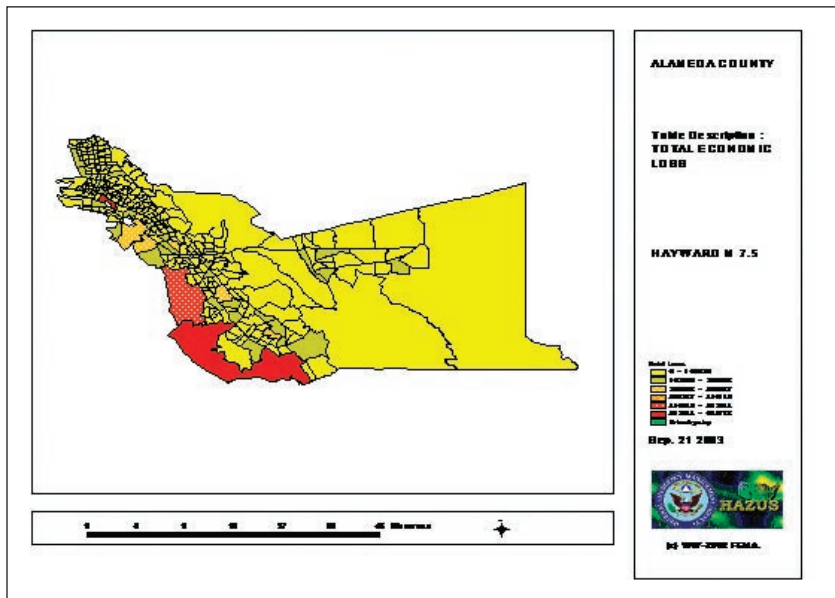
Figure 3-5
HAZUS Estimate of Total Economic Loss by Census Tract

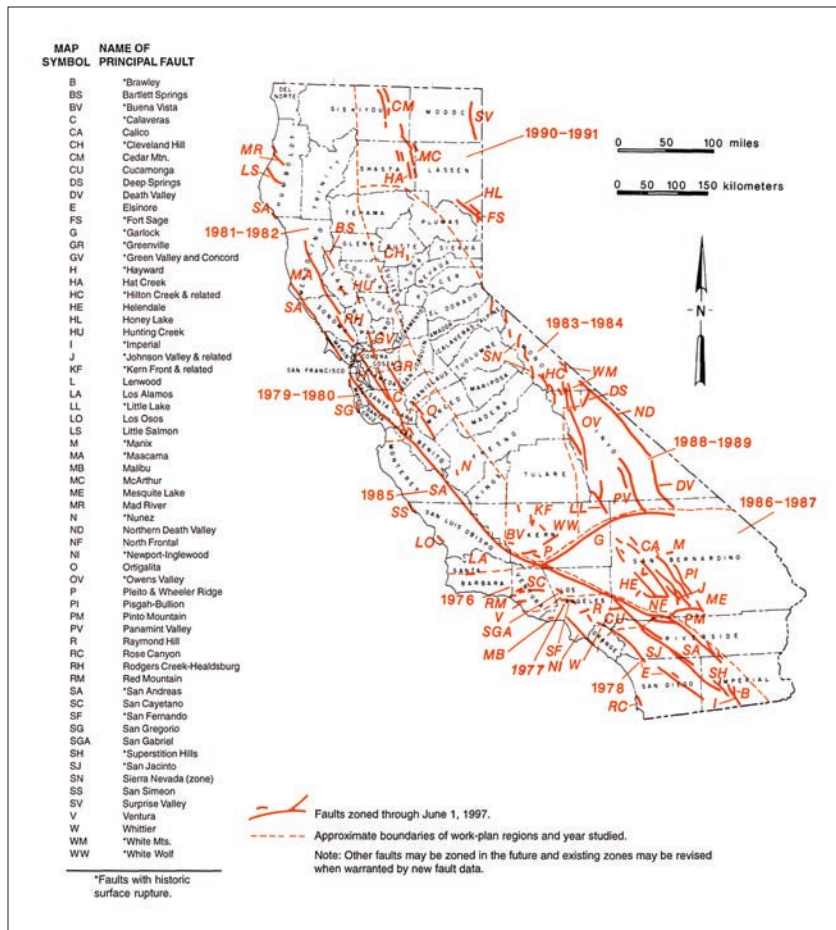
Figure 3-7
Principal Active Fault
Zones in California
SOURCE: CGS, SPECIAL
PUBLICATION 1999

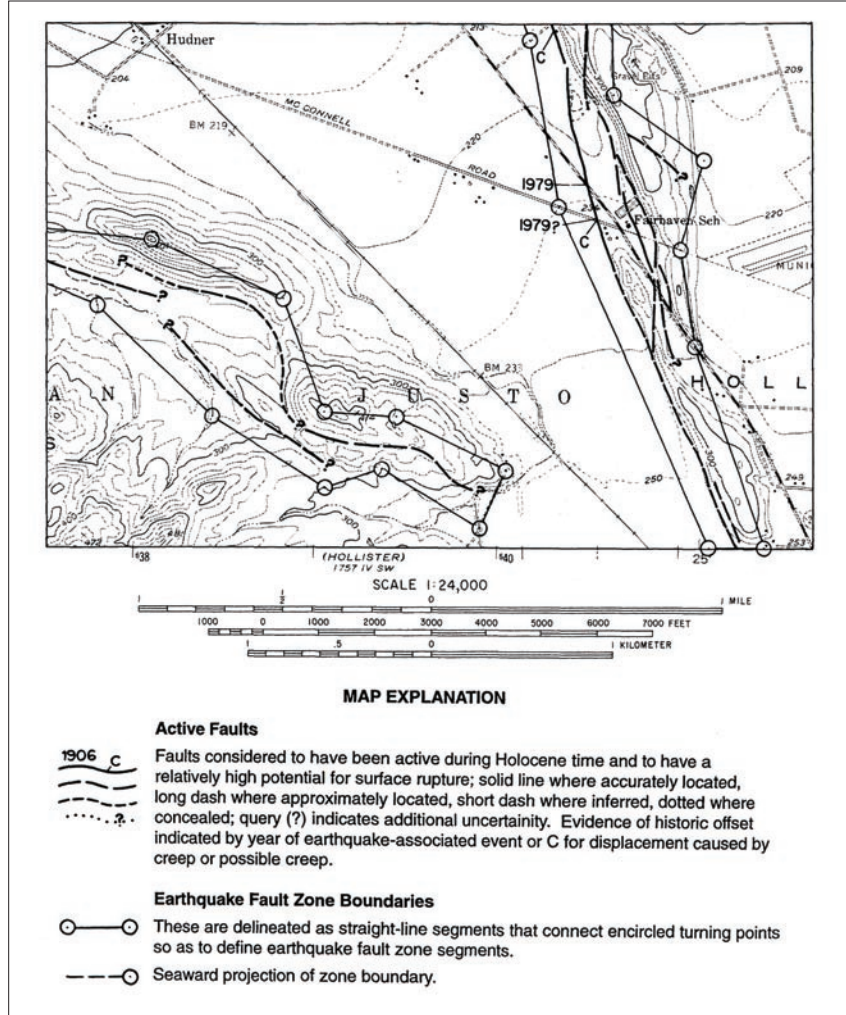
Figure 3-8: Alquist Priola Special Studies Zone (Earthquake Fault Zone).

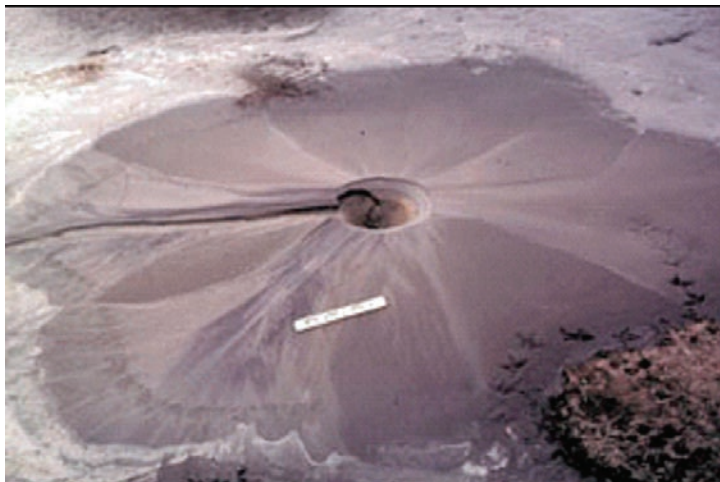
Figure 3-11: Sand Boil.

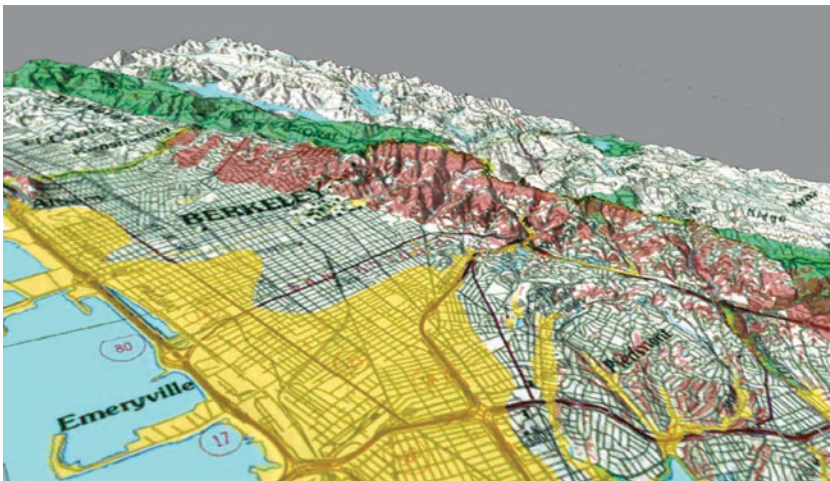
Figure 3-12: 3-D image of Liquefaction and Landslide Hazard Zone Map for Berkeley and Emeryville. Yellow indicates liquefaction, which is related to soil type and proximity to ground water.

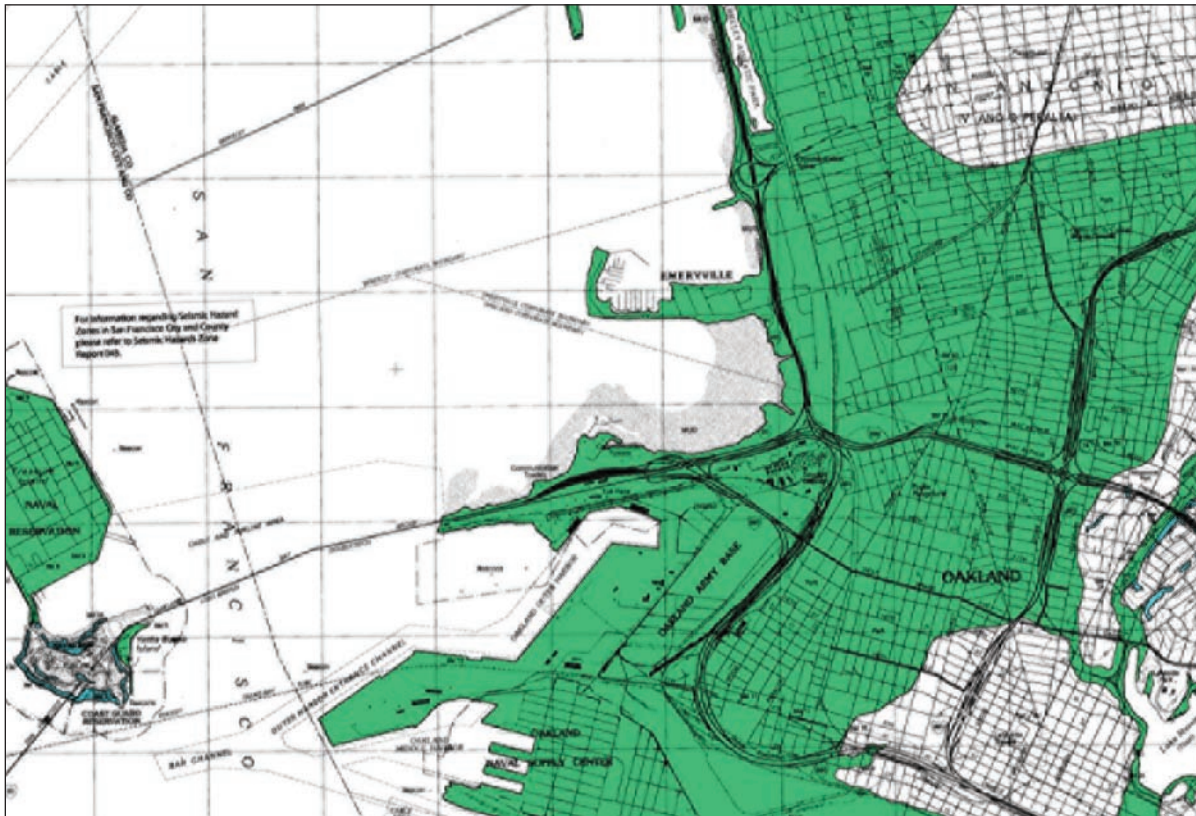
Figure 3-13: Liquefaction Hazard Zone Map for West Oakland and Emeryville.

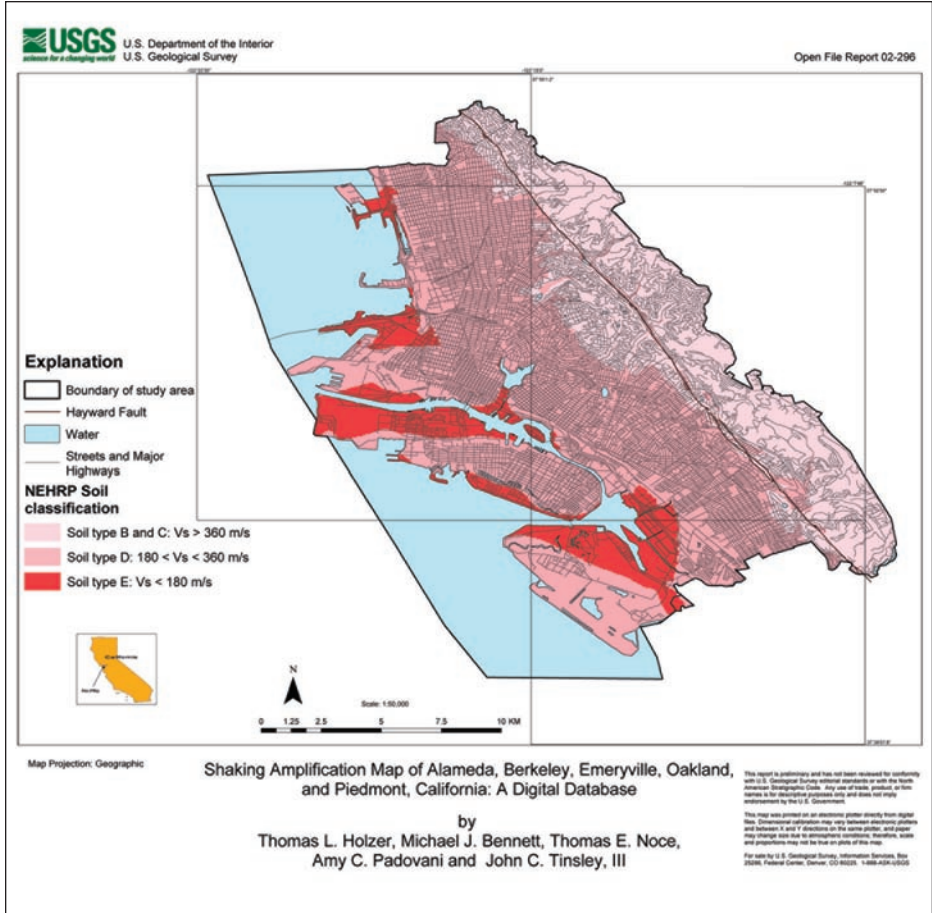
Figure 3-15: USGS Shaking Amplification Map of Alameda, Berkeley, Emeryville, Oakland and Piedmont, California. SOURCE: USGS (HOLZER ET AL.)

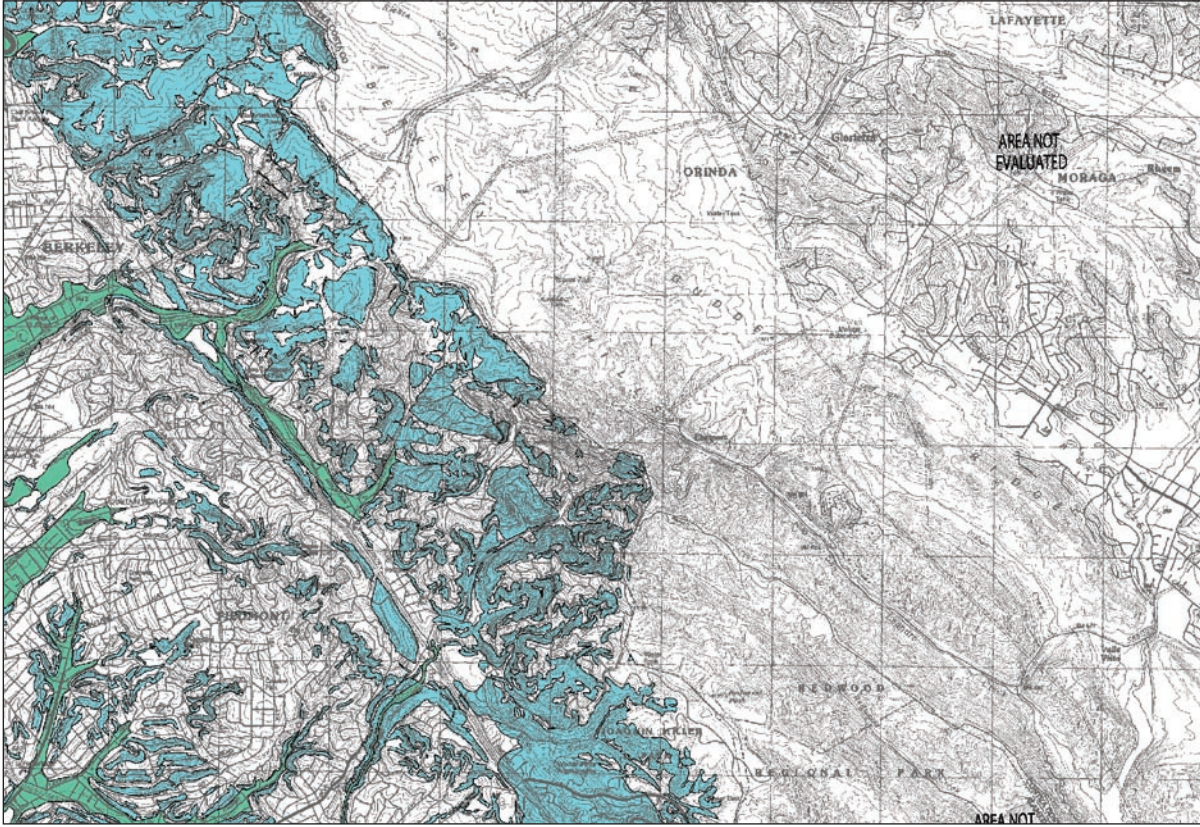
Figure 3-16: Landside Hazard Zones for Berkeley and Oakland, California. Blue areas are those that are susceptible to earthquake-caused landslides.

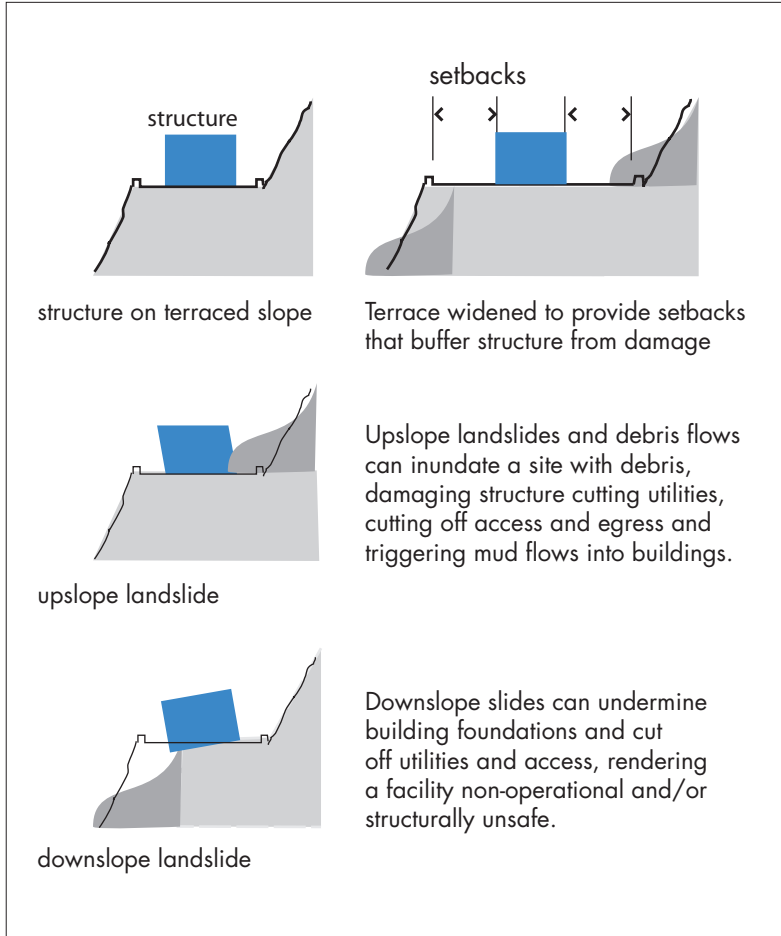
Figure 3-17
The effect of upslope and downslope landslides.

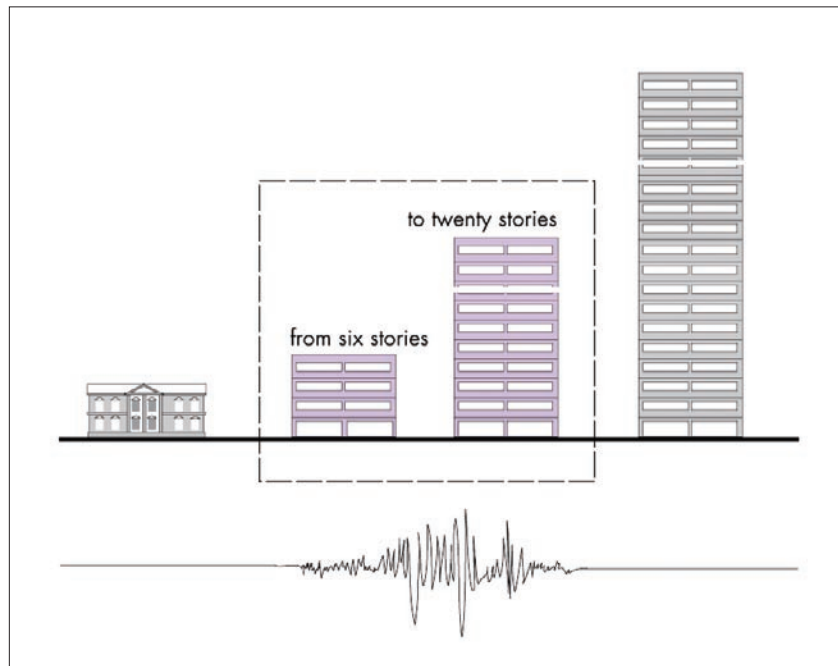
Figure 4-5: The vulnerable group: Mexico City, 1985. The periods of buildings in the 6 to 20 story range resonated with the frequency content of the earthquake.

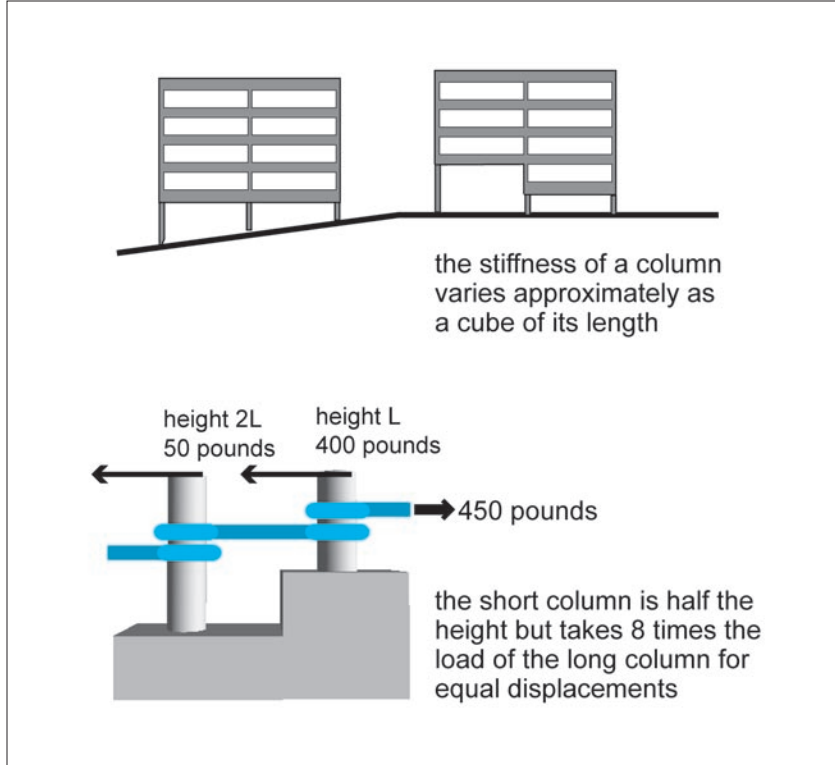
Figure 4-15: The short column problem.

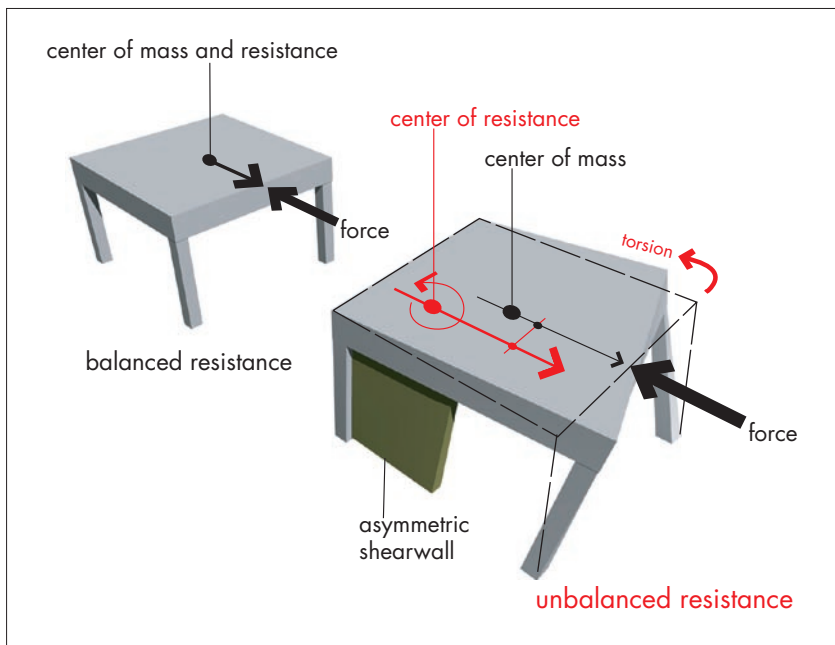
Figure 4-17
Torsional forces.

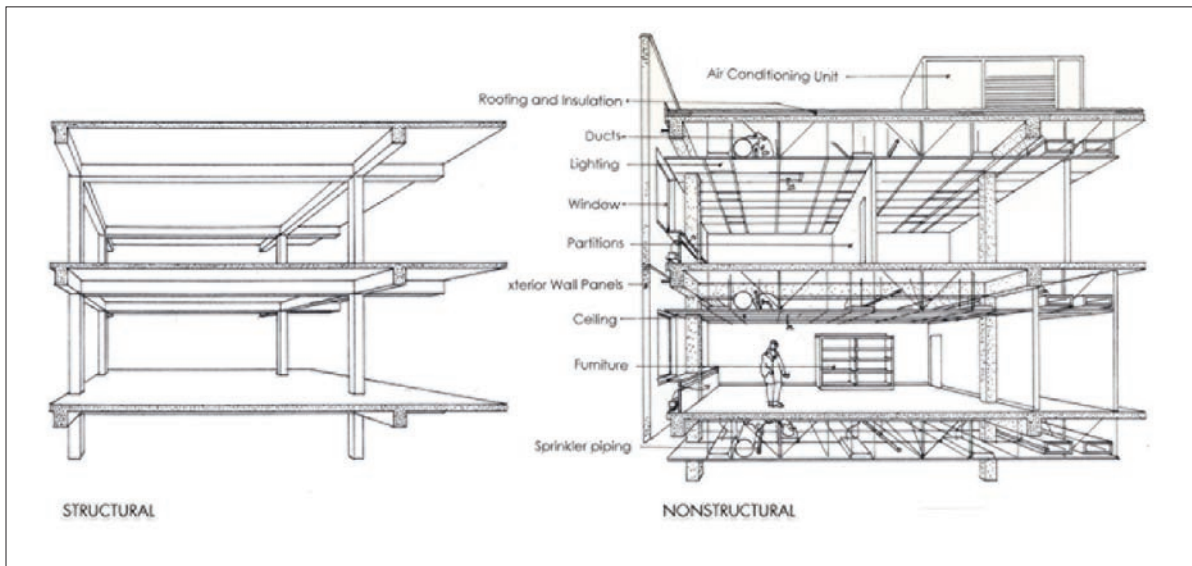
Figure 4-18: Structure (left), nonstructural components and systems (right).

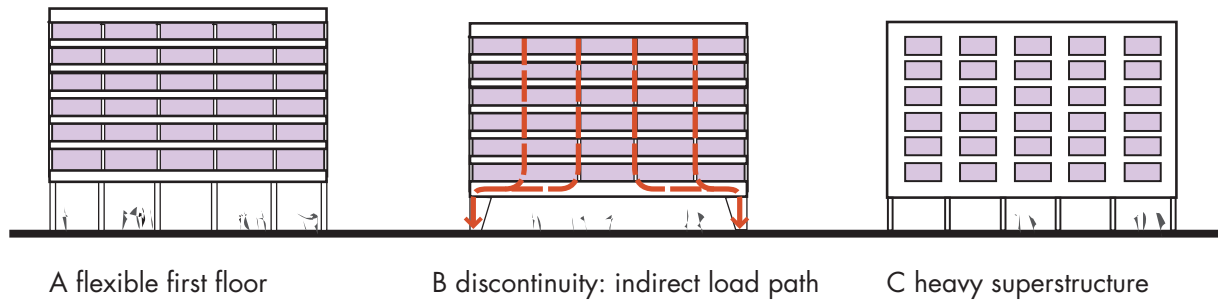
Figure 5-8: Three types of soft first story.

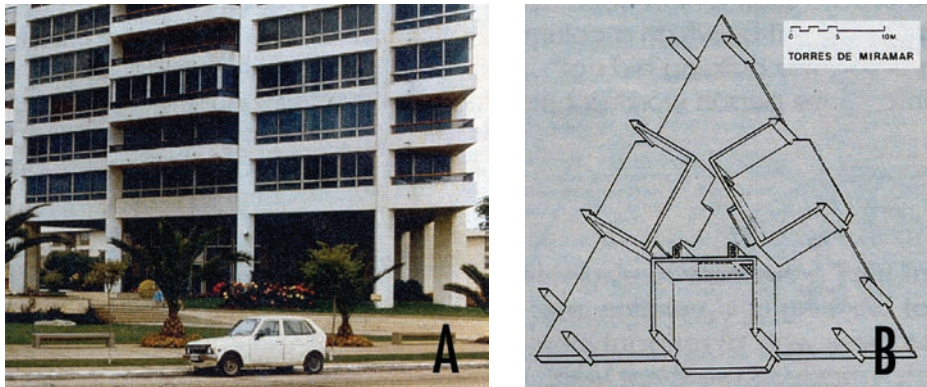
Figure 5-12: This apartment house appears to have a soft first story (Figure 5-12A), but the lateral force-resisting system is a strong internal shear wall box, in which the shear walls act as party walls between the dwelling units (Figure 5-12B). The architect achieved a light and elegant appearance, and the engineer enjoyed an optimum and economical structure.

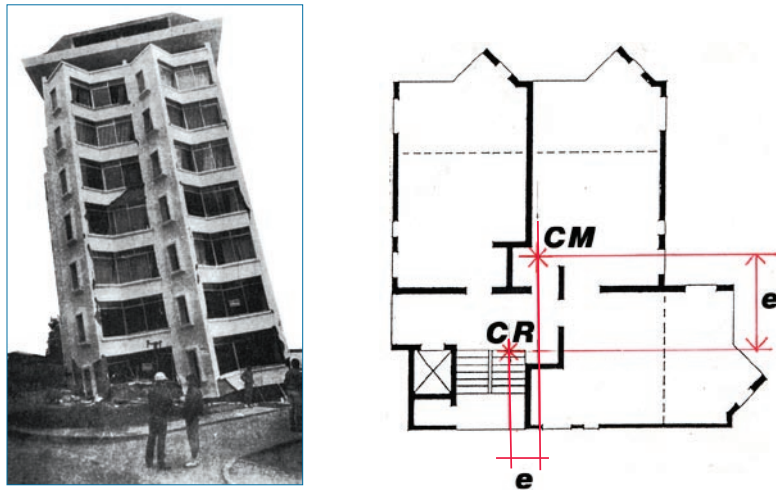
Figure 5-16: Left, the building after the earthquake. Right, typical floor plan showing the Center of Mass (CM), Center of Resistance (CR), and Eccentricity (e) along the two axes. PHOTO SOURCE: EERI

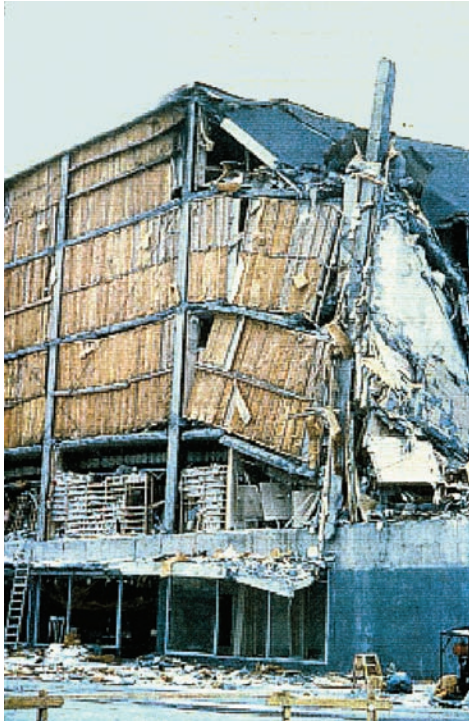
Figure 5-18: Penney's store, Anchorage, Alaska, earthquake, 1964. Left: Damage to the store: loss of perimeter precast panels caused two deaths. Right: Second-floor plan, showing unbalanced perimeter resistance. SOURCE: JAMES L. STRATTA

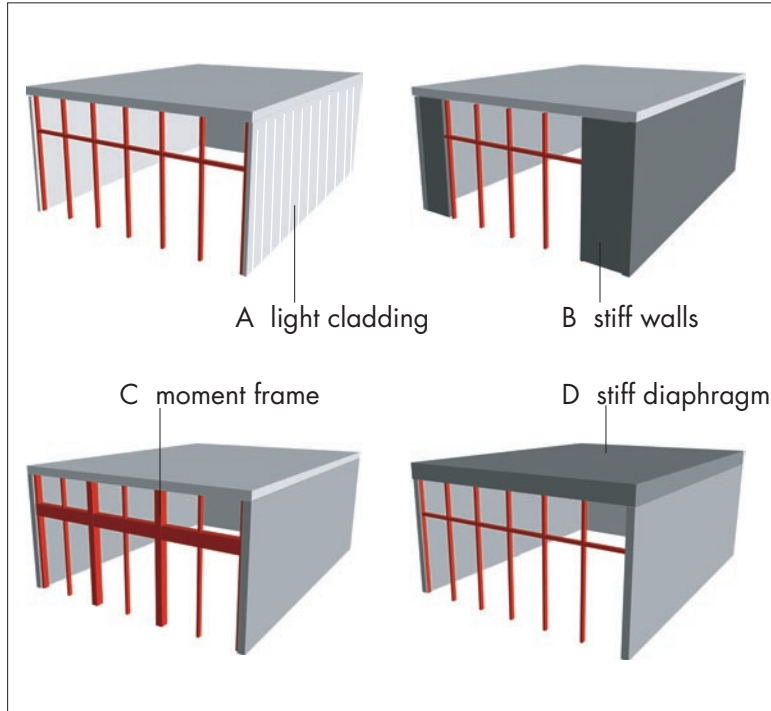
Figure 5-19
Some solutions
to store-front type
unbalanced-perimeter-
resistance conditions

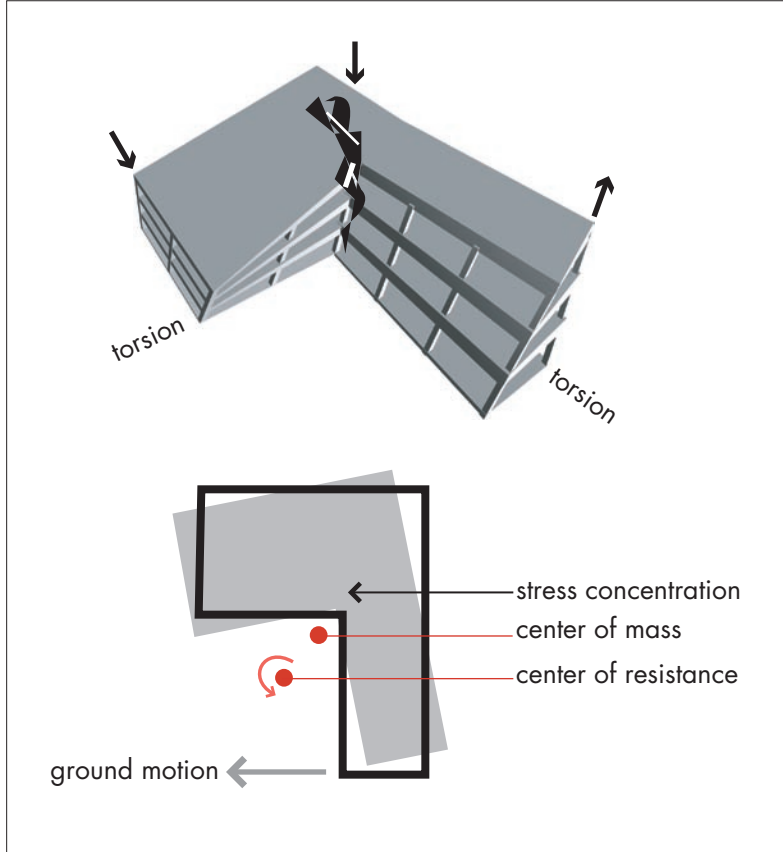
Figure 5-21
Re-entrant corner plan forms.

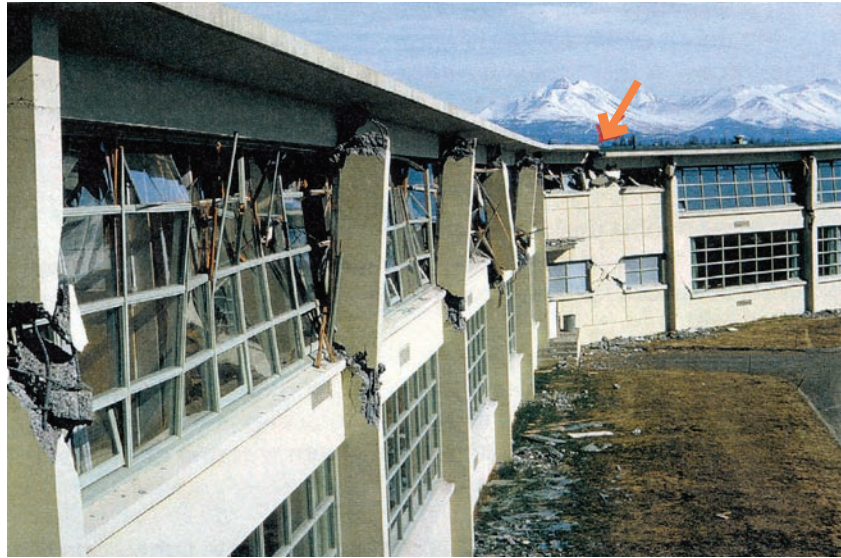
Figure 5-22: West Anchorage High School, Alaska earthquake, 1964. Stress concentration at the notch of this shallow L-shaped building damaged the concrete roof diaphragm.

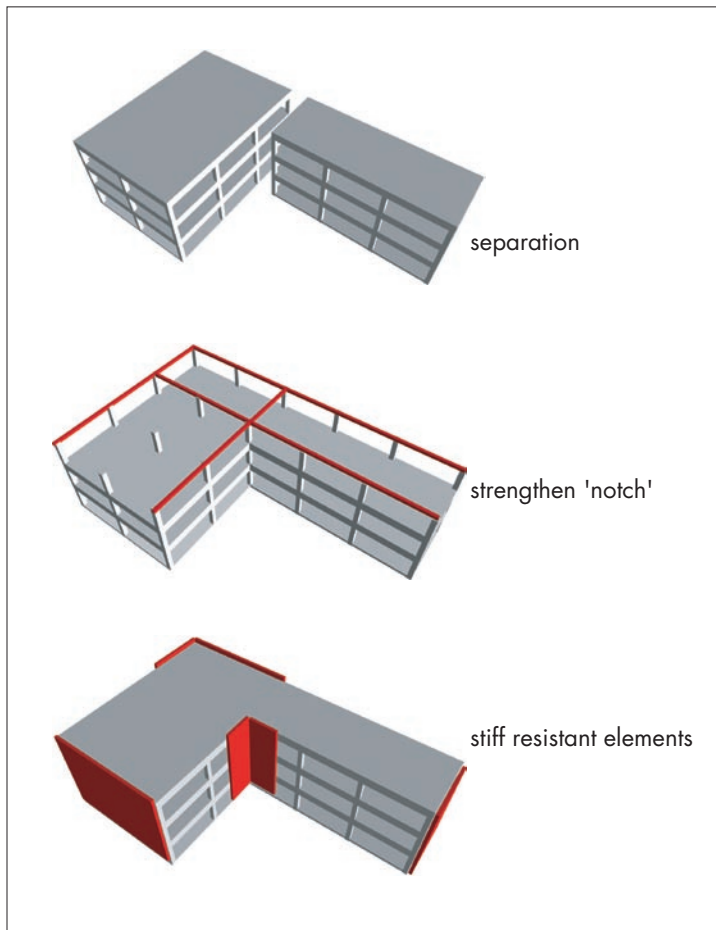
Figure 5-23
Solutions for the re-entrant-
corner condition.

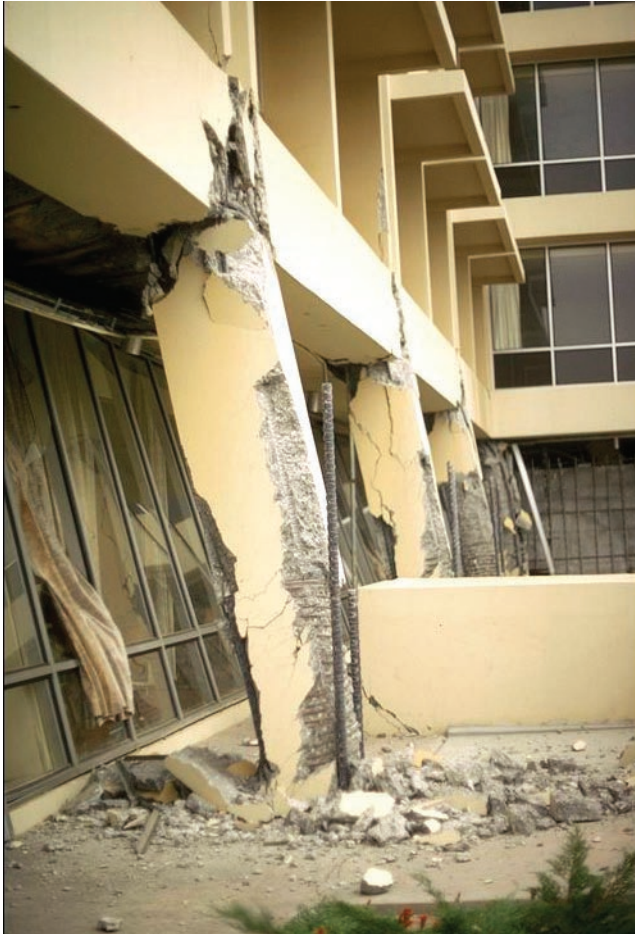
Figure 6-4: Sylmar, 1971, Damage to engineered building at Olive View Medical Center.

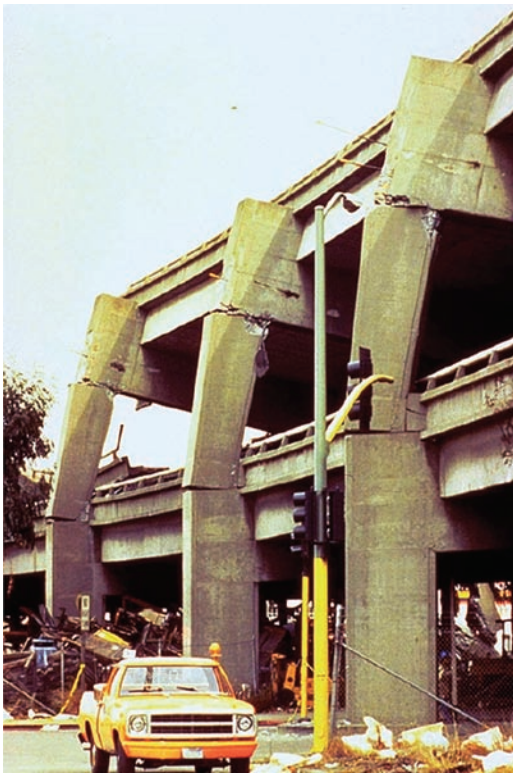
Figure 6-6: San Francisco, 1989, elevated highway support bents, an example of failure of engineered structures.
