Designing for Earthquakes

A Manual for Architects

FEMA 454 / December 2006

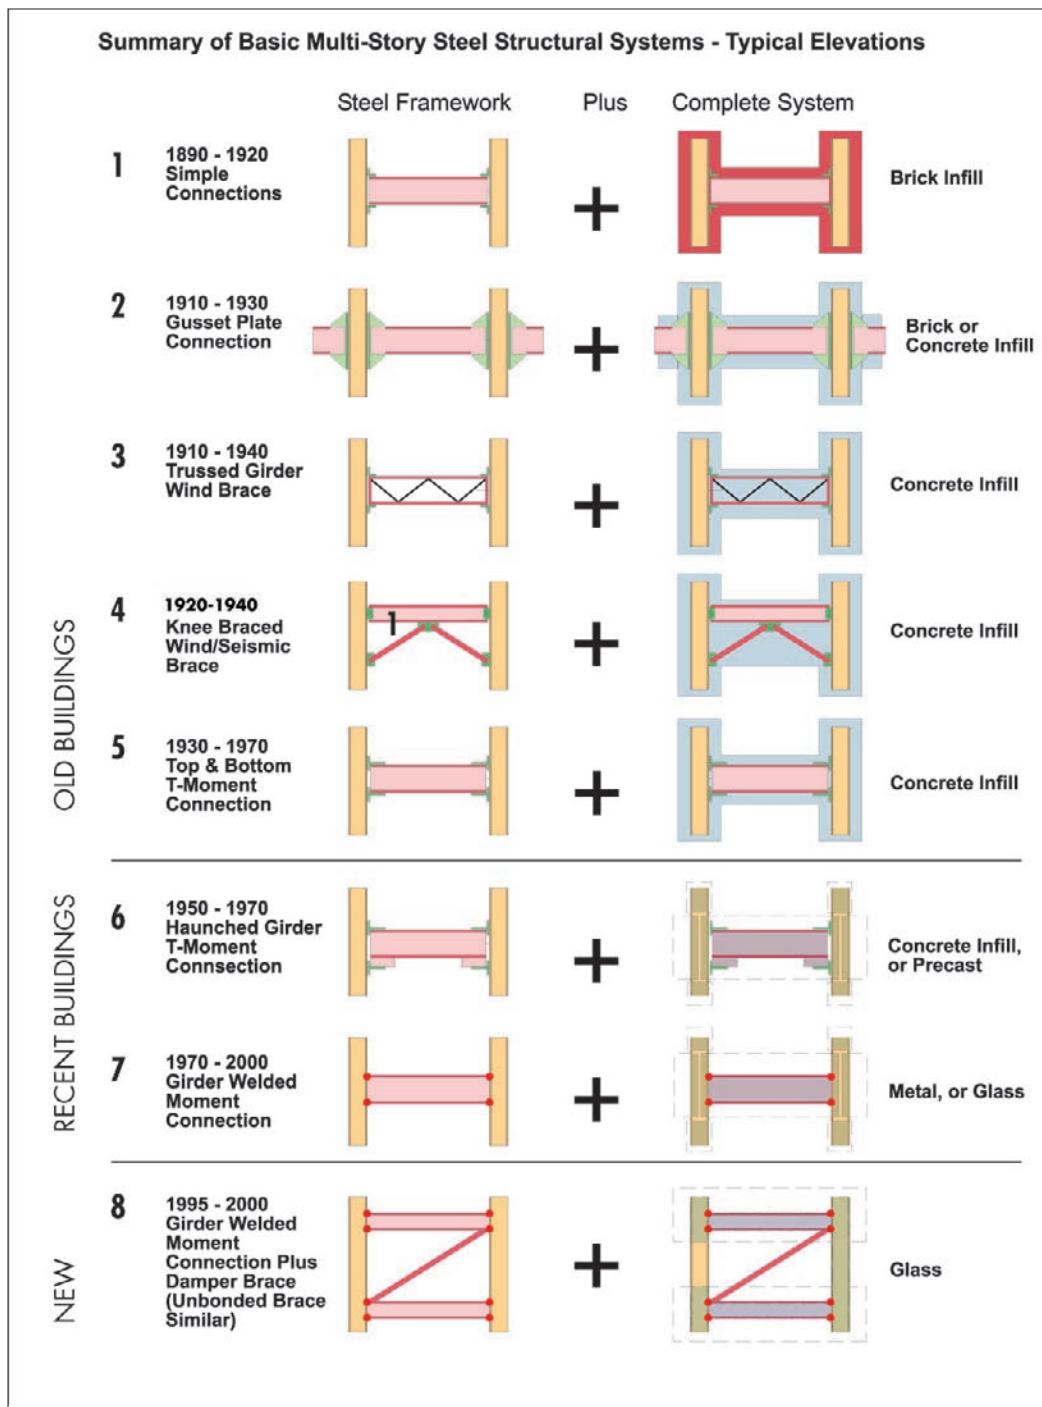
Figure 7-2: Steel building frameworks.

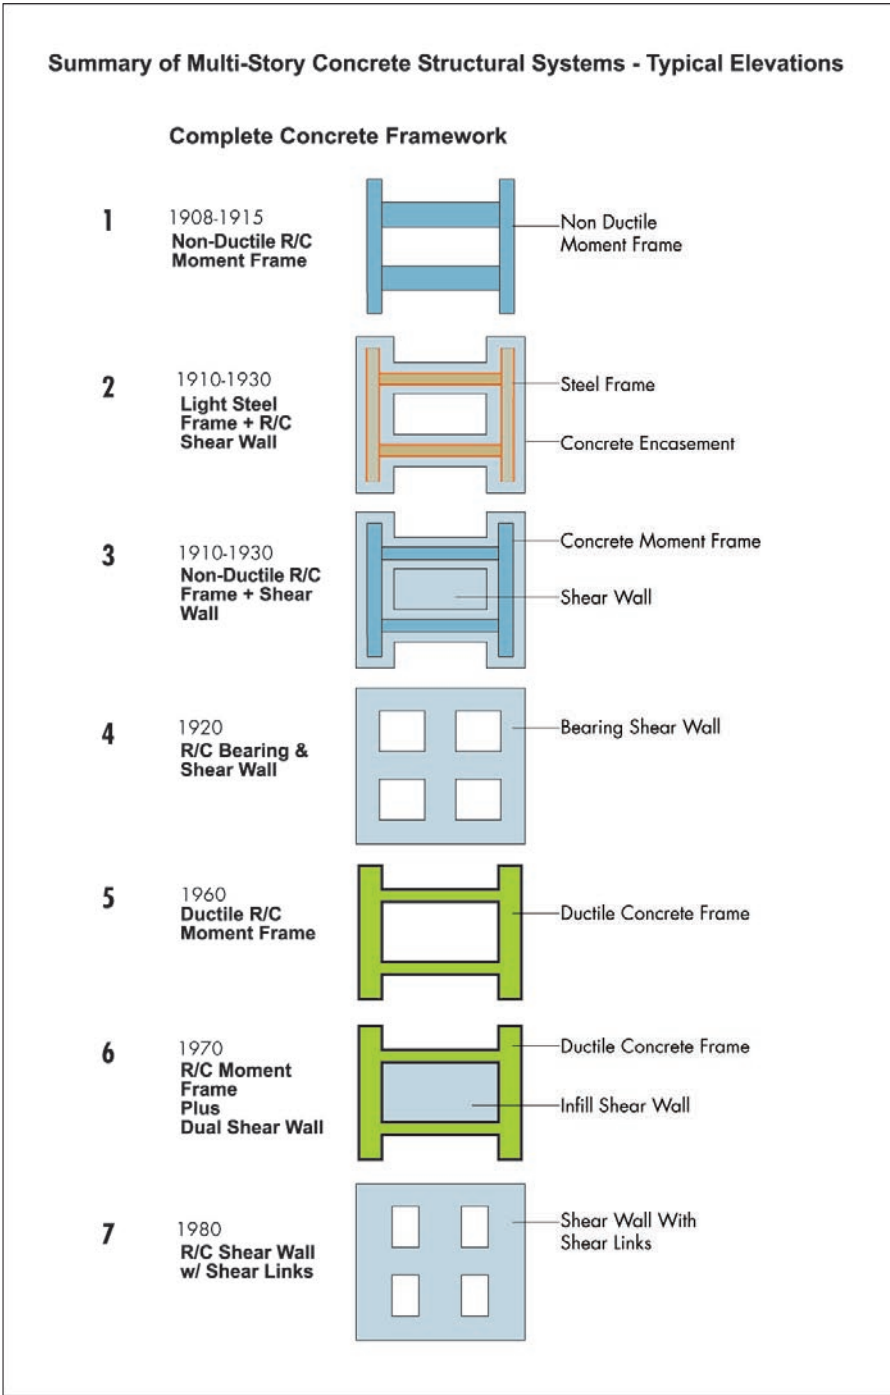
Figure 7-3: Concrete building frameworks

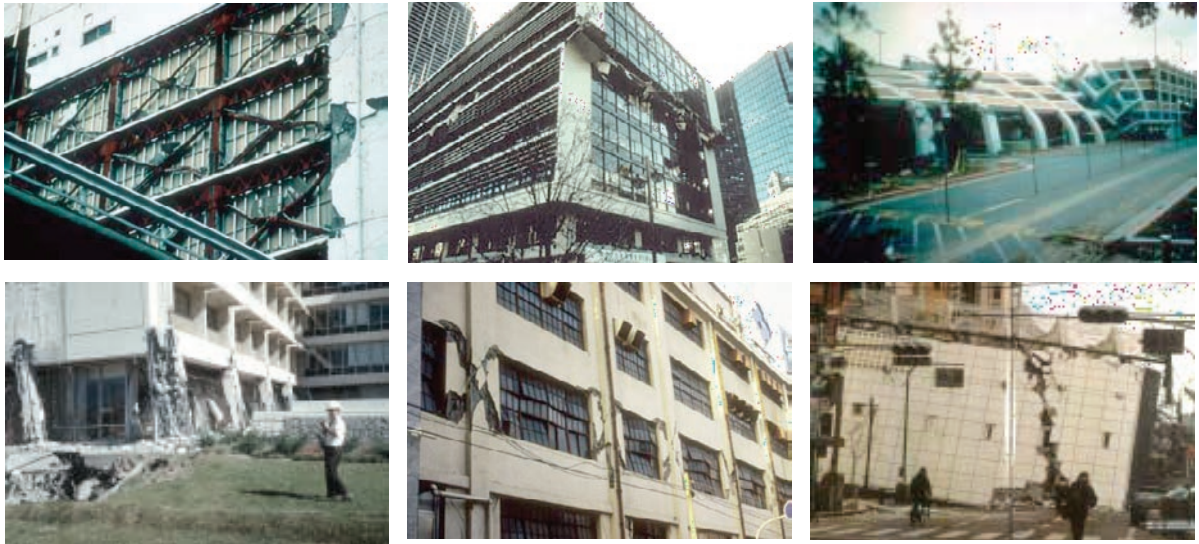
Figure 7-12: Examples of typical earthquake damage.

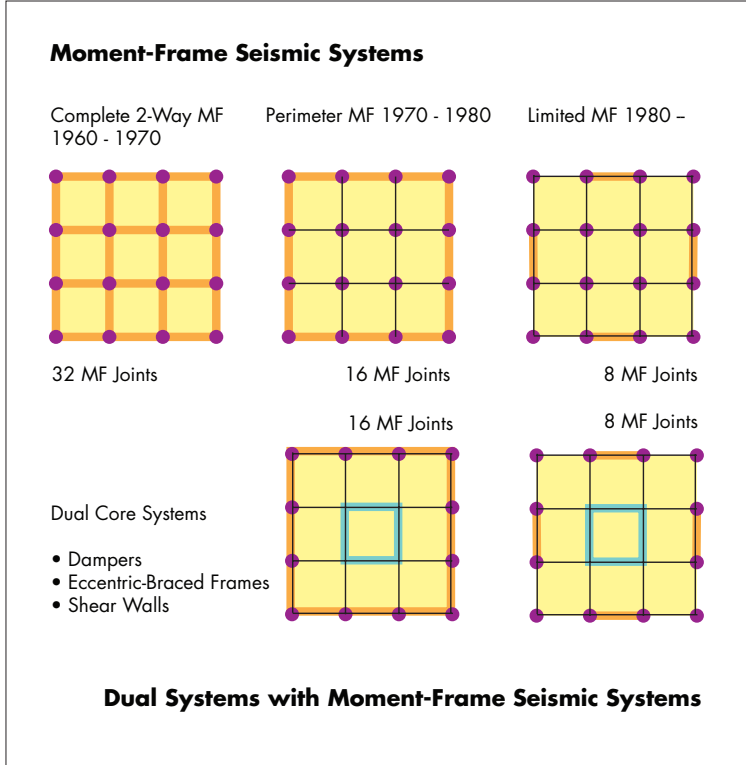
Figure 7-18: Single and multiple system concepts.

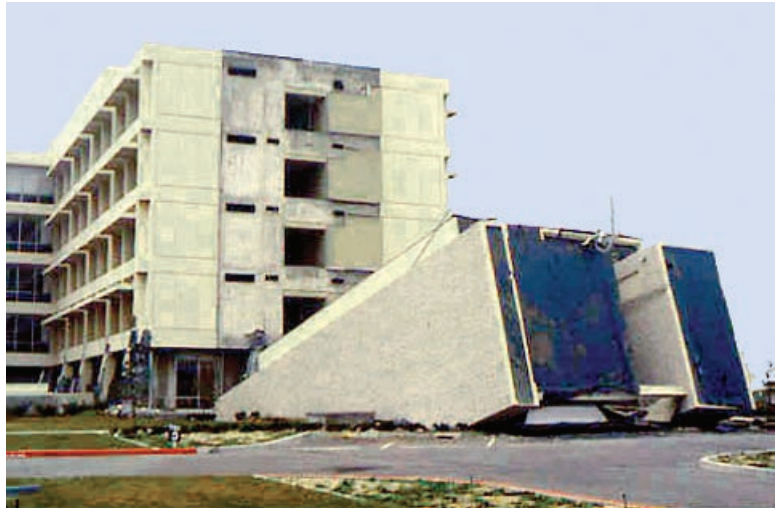
Figure 8-2: Olive View Hospital. A brand new facility that was damaged beyond repair in the 1971 San Fernando earthquake due to a shaking intensity that exceeded what was expected at the site and a design that, although technically complying with code at the time, contained several structural characteristics now considered major deficiencies. The lateral system contained nonductile concrete frames, discontinuous shear walls, and a significant weak story.

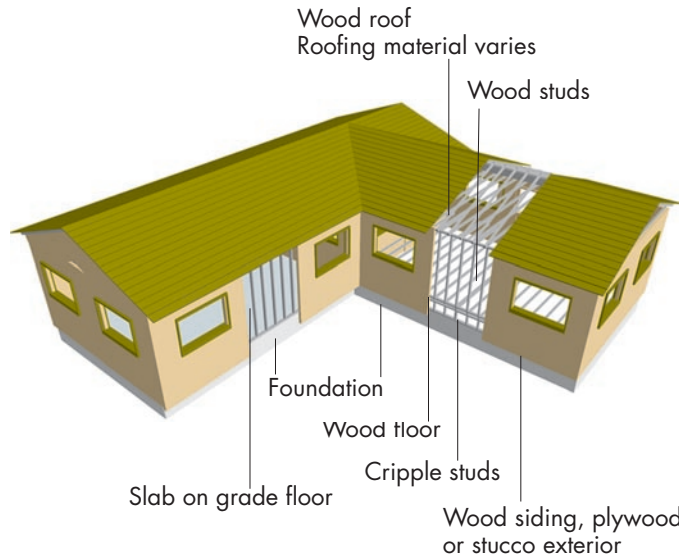
These buildings are generally single-family dwellings of one and two stories. Floor and roof framing consists of wood joists or rafters supported on wood studs spaced no more than 24 inches apart. The first floor may be slab on grade or wood raised above grade with cripple stud walls and post-and-beam supports. Lateral support is provided with shear walls of plywood, stucco, gypsum board, and a variety of other materials. Most often there is no engineering design for lateral forces.

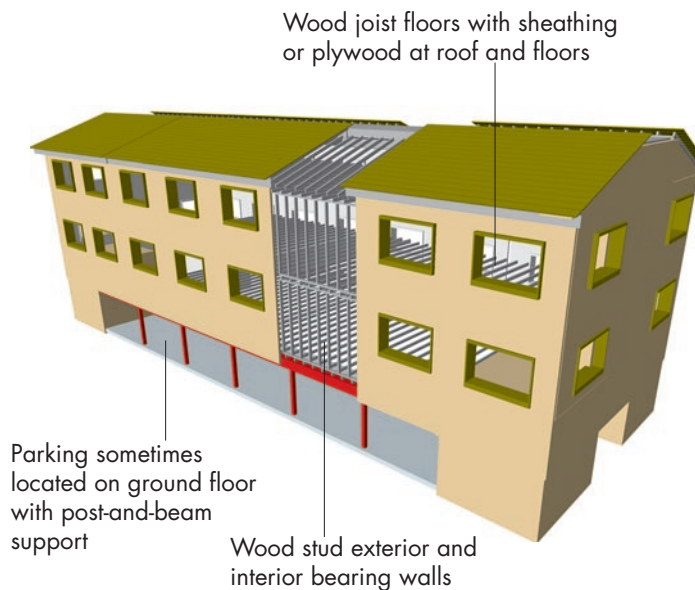
These buildings are framed with the same systems as W1 buildings but are most often multiple-story large residential-type structures, and, unless very old, are engineered. A common seismic deficiency is the tuck-under parking at the ground story that creates a soft or weak story. This building type is also often built on top of a one story concrete parking structure.

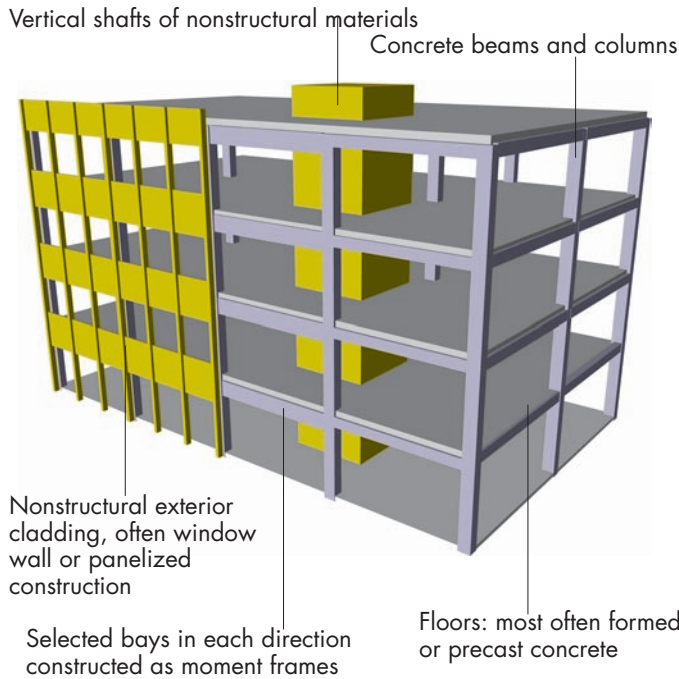
These buildings consist of concrete framing, either a complete system of beams and columns or columns supporting slabs without gravity beams. Lateral forces are resisted by moment frames that develop stiffness through rigid connections of the column and beams placed in a given bay. Moment frames may be developed on all framing lines or only in selected bays. It is significant that no structural walls are required. Floors are cast-in-place or precast concrete. Buildings with concrete moment frames could be used for most occupancies listed for steel moment frames, but are also used for multifamily residential buildings.

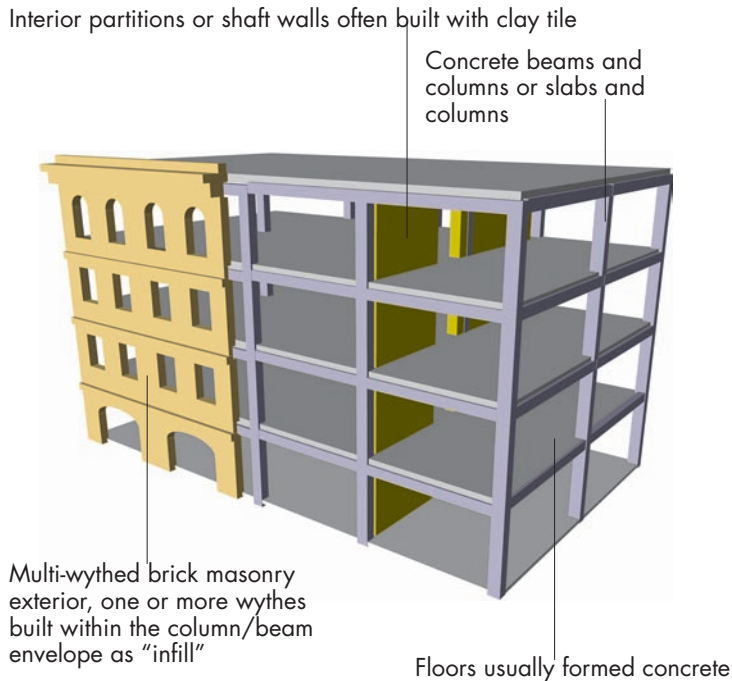
These buildings consist of concrete framing, either a complete system of beams and columns or columns supporting slabs without gravity beams. Exterior walls and possibly some interior walls are constructed of unreinforced solid clay brick, concrete block, or hollow clay tile masonry infilling the space between columns and beams. Windows and doors may be present in the infill walls, but to act effectively as shear-resisting elements, the infill masonry must be constructed tightly against the columns and beams. The building type is similar to S5, but is more often used for industrial and warehouse occupancies.

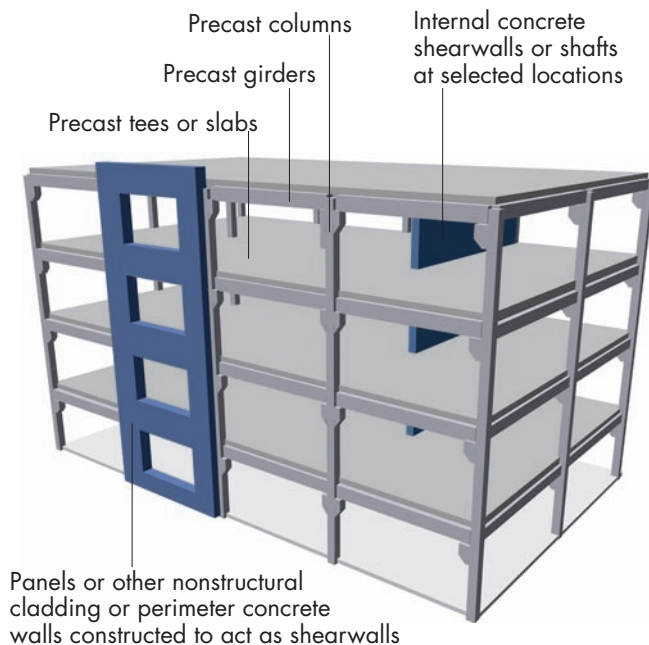
These buildings consist of concrete columns, girders, beams and/or slabs that are precast off the site and erected to form a complete gravity-load system. Type PC2 has a lateral force-resisting system of concrete shear walls, usually cast-in-place. Many garages have been built with this system. The building type is most common in moderate and low seismic zones and could be used for many different occupancies in those areas.

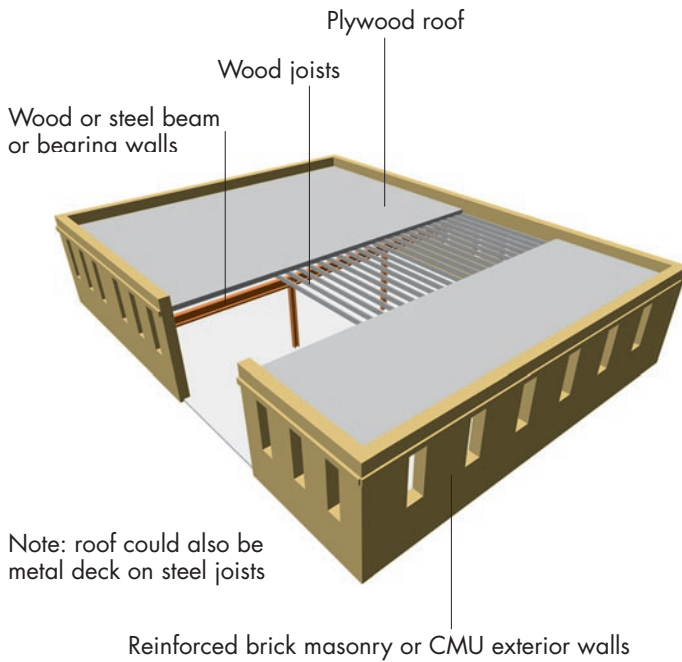
These buildings take a variety of configurations, but they are characterized by reinforced masonry walls (brick cavity wall or CMU) with flexible diaphragms, such as wood or metal deck. The walls are commonly bearing, but the gravity system often also contains post-and-beam construction of wood or steel. Older buildings of this type are generally small and were used for a wide variety of occupancies and are configured to suit. Recently, the building type is commonly used for one-story warehouse-type occupancies similar to tilt-up buildings.

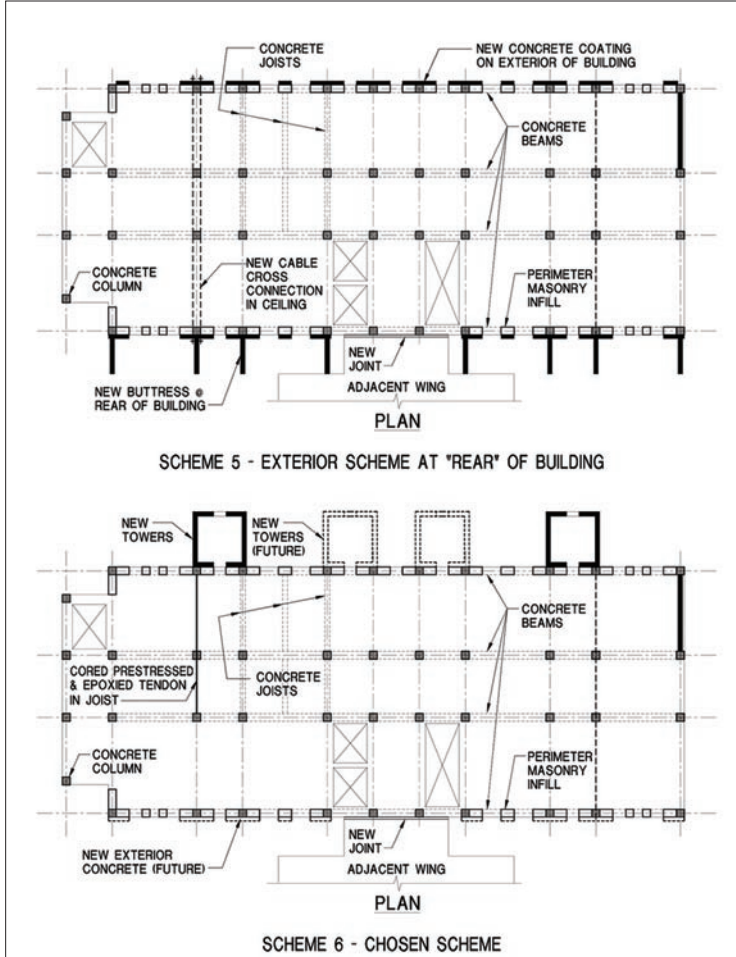
Figure 8-9c: Example of effect of non technical issues on retrofit schemes.
