# Techniques for the Seismic Rehabilitation of Existing Buildings

FEMA 547/2006 Edition

**FEMA 547 – October 2006**

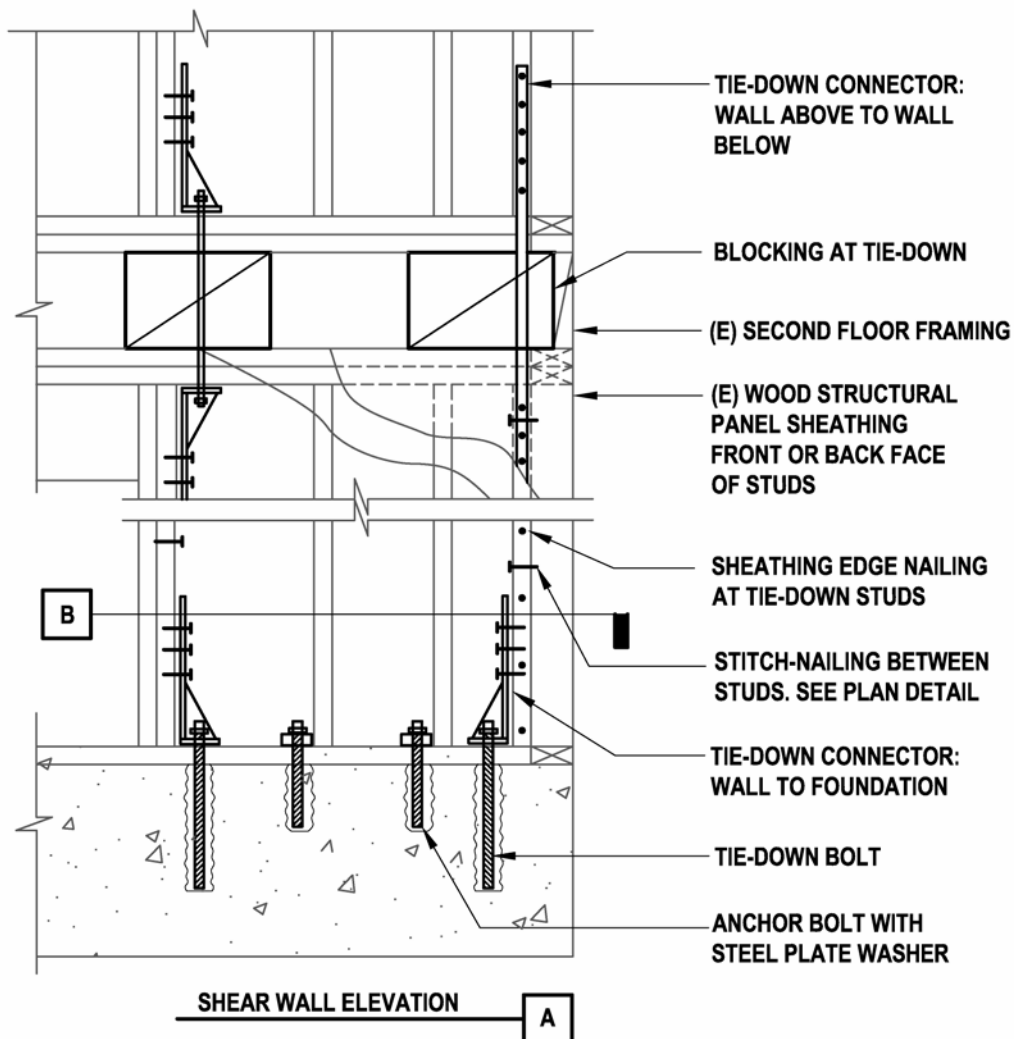
Figure 6.4.4-1A illustrates a shear wall elevation with commonly used tie-down connectors for a slab-on-grade condition. Figure 6.4.4-1B illustrates fastening to develop a load path between the tie-down connector and the shear wall sheathing edge nailing. For sheathing and framing conditions other than those shown, similar fastening must be provided to complete the load path.

**Figure 6.4.4-1A: Shear Wall Elevation with Enhanced Overturning Detailing**

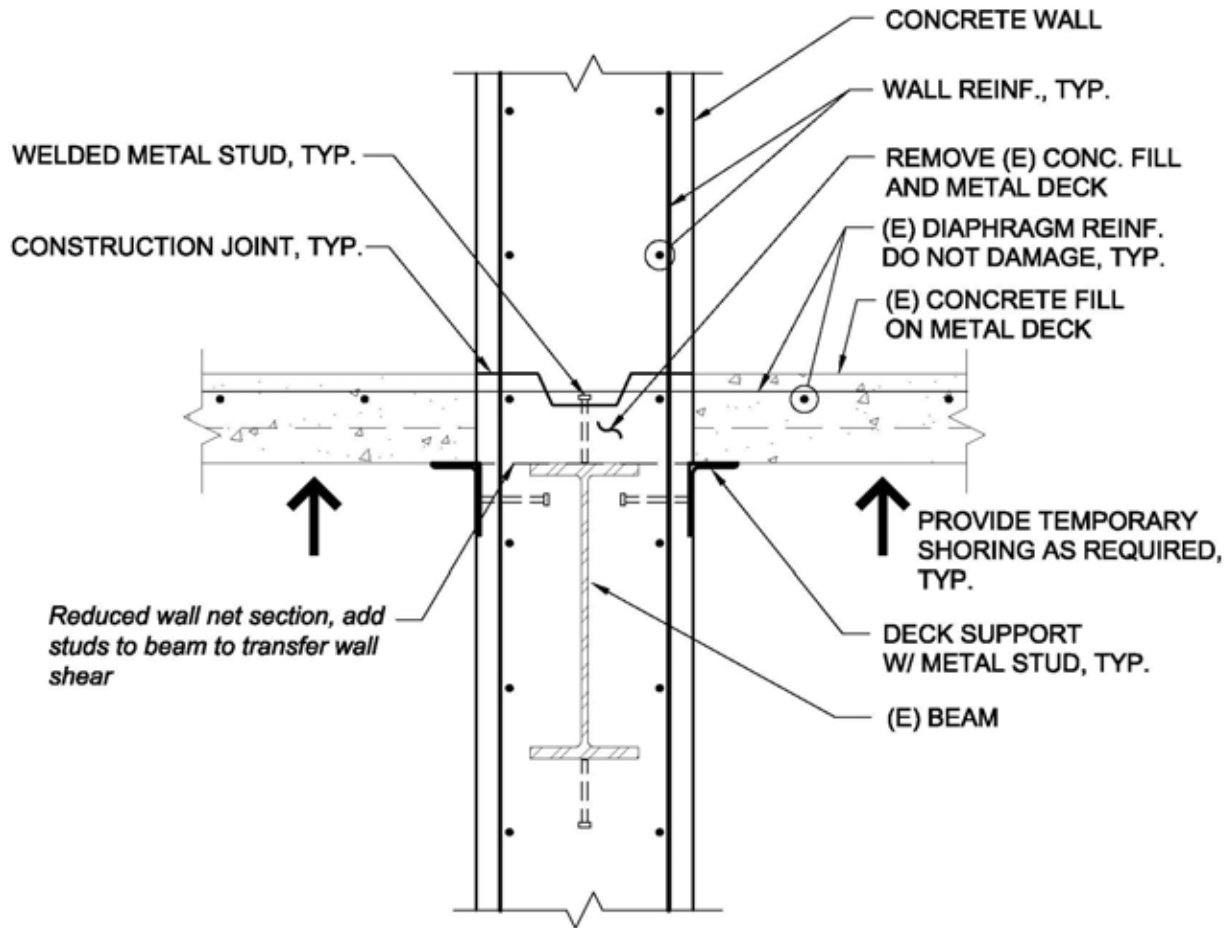
**Note:**  
Offset wall to one side of beam if additional room required for vibrating equipment or for shotcrete construction.

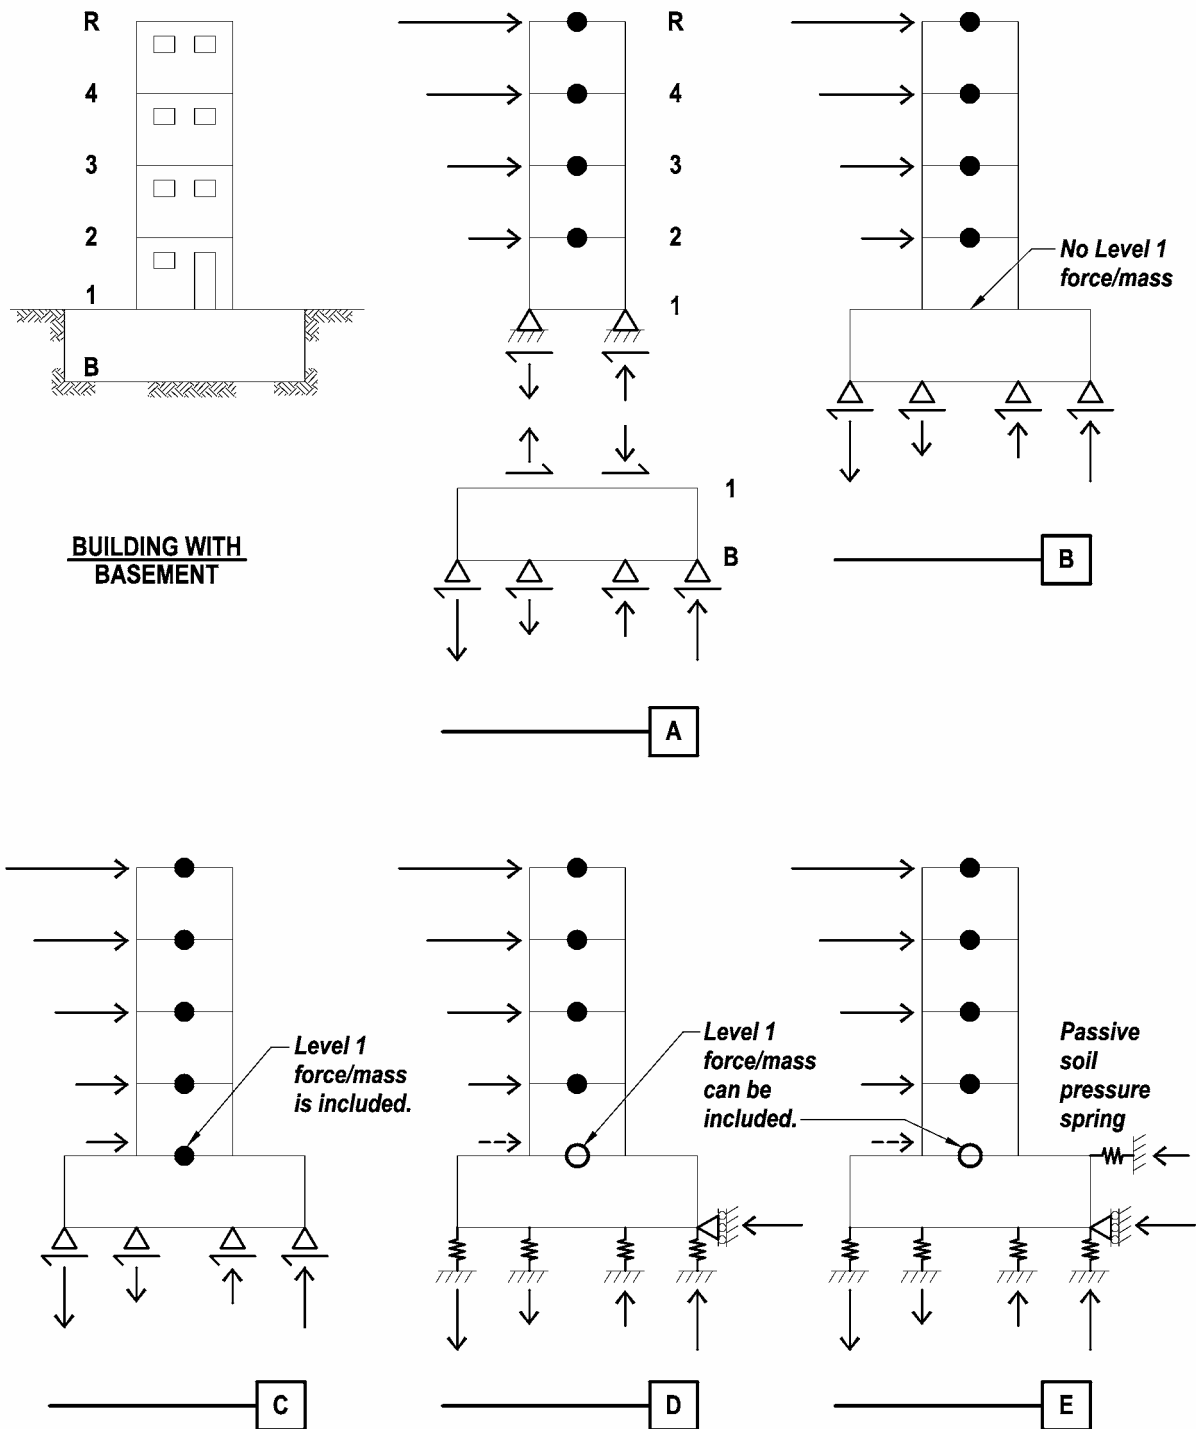
Figure 23.4-1: Modeling Approaches for Buildings with Basements

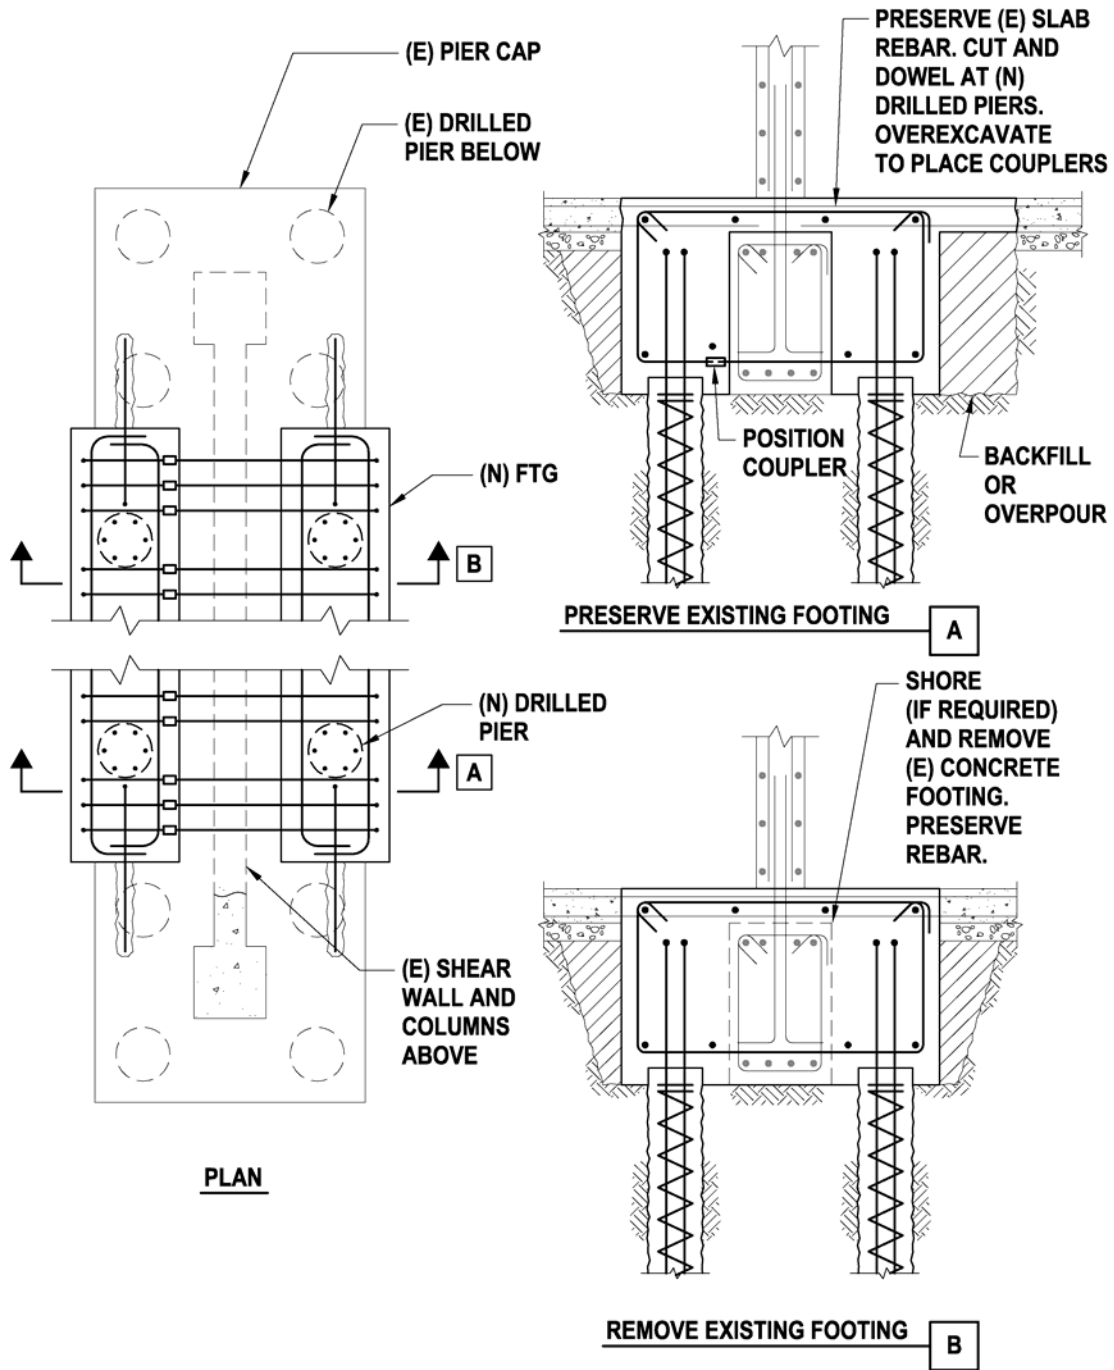
Figure 23.8.3.-1: Adding Drilled Piers to an Existing Drilled Pier Foundation

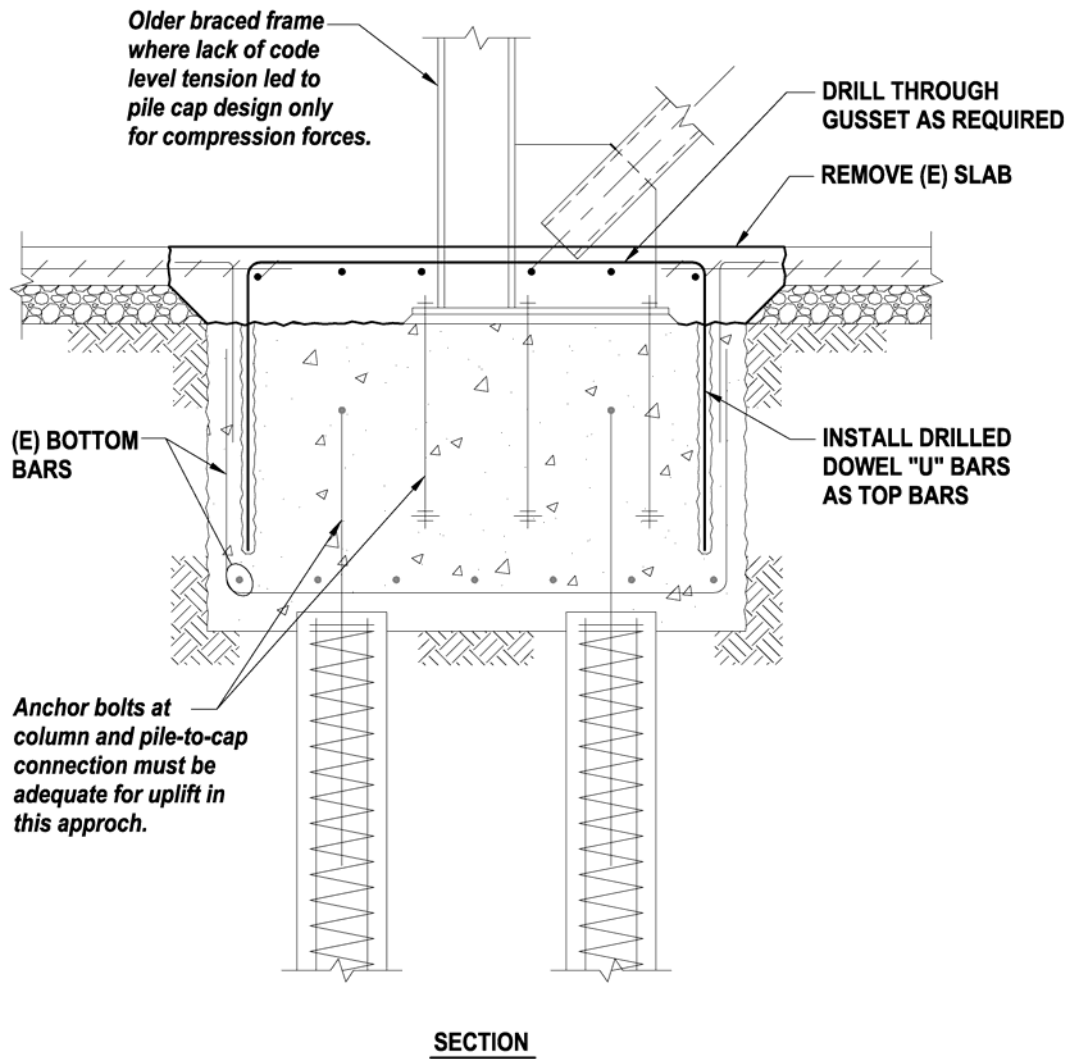
**Figure 23.8.5-1: Adding Top Bars to an Existing Pile Cap**

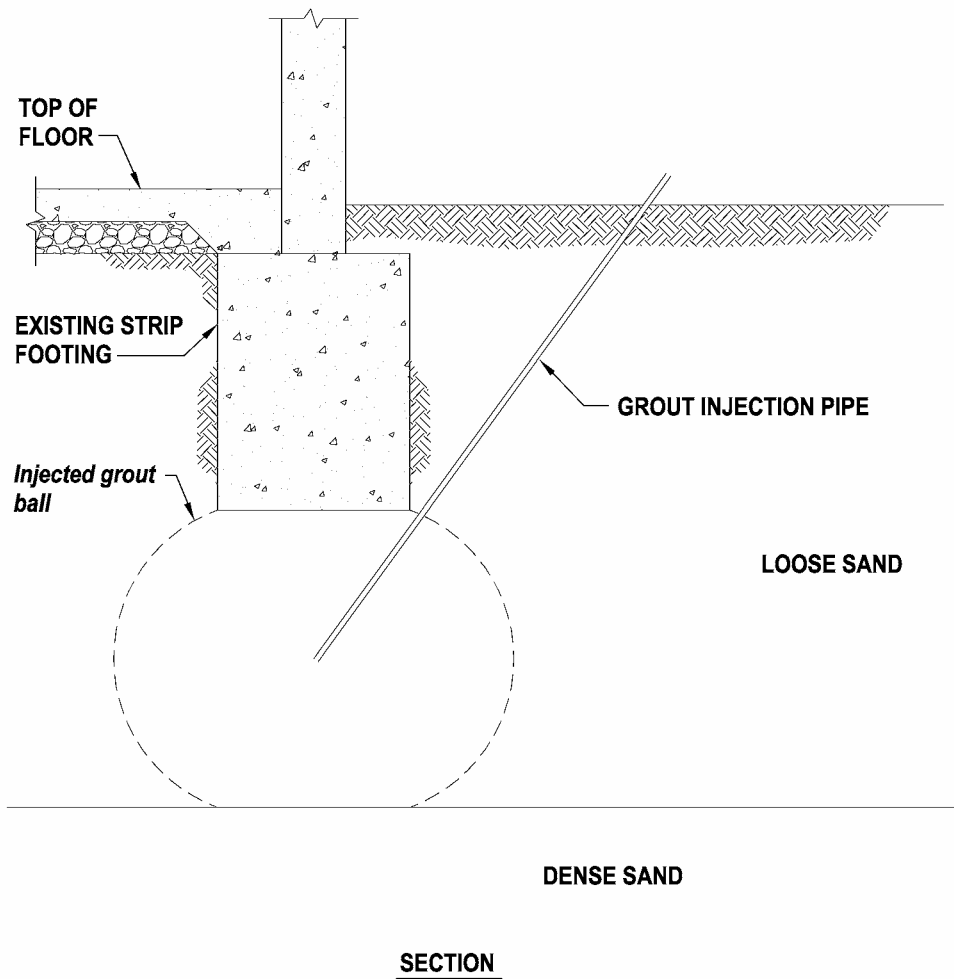
**Figure 23.9.3-1: Permeation Grouting of Loose Sand Under Existing Shallow Foundation**

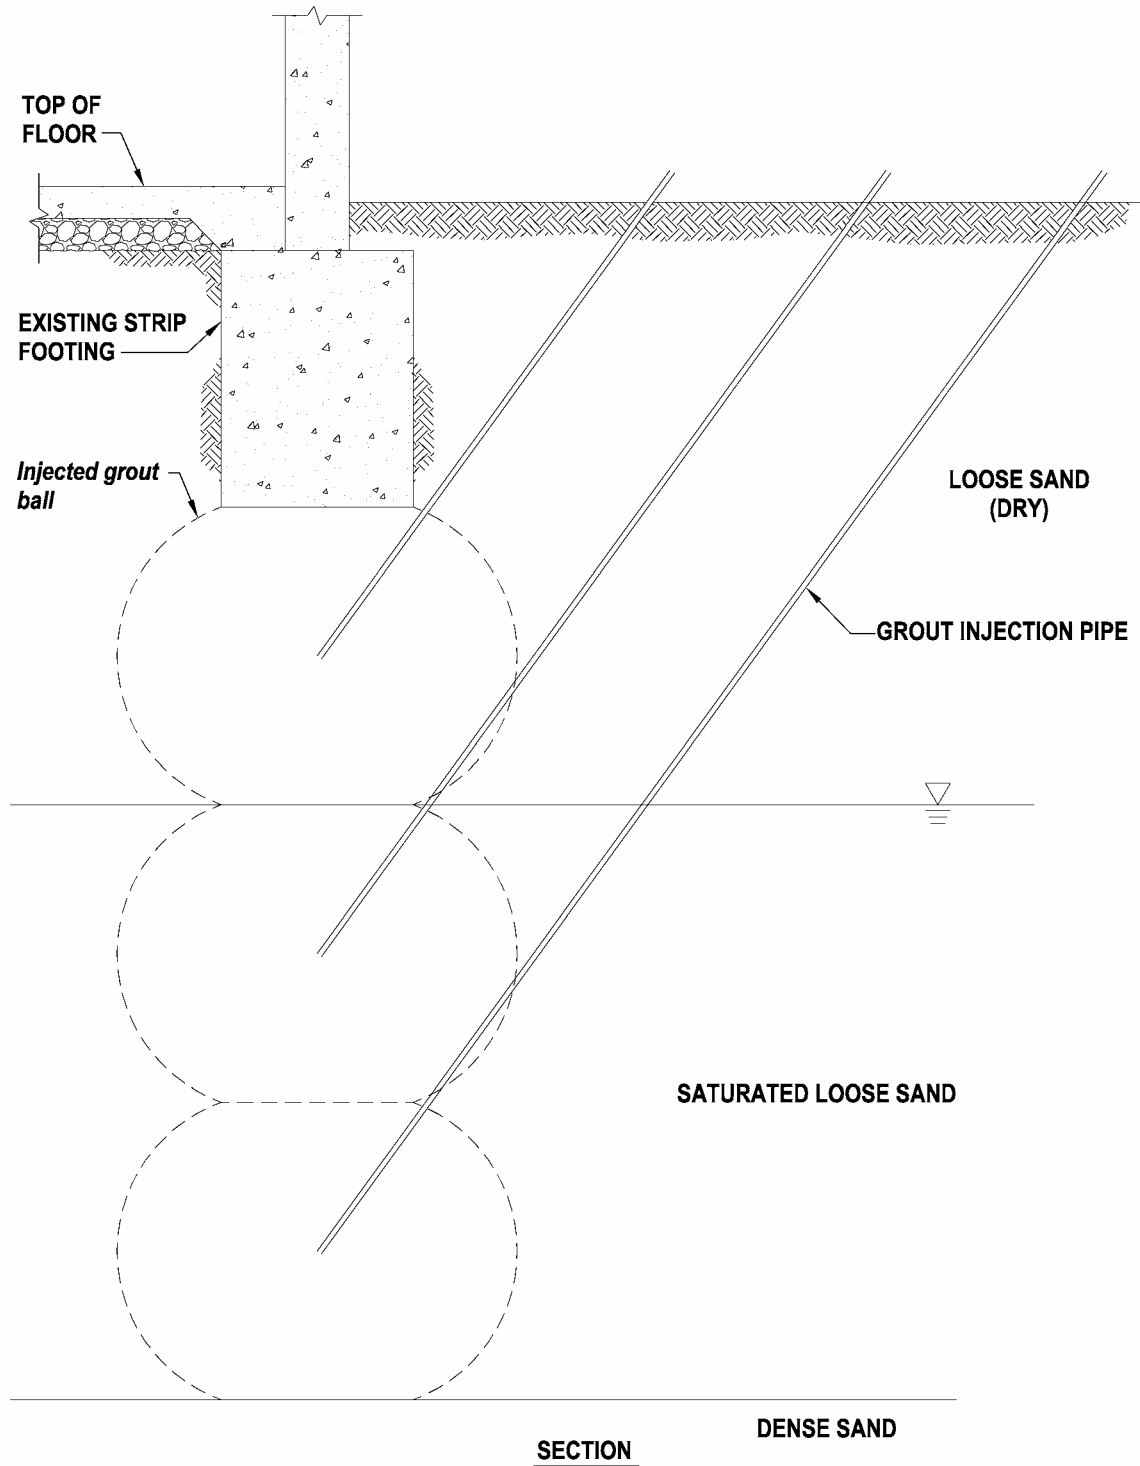
**Figure 23.9.3-2: Permeation Grouting of Liquefiable Layer Under Existing Shallow Foundation**
